Accident Investigation Report

Underground Salt Haul Truck Fire at the Waste Isolation Pilot Plant February 5, 2014

March 2014

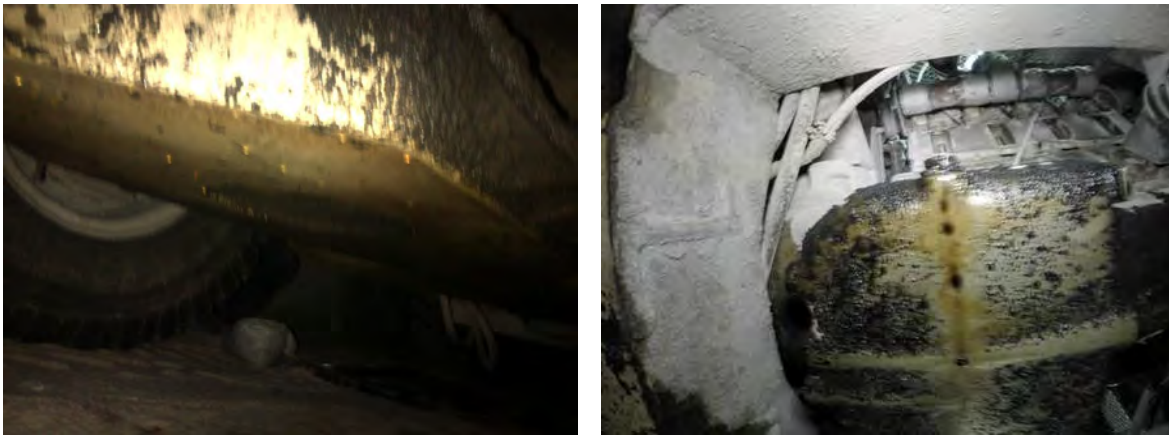
- There was significant buildup of engine and hydraulic oil on other mining equipment including Salt Haul Truck 74U006A. (Figure 13)

Figure 13: Buildup of Engine Fluids on the Underside of Vehicles in the Mine

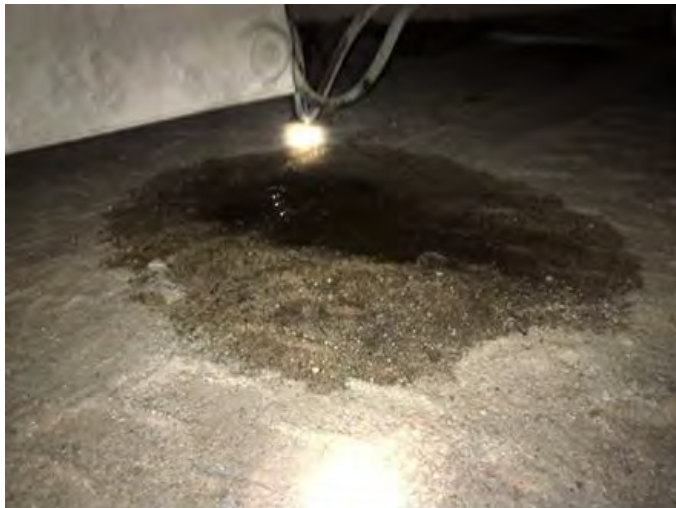
- There was a three-foot diameter puddle of hydraulic fluid underneath Salt Haul Truck 74U006A. (Figure 14)
- The daily Operator's Checklist was completed on February 5, 2014, for Salt Haul Truck 74U006A with no deficiencies indicated.
- There was an Out of Service tag on Salt Haul Truck 74U006A indicating that a lighting deficiency existed.
- Several mine phones were found to be inoperable (run to battery failure). Twelve of 40 phones tested were non-functional.
- Numerous components of the mine ventilation system were out of

Figure 14: Hydraulic Fluid under Truck 74U006A

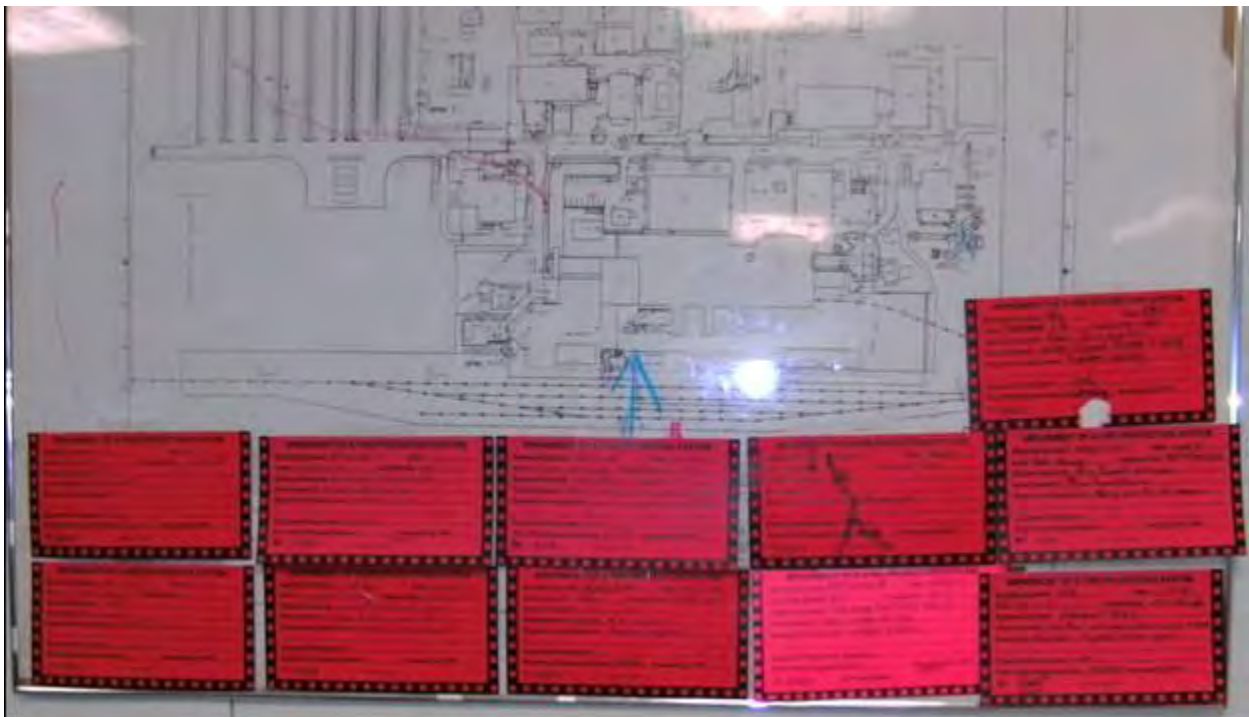
The Board reviewed the equipment status and condition in the CMR and the U/G. The condition of critical pieces of equipment, such as the 700 exhaust fans, indicates that management has not taken prompt action to resolve longstanding deficiencies. Many items have been out of service or in a reduced status for more than six months. It was not clear that NWP had a clear approach to prioritizing maintenance activities in regard to critical equipment or that there is an effective formal process to identify compensatory measures other than a fire watch for impaired safety-related equipment. Additionally, the equipment and components that affect normal operation of the mine ventilation system did not appear to have been effectively evaluated and dispositioned regarding their impact on system operation. (Figure 16)

Figure 16: Fire Protection System Impairment (Out-of-Service Tags) in the CMR

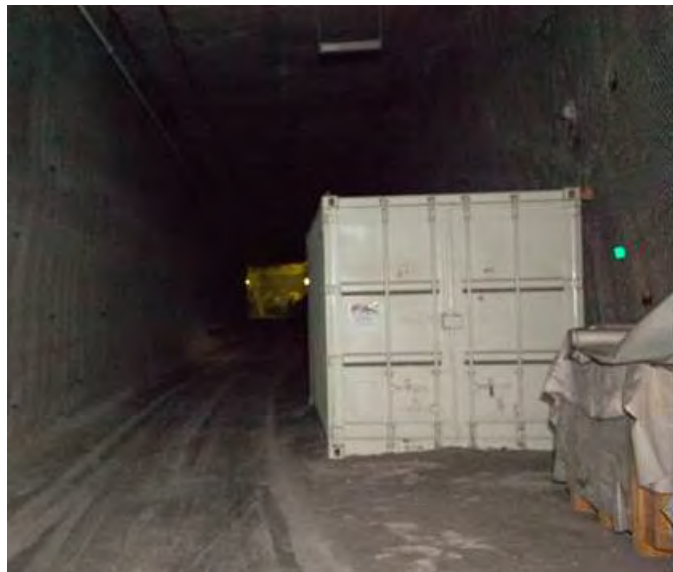
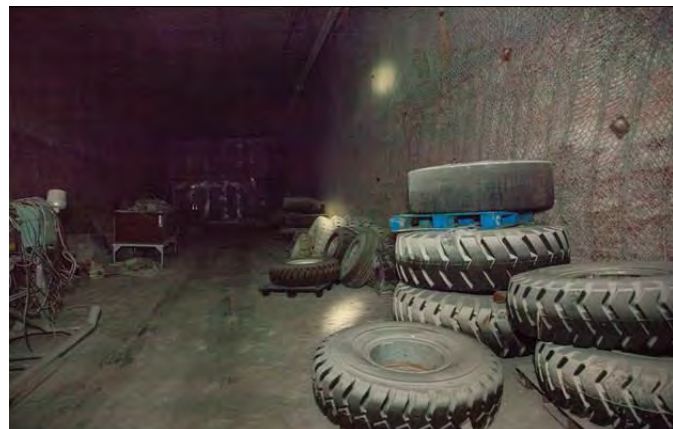
While these fire protection reviews addressed only the control of combustible materials, material storage and staging is really the issue. Salt movement requires periodic touchup to the ribs and back (walls and ceiling) to maintain the non-waste work areas, and the floors throughout the mine, in good repair. As a result, equipment and materials are moved out of an area and staged in the drifts. Although this staging is temporary storage, the condition can last several months. The Board observed materials

Figure 17: Combustible Loading in the Mine

stored on either side of the drifts, materials that obscured reflectors, and stored combustibles exceeding the 5 megawatt (MW) limit. Personnel group interviews indicated storage on only one side of drift could have made navigation in drift easier.

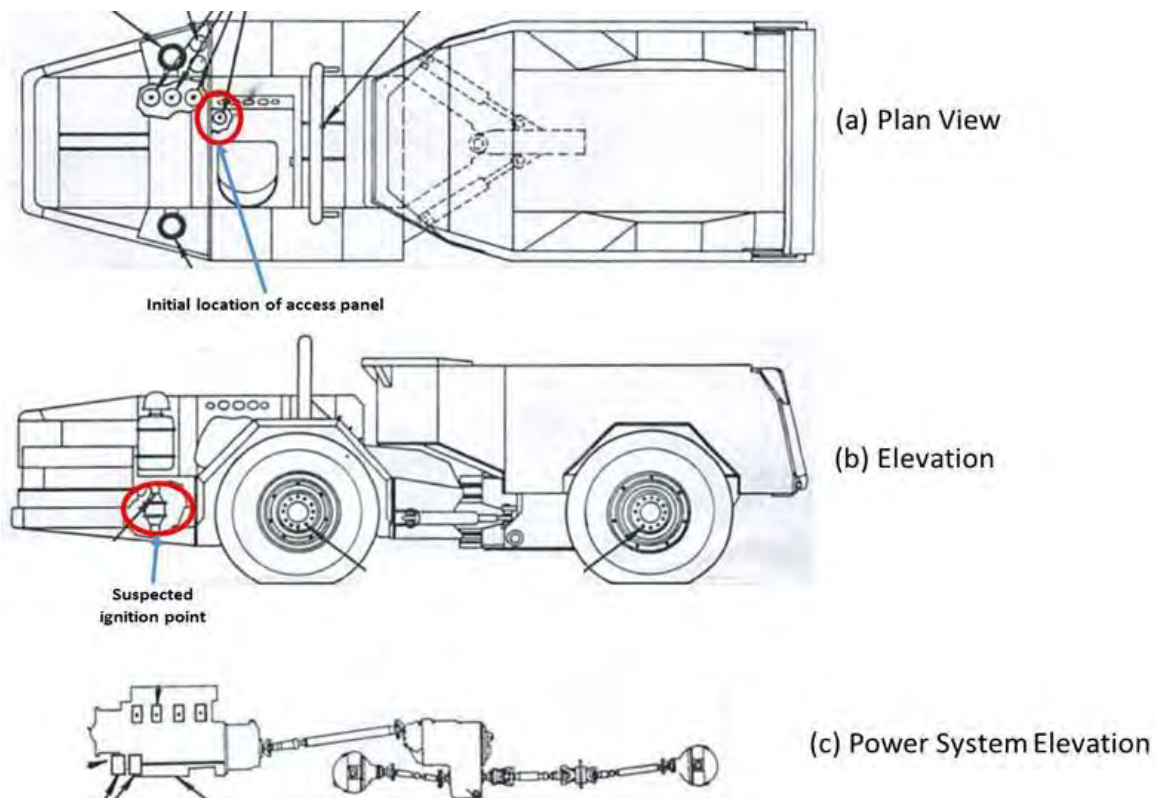
Fire ignition is presumed to have occurred near the exhaust system piping on the lower left side of the haul truck forward of the front wheel (see Figure 18). This area is enclosed by steel construction, making early visual detection difficult. The initial material ignited was a combustible liquid leaking onto the exhaust system. The liquid could have been free flowing or an accumulation on exposed surfaces. The flashpoint temperatures for haul truck fluids are listed in Table 2. The operating temperature of a typical catalytic converter will range from 300 to 500° C; however, this may exceed 500° C during abnormal engine operation (NFPA 921-2014, *Fire and Explosion Investigations*). All of these values exceed the flashpoints shown in Table 2.

Figure 18: Salt Haul Truck

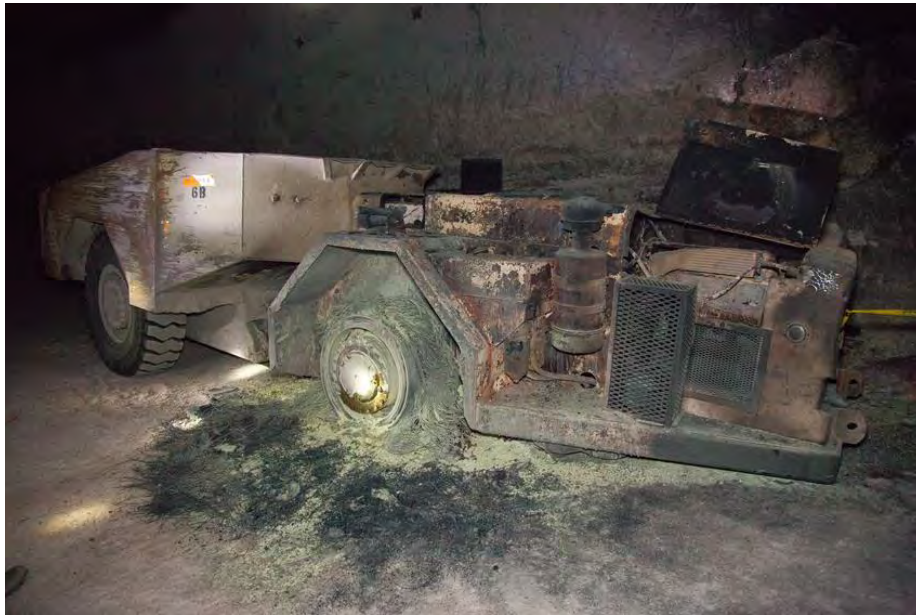
Ignition of the front tires likely occurred within 10 minutes of fire ignition (see Figure 21). Involvement of the tires produced heavy black smoke at the Salt Handling Shaft station before 1053 (1051 plus two minutes for the Salt Handling Shaft Bottom Lander to move to the station).

Figure 21: Salt Haul Truck Damage
(Engine Cowling Was Opened Post-Fire)

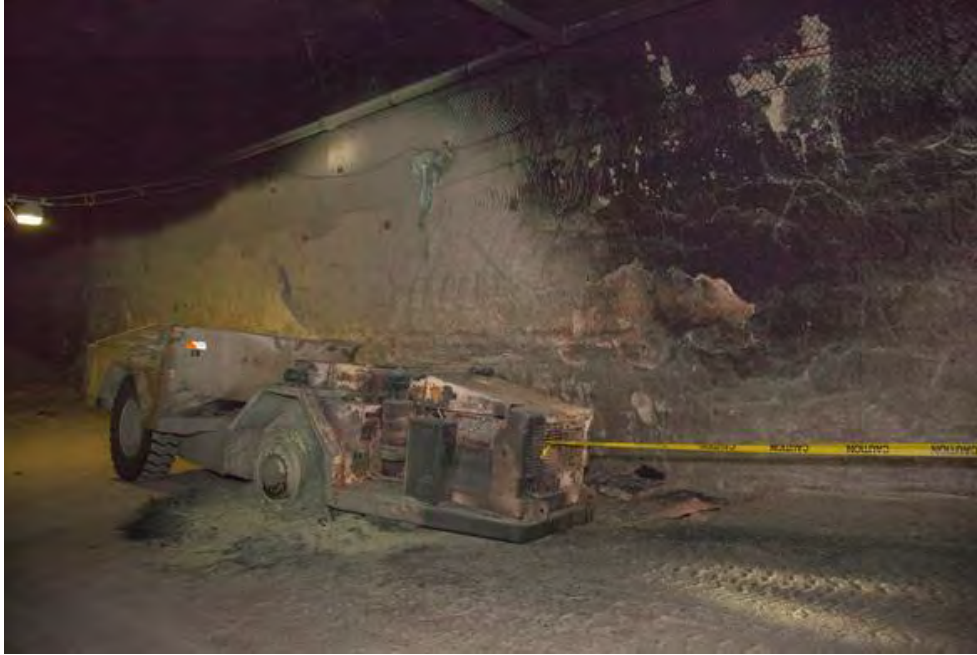
Figure 22: Haul Truck and Rib Spalling

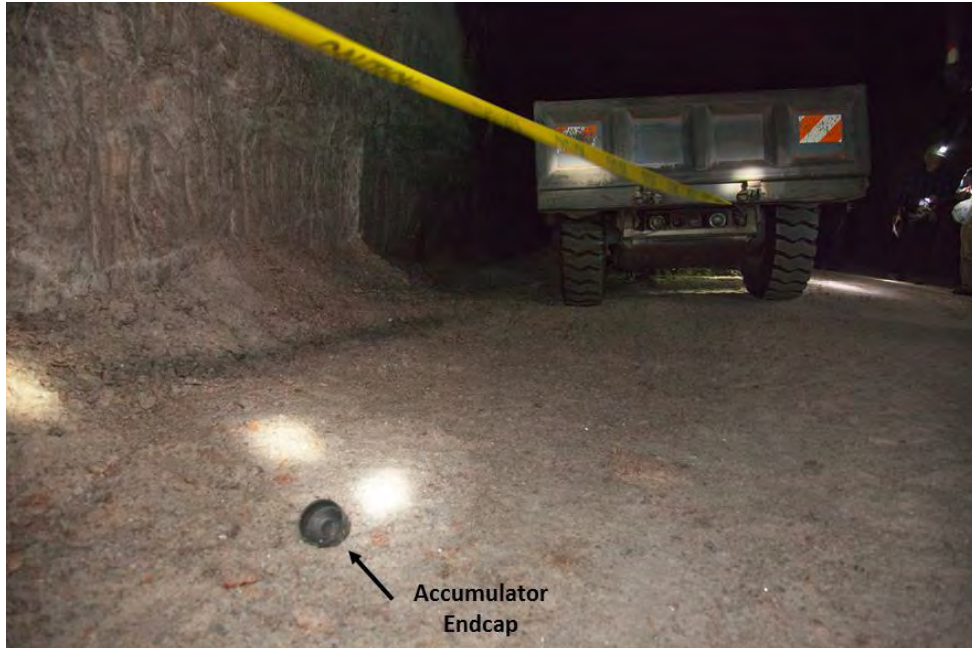
Sometime during the intense burning period an accumulator within the engine compartment burst. This ejected an end-cap which ruptured an access plate and went through the hauler operator compartment. The end-cap traveled approximately 10 feet beyond the back of the haul truck (see Figure 25). The access plate was severely deformed and traveled approximately 20 feet beyond the end of the haul truck (see Figure 26).

Figure 25: Accumulator Endcap (MG 3591)

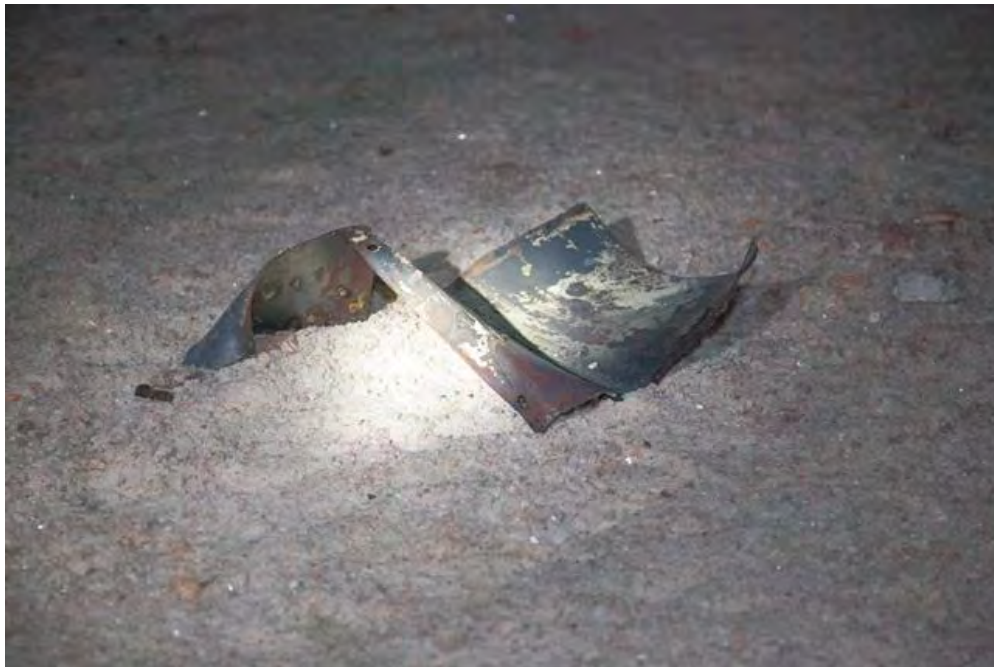
Figure 26: Damaged Access Plate
