# **WIPP Underground Radiological Event Investigation Summary February 14, 2014**

**Ted Wyka**  
**Chairman, Accident Investigation Board**  
**March 2014**

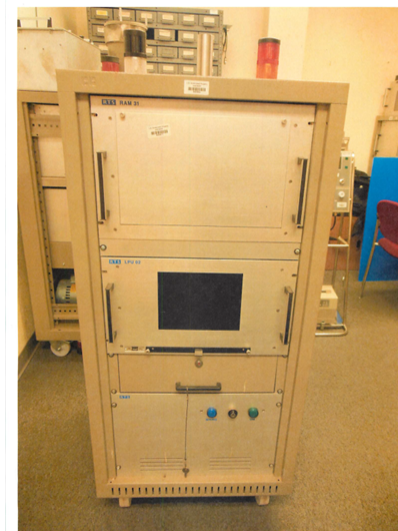
### **Continuous Air Monitor (CAM)**

The alarm was from a Continuous Air Monitor (CAM) in the underground that was monitoring an active transuranic (TRU) waste panel.

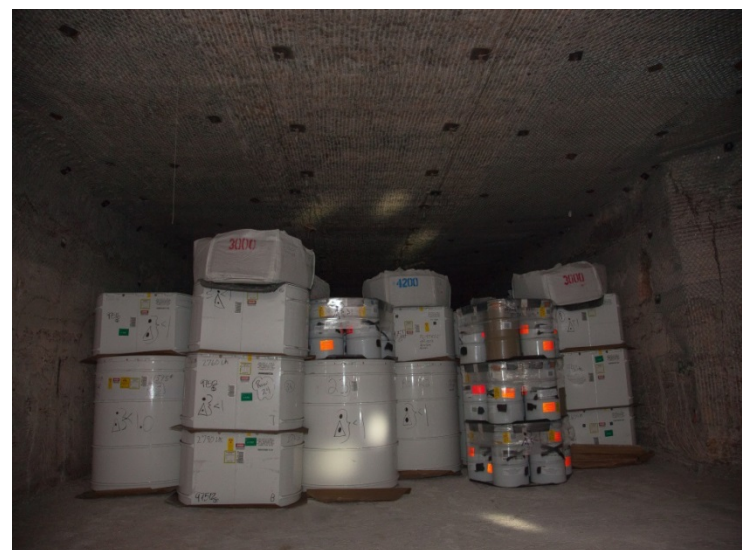
**Active Waste Face at Panel 7, Room 7**

As the underground was inaccessible, the Board was unable to determine the physical mechanism of container(s) failure, e.g., back (roof) or rib (wall) fall, puncture by a failed roof bolt, over pressurization, etc. is unknown at this time and must be determined once access to the U/G is restored.
