Accident Investigation Report

Phase 2 Radiological Release Event at the Waste Isolation Pilot Plant, February 14, 2014

April 2015

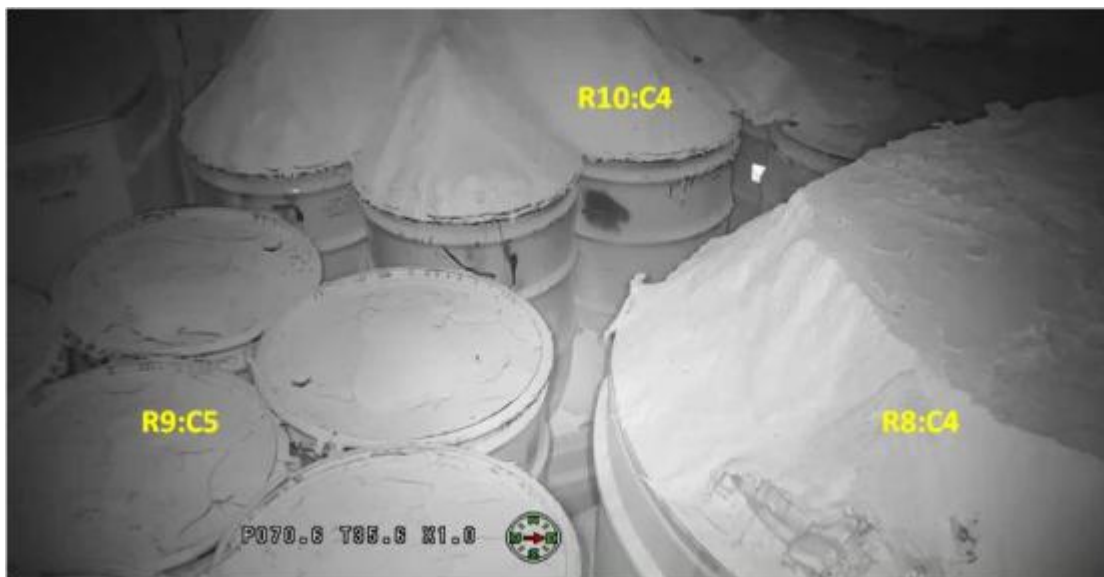
Figure 6-22: Damage at R9:C5 and R10:C4

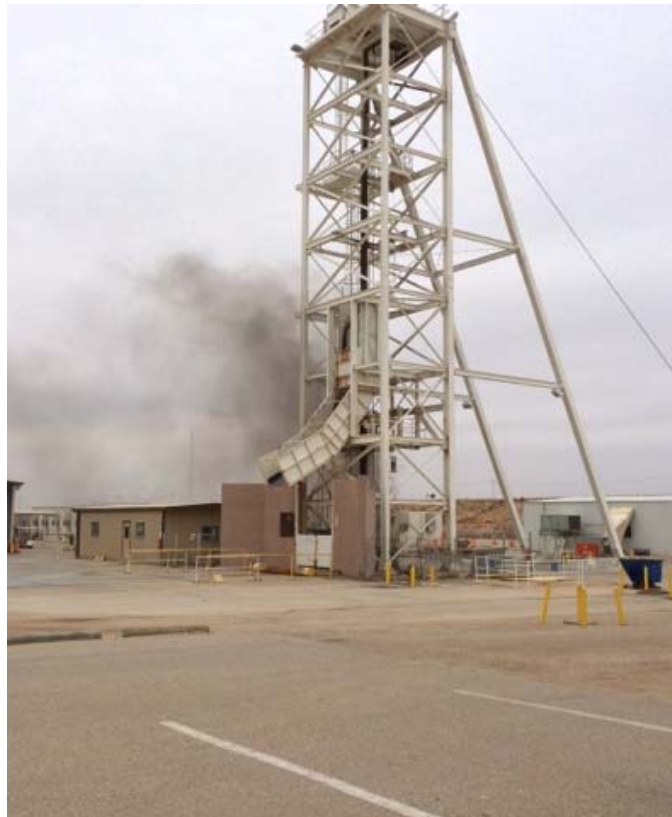
Upcasting in the Salt Handling Shaft did occur following the change to filtered mode (Figure 6-43). This upcasting increased the airflow moving past the salt haul truck fire. The flow behavior in the Salt Handling Shaft was modeled by a Bernoulli's fluid equation, recognizing that the volumetric flow up the shaft was induced by the thermal gradient, and would create a friction flow resistance. Simultaneous solution of the flow equation, and the energy balance equation, as discussed for the early portion of the fire, demonstrated that the temperature at the based of the Salt Handling Shaft was about 82°C when the energy release rate was 15 megawatts.

Figure 6-43: Upcasting Observed at the Salt Shaft on February 5, 2014
