SOME ASPECTS OF THE ROCK BURSTS
IN THE KIRKLAND LAKE GOLD MINES AT
KIRKLAND LAKE ONTARIO CANADA

A THESIS
SUBMITTED
TO
THE BOARD OF TRUSTEES PRESIDENT
AND FACULTY
OF
THE NEW MEXICO SCHOOL OF MINES
IN PARTIAL FULFILMENT OF THE REQUIREMENTS
FOR
THE PROFESSIONAL DEGREE OF
GEOLOGICAL ENGINEER

BY *Walter Riddell*
Walter Riddell
Kirkland Lake, Ontario
April 15, 1936.

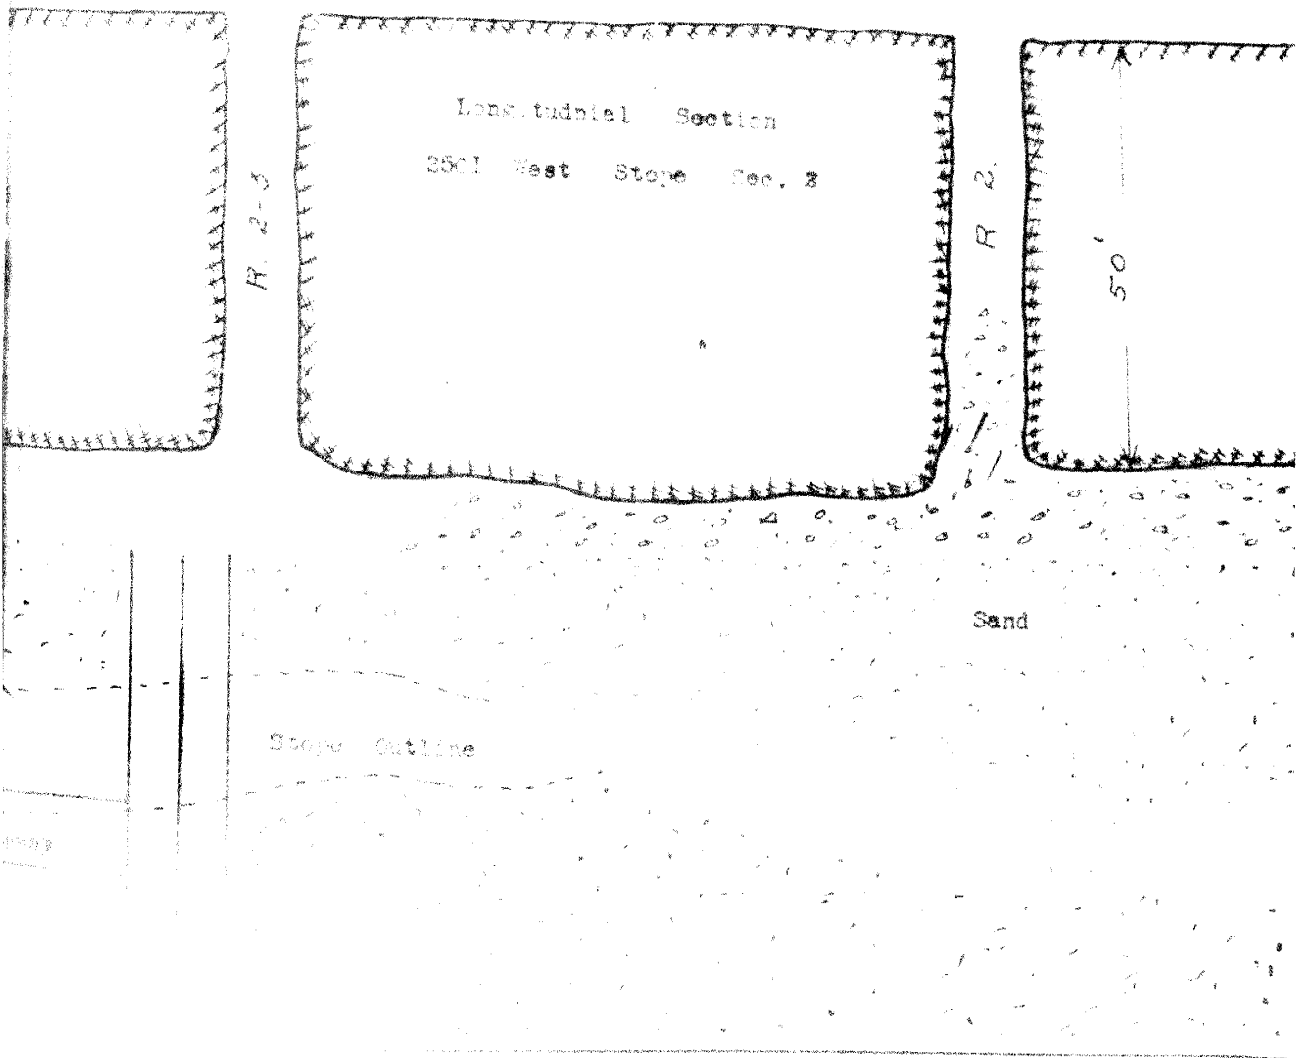
2401 W. Drift

The track was heaved at No. 2 raise and the footwall shattered. No. 2 raise walls were badly shattered and the timber in the raise damaged.

The stope walls were shattered at 2--3 raise and at a point 20 feet east of 2--3 raise the square sets were down. The damage extends over beyond No. 2 raise. Figure shows the narrow condition of stope on page 74. Photograph on page 75 shows the fractured condition of the foot-wall. The area marked in red is the rock burst zone.

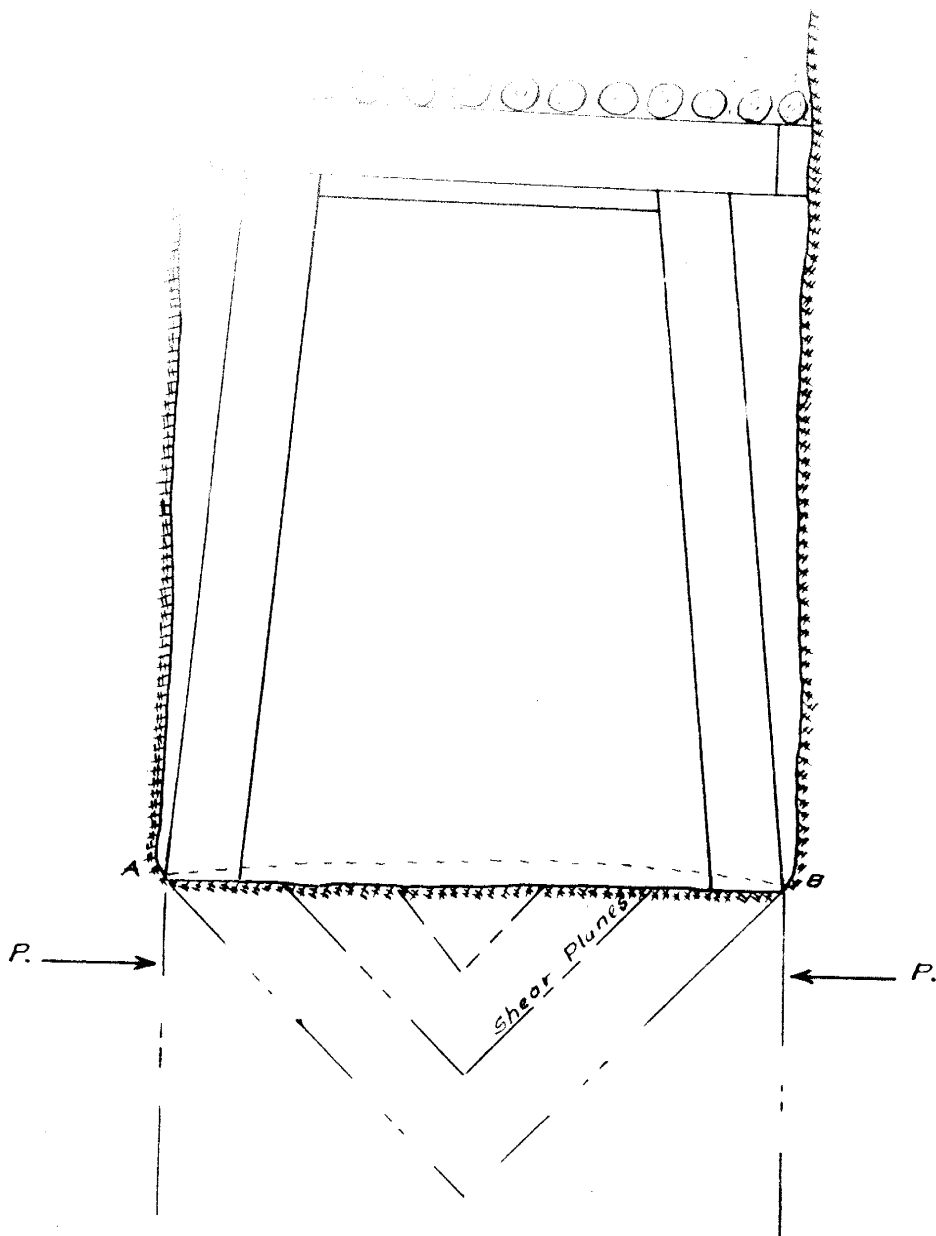
... results by Daubree, Leith and others we
 ... under pressure shears at approximately
 ... If we represent A-B as a cross-section of
 ... figure on page 59 we can understand how the
 rock is thrust upward from the floor pillar when a rock
 burst occurs as shown in photograph on page 60 . The only
 difference between these figures and the actual conditions
 of a drift is that the rock in the drift has only one way
 to break--hence there is no down shear unless the pillar
 is thin.

If we take a narrow section of the drift--say a
 section 7 feet wide, where most of the rock bursts have
 occurred--and analyze the force diagram it will be seen
 that the ability of the floor pillar to resist shear
 is directly proportional to its width. Rock before it
 ruptures or reaches its elastic limit arrives at a certain
 degree of curvature as indicated on the dotted line in
 figure on page 59. Also in a wide section there is more
 tendency for the small fractures to bring on crushing,
 and less likelihood of shearing and bursting.

Cross-section of drift showing the shear planes in floor pillar

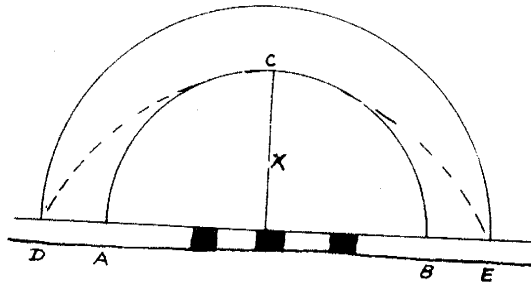
Span D--E Restricted Dome Span D-C-E

Natural Dome Span A--B

In the above sketch A-B represents a stoped portion of the vein which has been supported by a compressible method. The dome ABC has formed and developed sufficient expansion to attain the ultimate compression on the supporting medium.

Additional stoping produces additional stress, but for doming to continue into the walls additional volume for the broken rock is now required within the dome. Along the line X the maximum compression has already been attained, unless the supports fail or the walls shear between supports.

If neither of these conditions result from the stress, the penetration of the dome into the walls must cease, and subsequent stoping results in the development of a flat dome with the supporting medium acting as an abutment.
