1990 Site Investigation
and
Benzene Hazard Assessment
at the
Bass Site in Albuquerque, New Mexico

Robert R. Alexander

*Submitted in Partial Fulfillment of the Requirements for
the Degree of Master of Science in Geology*

New Mexico Institute of Mining and Technology

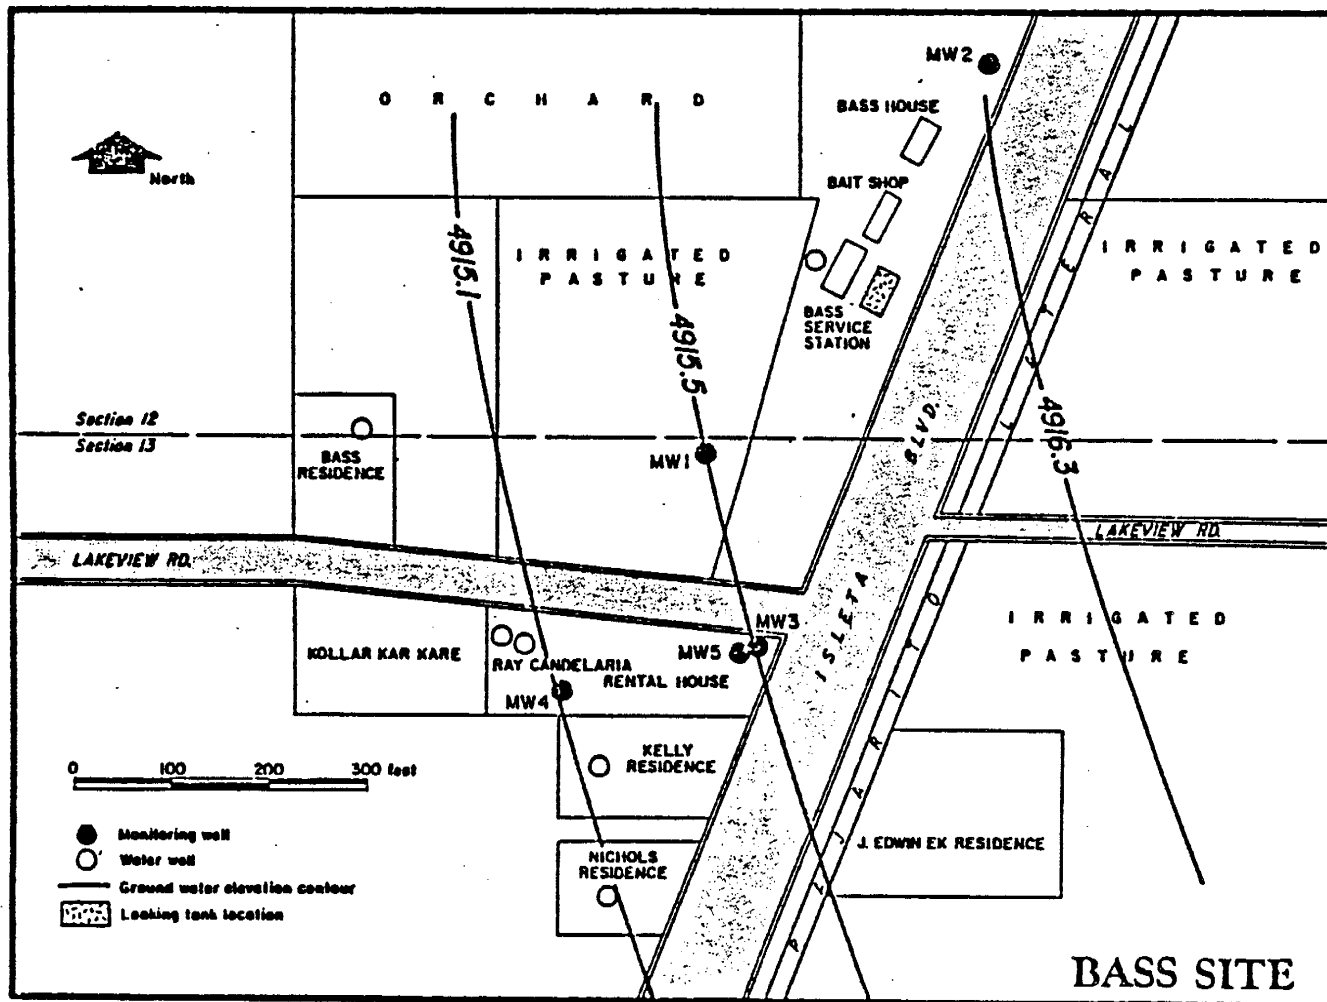
8. Ground water flow beneath the Bass Site is toward the west-southwest with a shallow gradient of just 0.002 (\approx 12 feet/mile). See Figure 2.
9. Ground water flow velocity is estimated to be in the range of 30 to 150 m/year.

Figure 2. Water table contour map of the Bass Site (from Jercinovic, 1984).

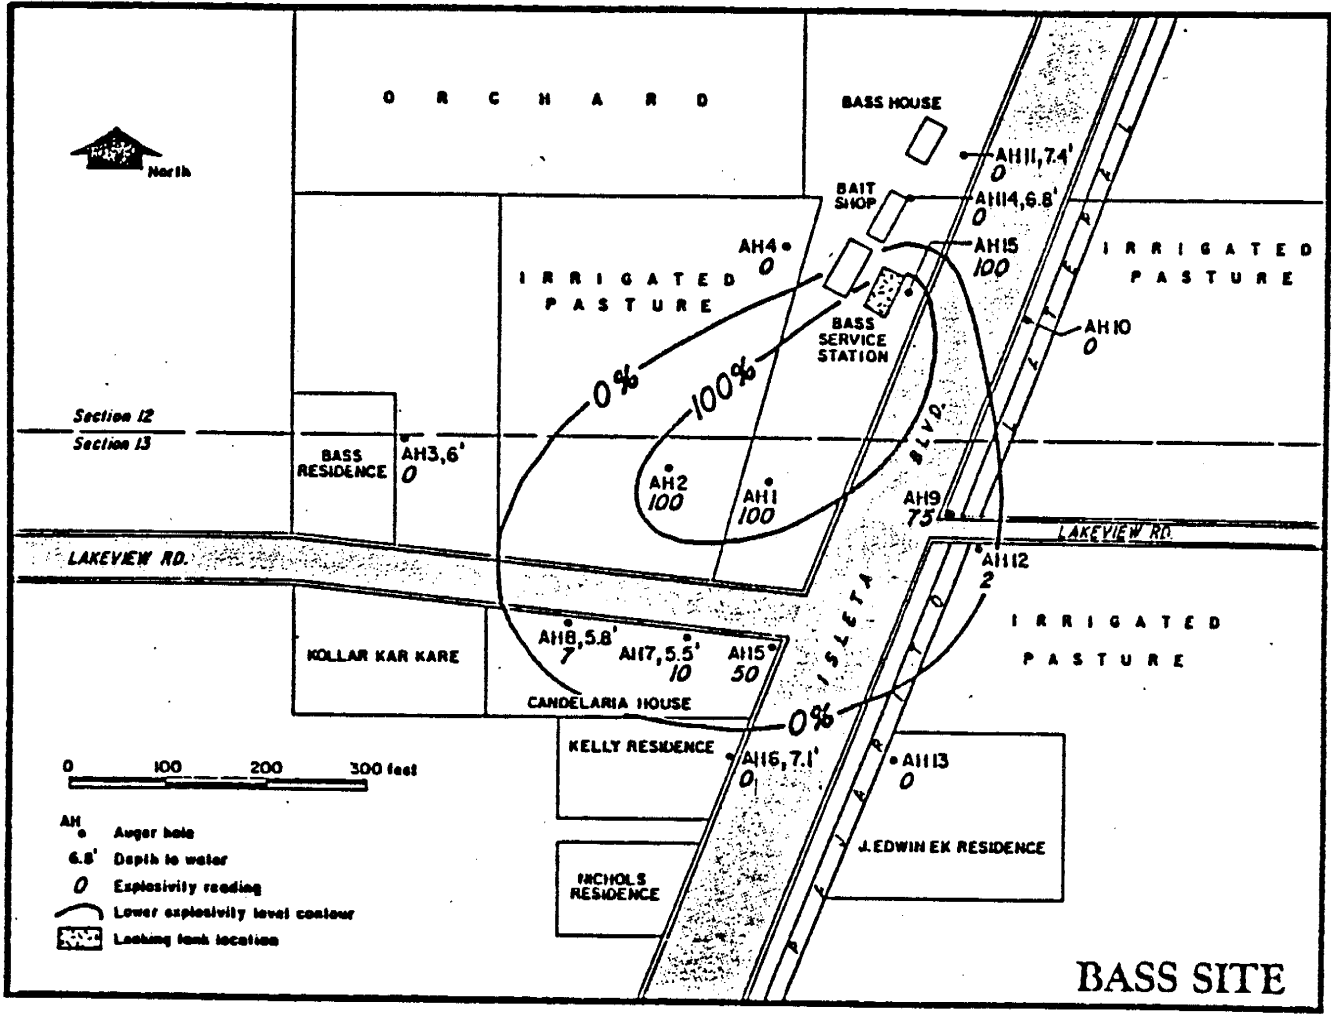
10. An explosivity survey (Figure 3) indicated that contamination has migrated off of the site property boundaries.
11. Of the five monitoring wells installed for this investigation, only the upgradient well (MW2) did not show evidence of petroleum contamination (see Figure 1 for well locations). In addition, a sampling round in August, 1983, showed that three downgradient domestic wells had detectable concentrations (1.4-23.0 ppb BTEX) of the same contaminants found in the monitoring wells (see Table 5).

Figure 3. Explosivity contour map of the Bass Site (from Jercinovic, 1984).

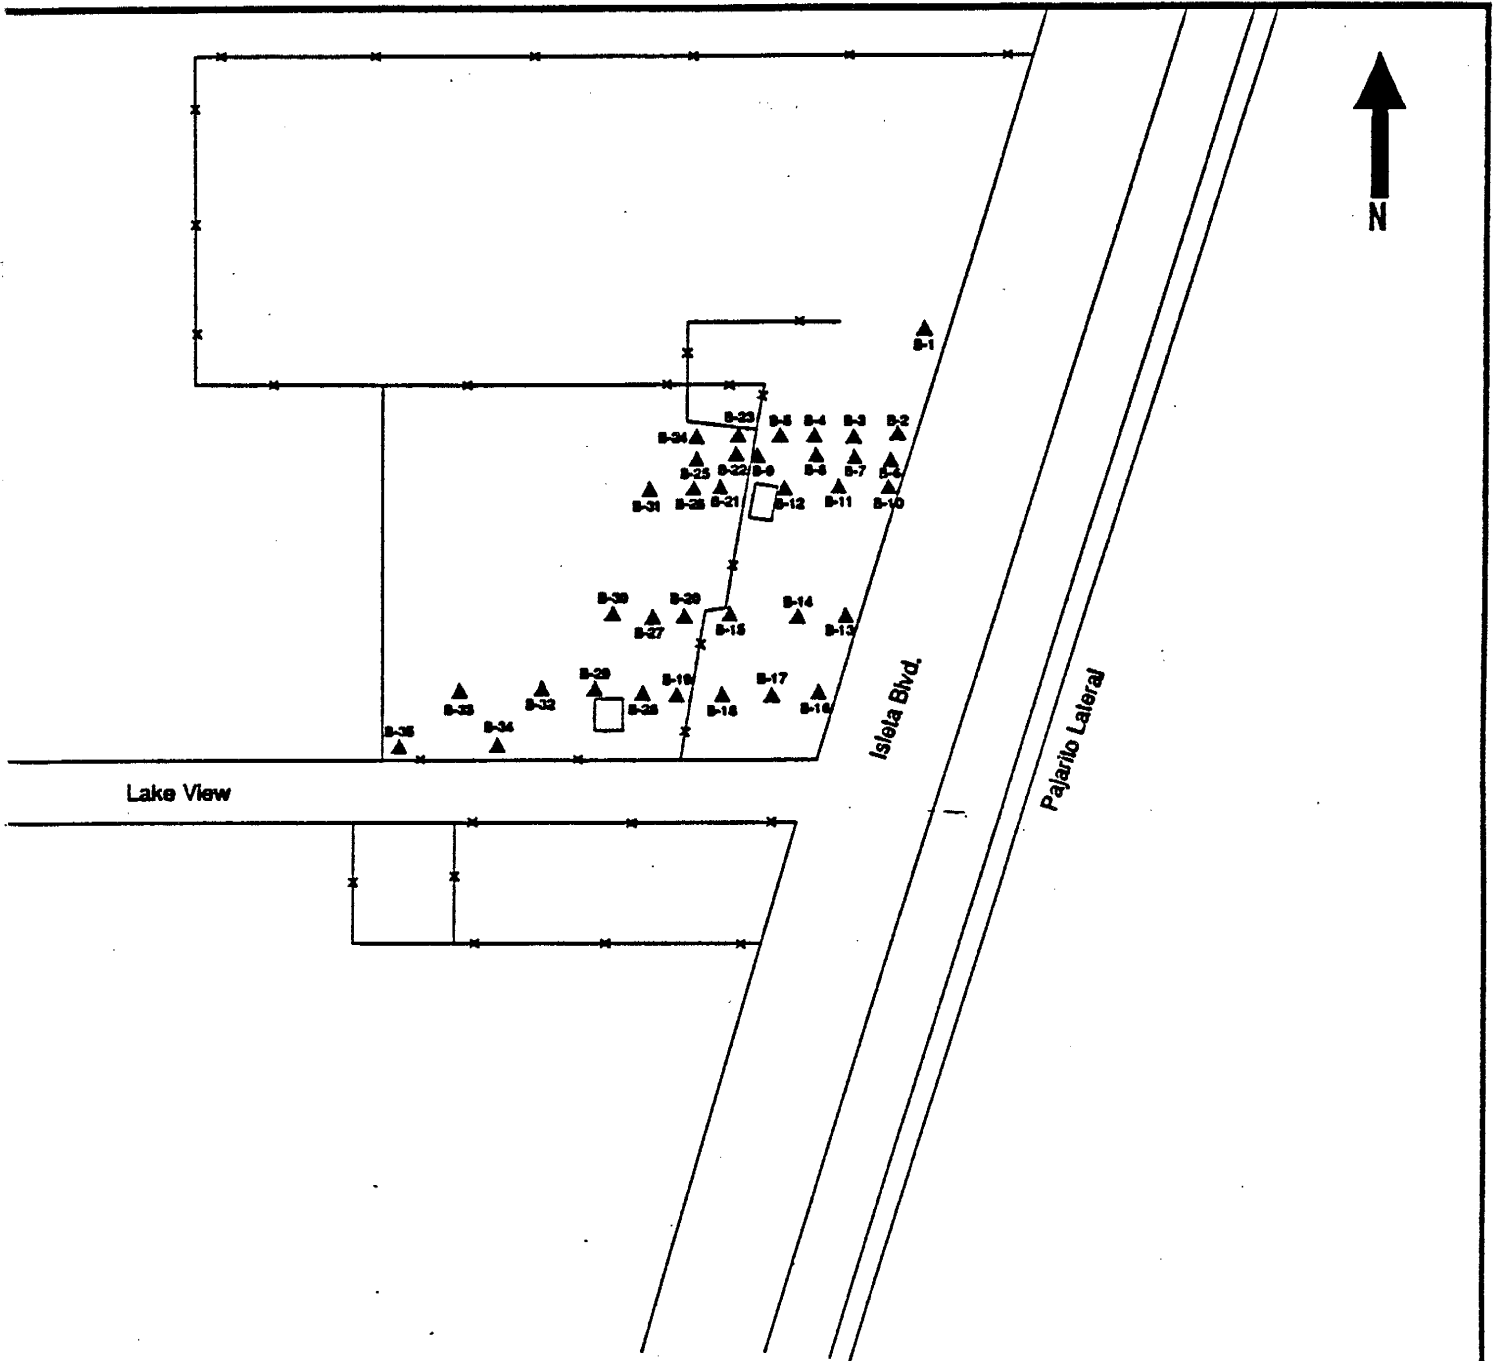
Figure 8 shows the boring locations. The boring was carried out using a hand auger. Each 5 foot flight had convenient clips on each end so that the handle, buckets, or additional flights could be easily added or removed. Both sand and clay buckets were used, depending on the lithology encountered. Each borehole was logged and its location recorded in a field book.

The stratigraphy at the Bass Site was remarkably consistent. In cross section, clayey overbank materials dominated the upper 4 feet and were underlain by medium to coarse aquifer sands (Figures 9 and 10). Generally, the caving in of saturated aquifer sands limited borehole depth to 8-9 feet. Frequently, contaminated soils were coated with a black, tarry-looking substance, indicative of microbial action on petroleum products, and gave off a strong gasoline odor. While no augering was performed outside the Site's property boundaries, it is apparent that the contaminants have migrated off the Bass property boundaries to the east and south.

Boring Locations
Bass Site
Billings & Associates, Inc. October, 1990

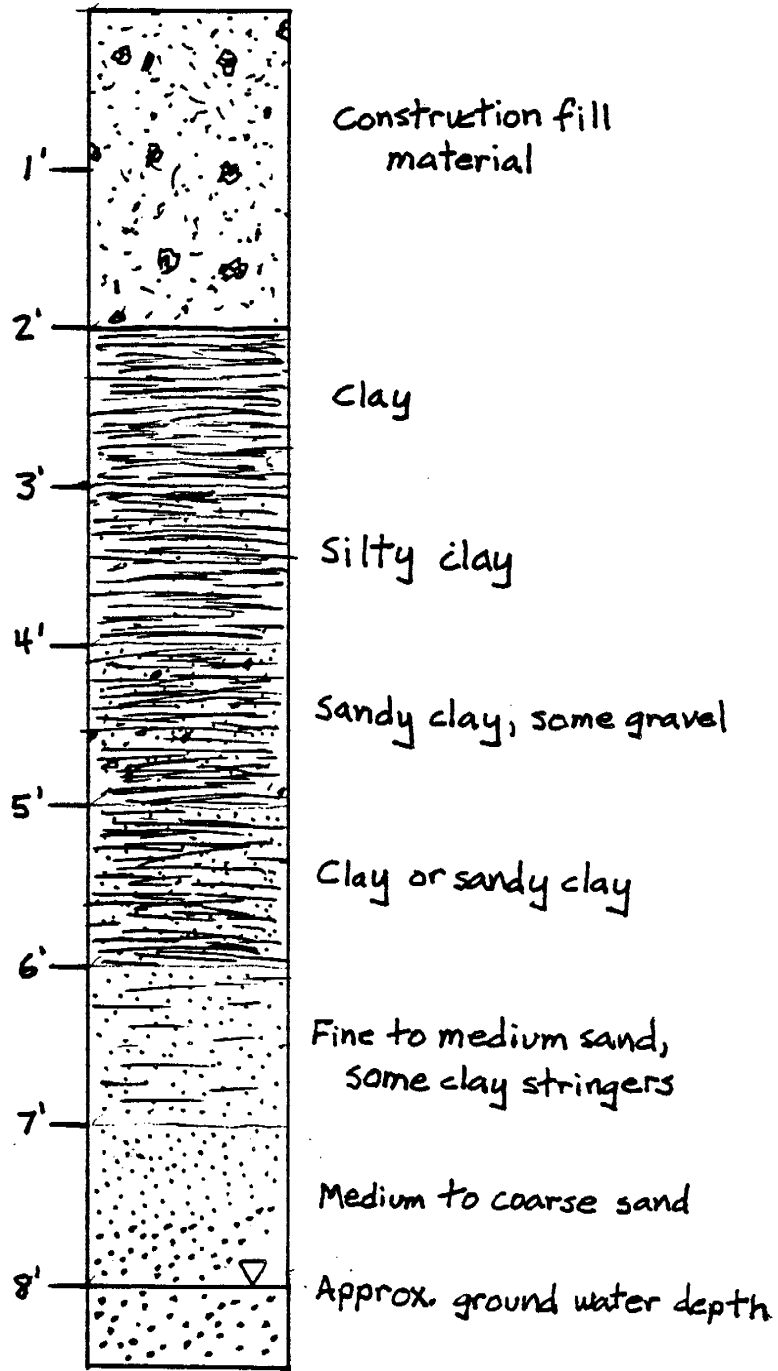
Figure 9. Representative stratigraphy at the Bass Site.

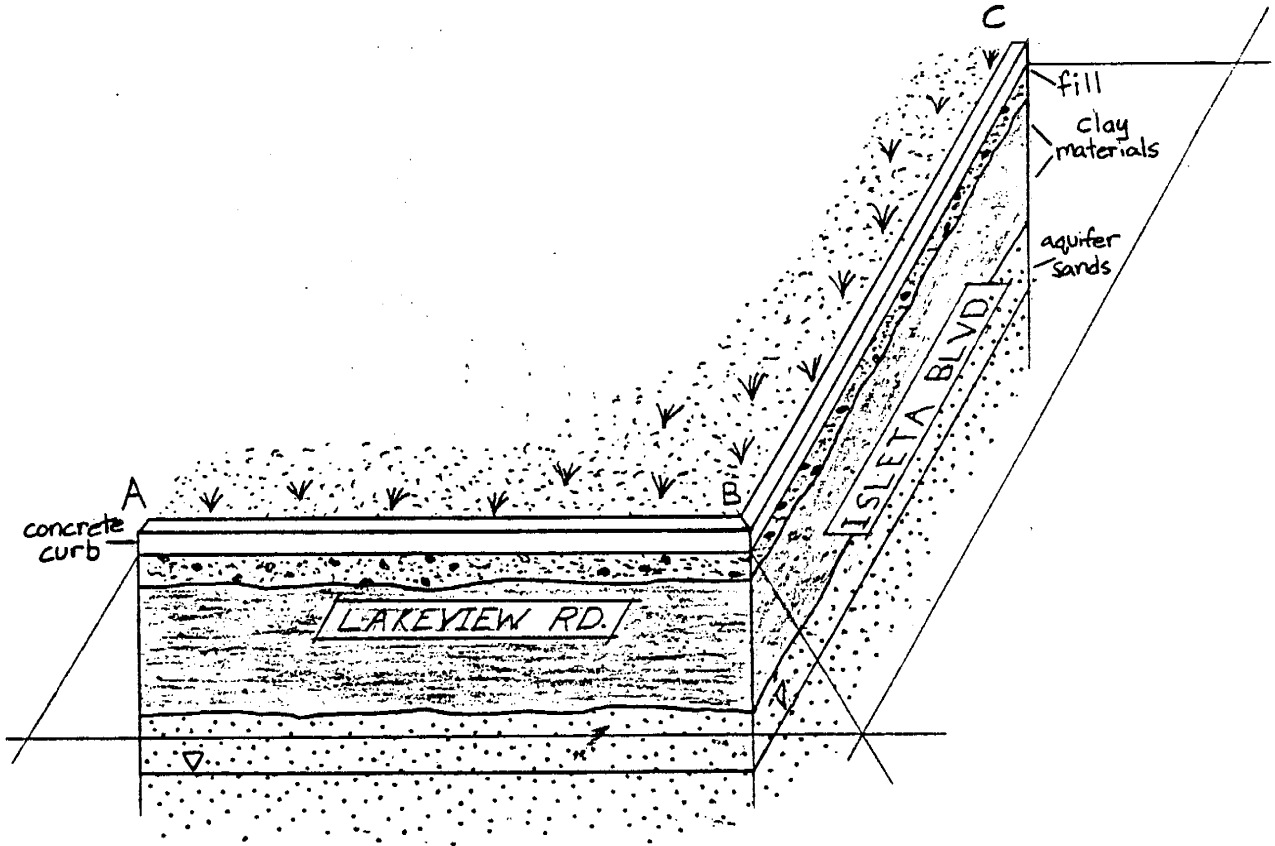
Figure 10. Three-dimensional sketch of Bass Site stratigraphy.

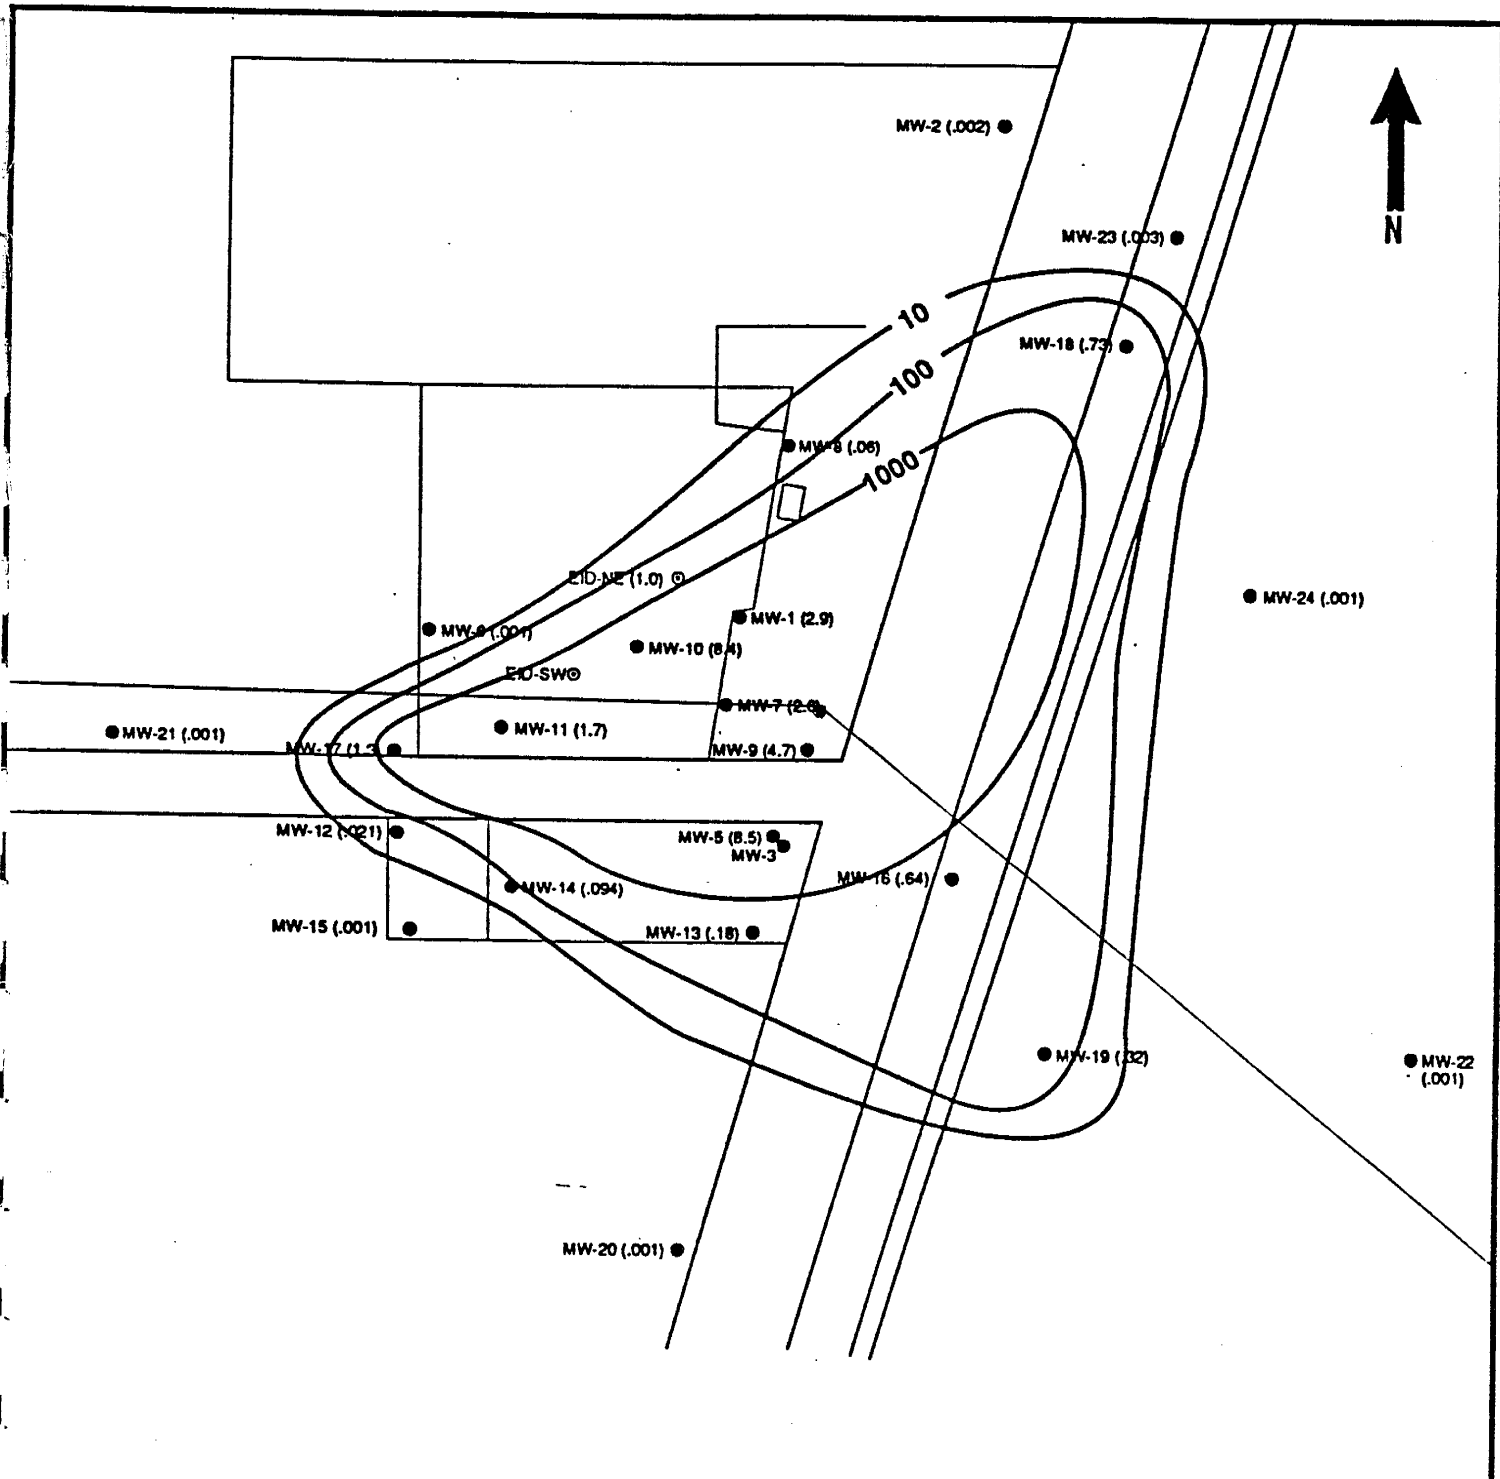
Figure 13

BAI prepared several benzene contour maps using data collected by other contractors (Figures 13-17). Comparing these maps to each other and to the one prepared using the August, 1990 (Figure 18), data reveals that the shape of the benzene plume has changed little over time. This consistency of shape, as noted earlier, is probably the result of a state of dynamic equilibrium between benzene supplied from the clayey materials to the ground water and the simultaneous dilution or biodegradation of this component down gradient. In the risk assessment discussed later, it is assumed that this process would provide a constant source of contamination if no remedial action is taken.

Benzene Concentration January 1988
Bass Site
Billings & Associates, Inc. April, 1990

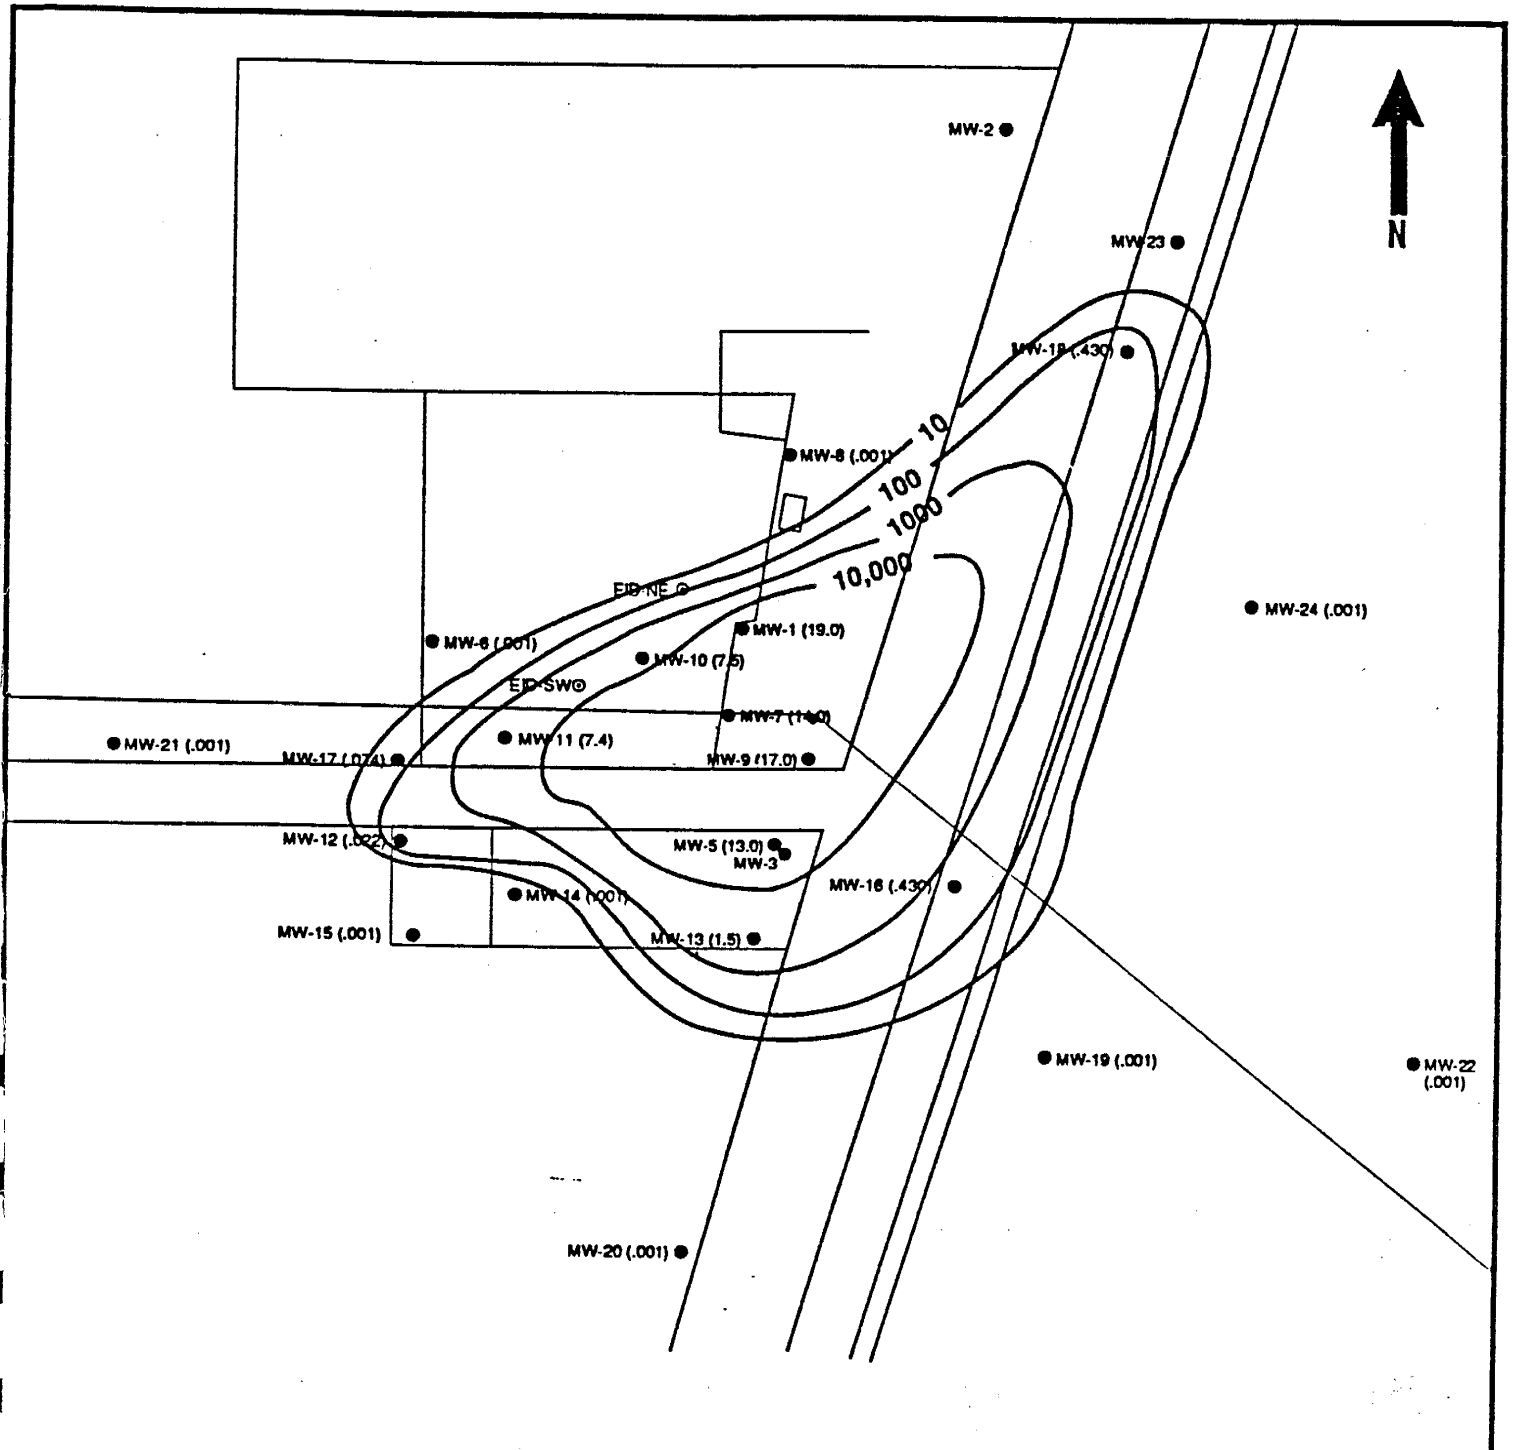
Figure 15

Benzene Concentration February 1989
Bass Site
Billings & Associates, Inc. April, 1990

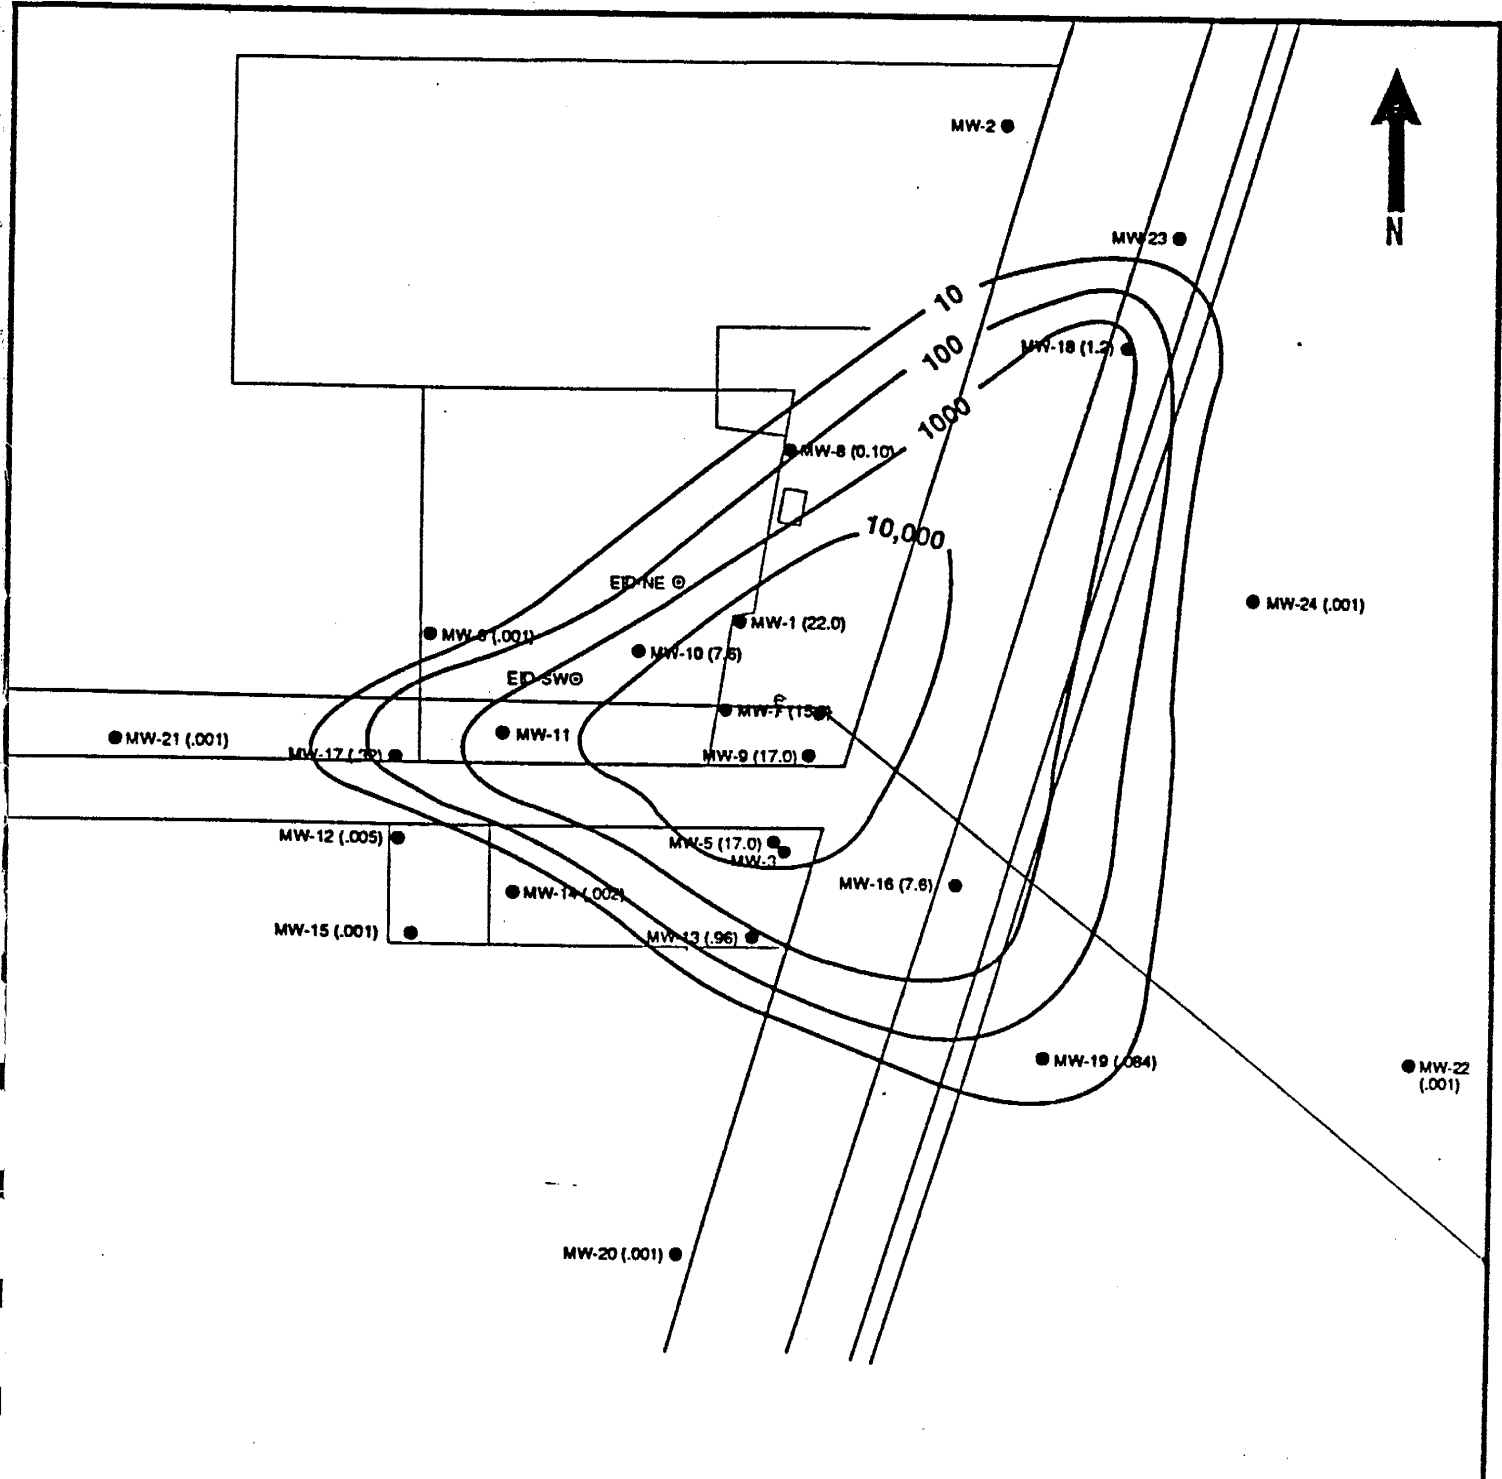
Figure 16

Benzene Concentration April 1989
Bass Site
Billings & Associates, Inc. April, 1990

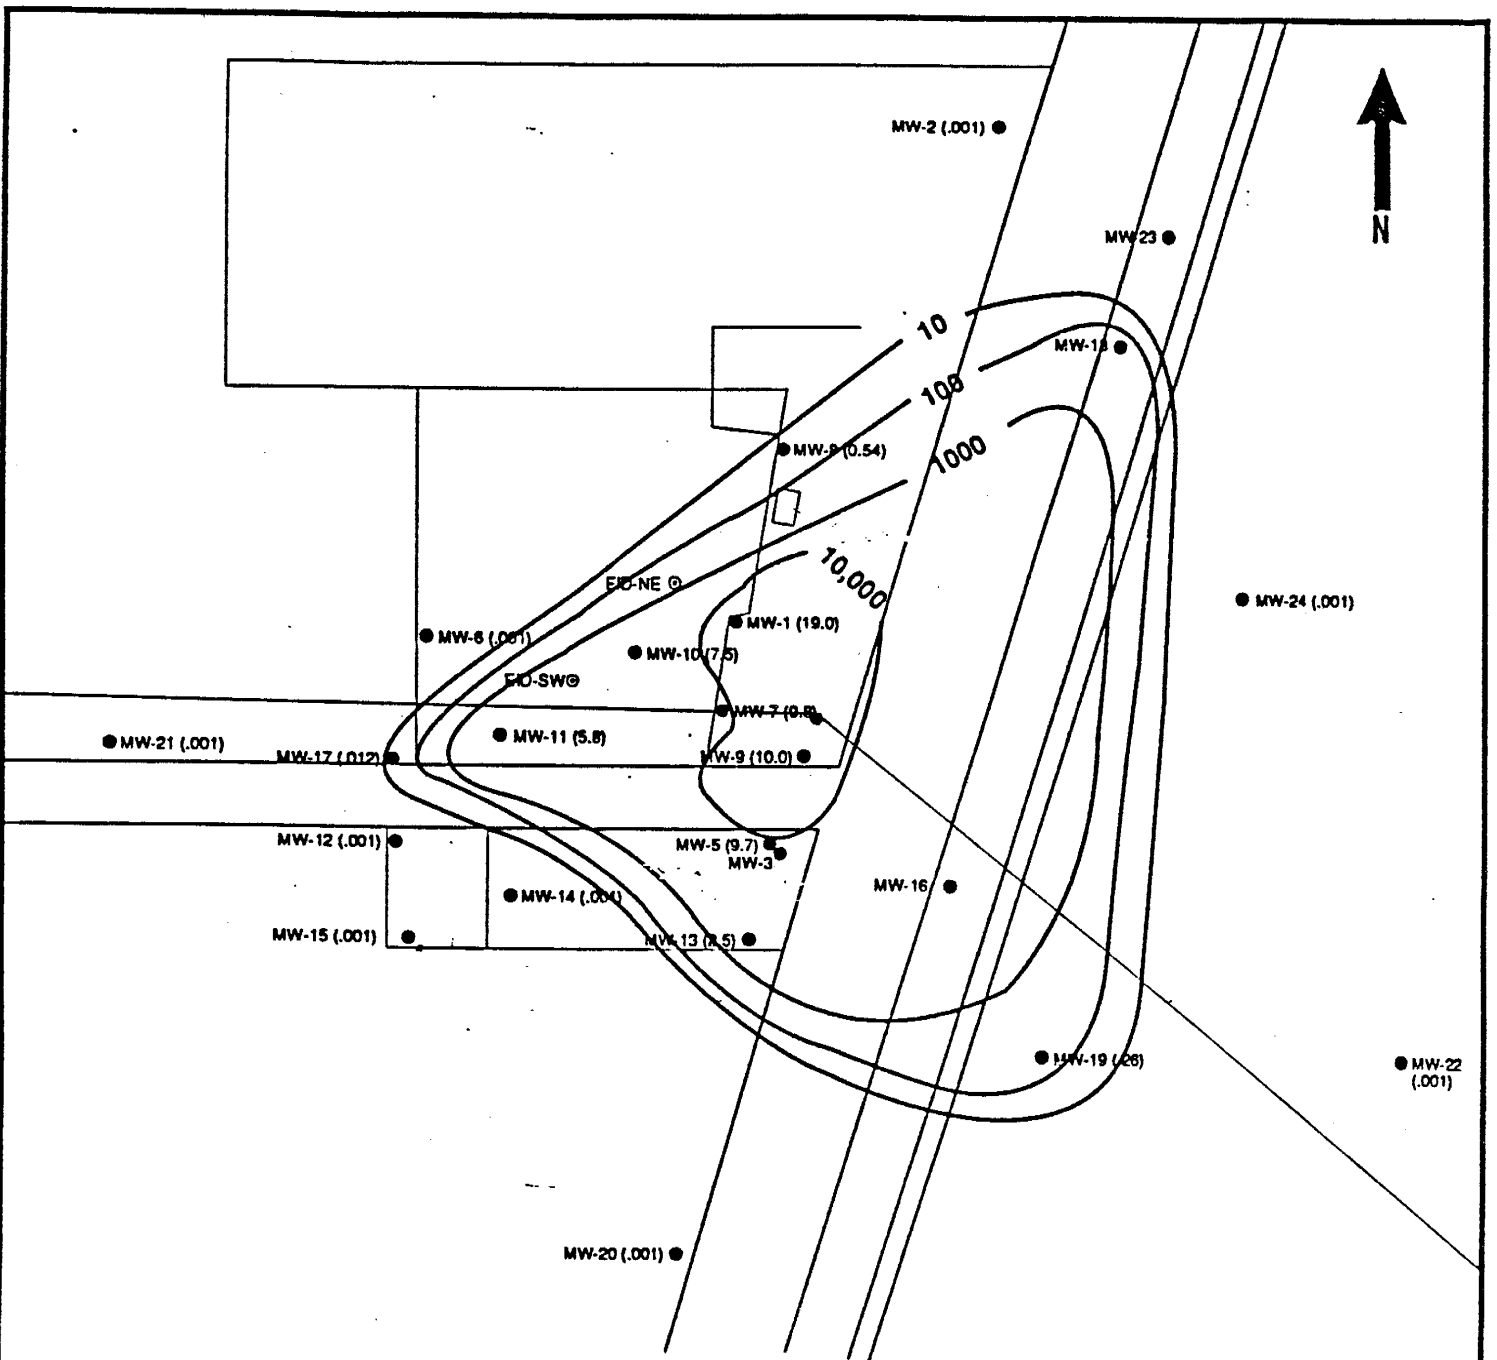
Figure 17

Benzene Concentration July 1989
Bass Site
Billings & Associates, Inc. April, 1990

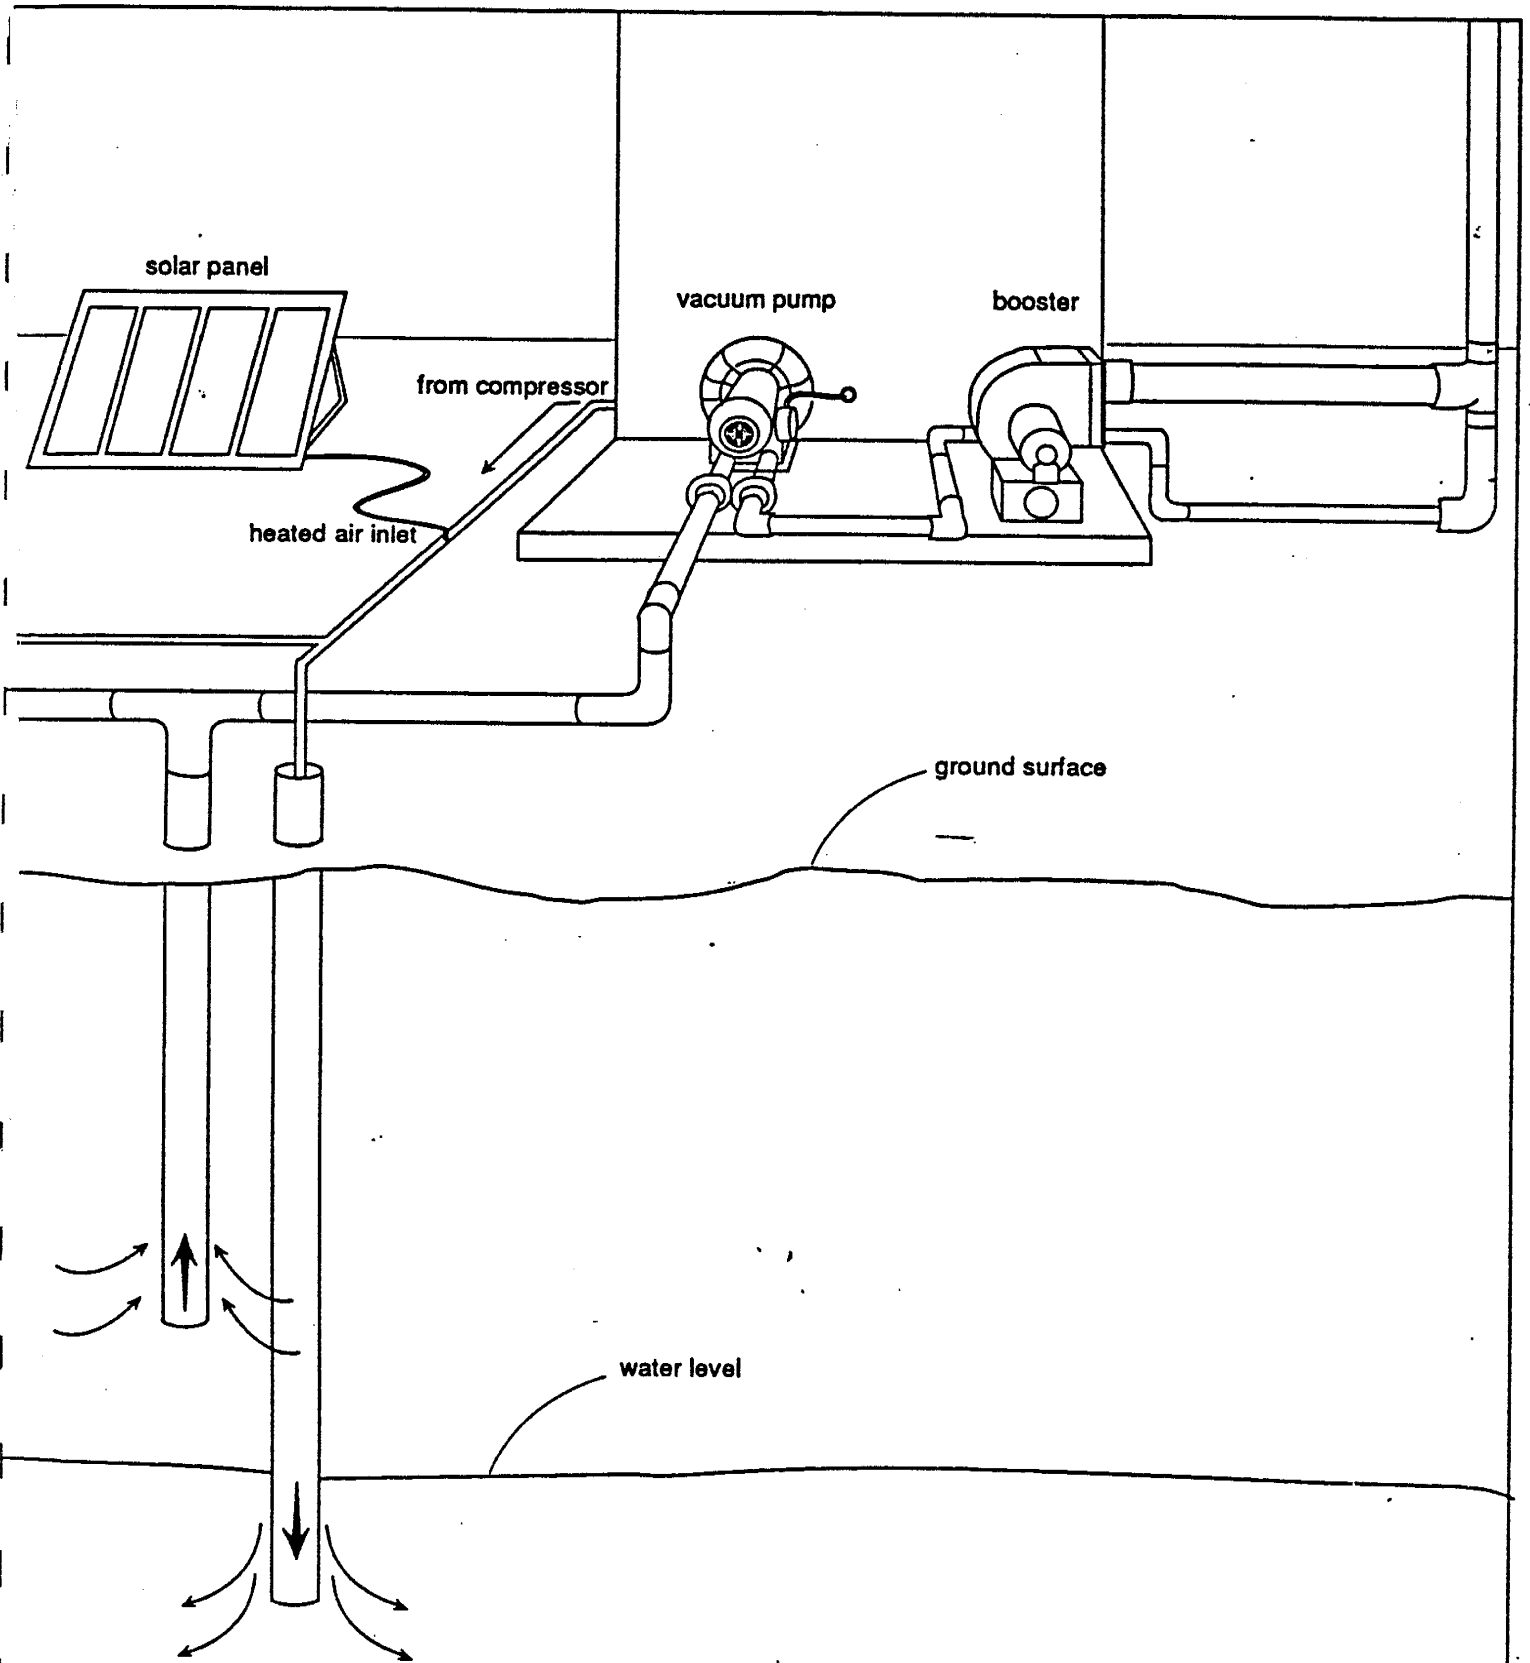
Figure 21

Cross Section-SVVS System (patent pending)
Bass Site
Billings & Associates, Inc. April, 1990

An innovative approach is being employed by BAI to remediate the Bass Site. While similar in some respects to the configuration shown in Figure 20, the Subsurface Volatilization and Ventilation System (SVVS, patent pending, 1989) contains several unique features. A well nest consisting of an air injection well screened below the water table and an extraction well screened above it in the vadose zone operate simultaneously. This creates an air flow pattern which introduces oxygen to the ground water and vadose zone and removes any volatile organics present in the soil gas (see Figure 21).

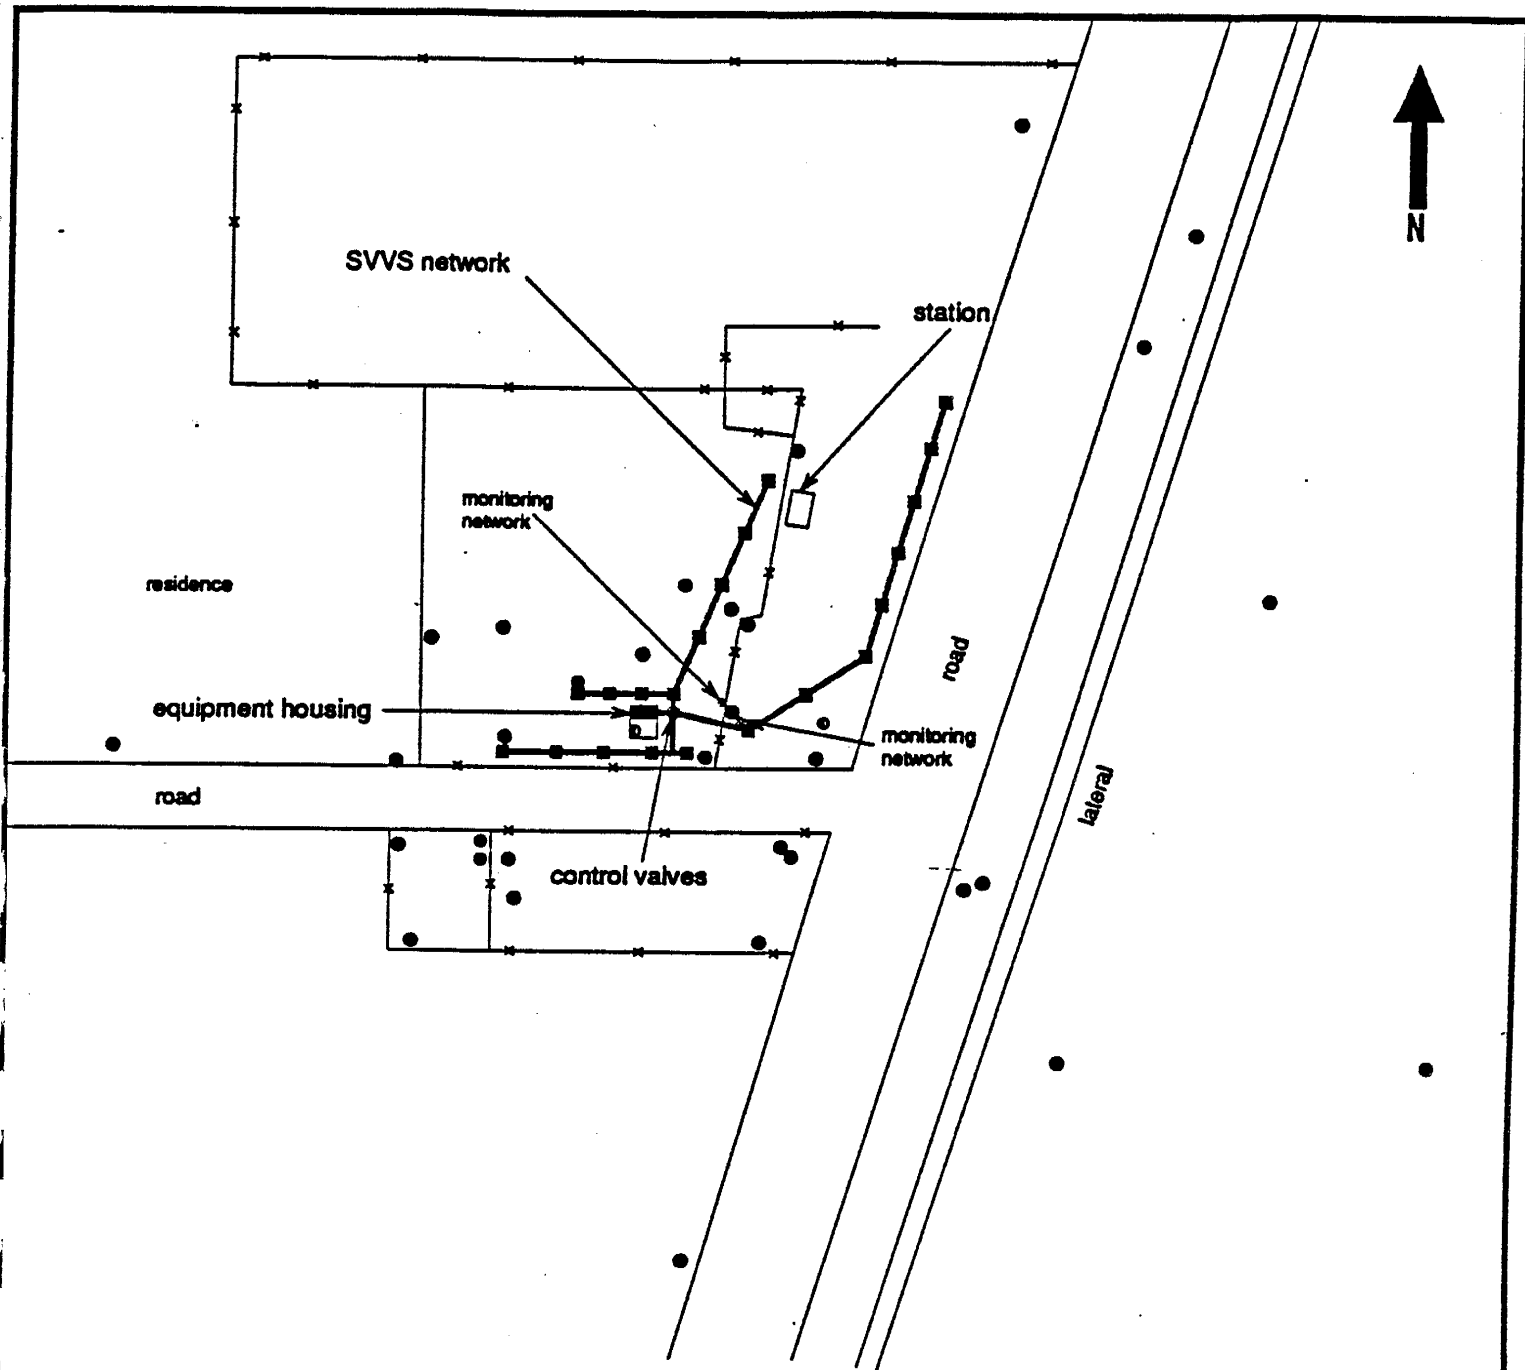
Figure 23

Horizontal Layout
AEHD/EID
Billings & Associates, Inc. September, 1990

The SVVS employs a series of these injection/extraction well nests distributed over the areas of greatest petroleum contamination. The preliminary layout of the system is shown in Figure 22. This layout was changed, however, as a result of the soil gas and augering surveys. For example, these surveys revealed that the area around MW-9 showed reduced levels of contamination. As a result, the well nests were moved to an area of greater contamination to the northwest, as shown in Figure 23.
