1990 Site Investigation
and
Benzene Hazard Assessment
at the
Bass Site in Albuquerque, New Mexico

Robert R. Alexander

*Submitted in Partial Fulfillment of the Requirements for
the Degree of Master of Science in Geology*

New Mexico Institute of Mining and Technology

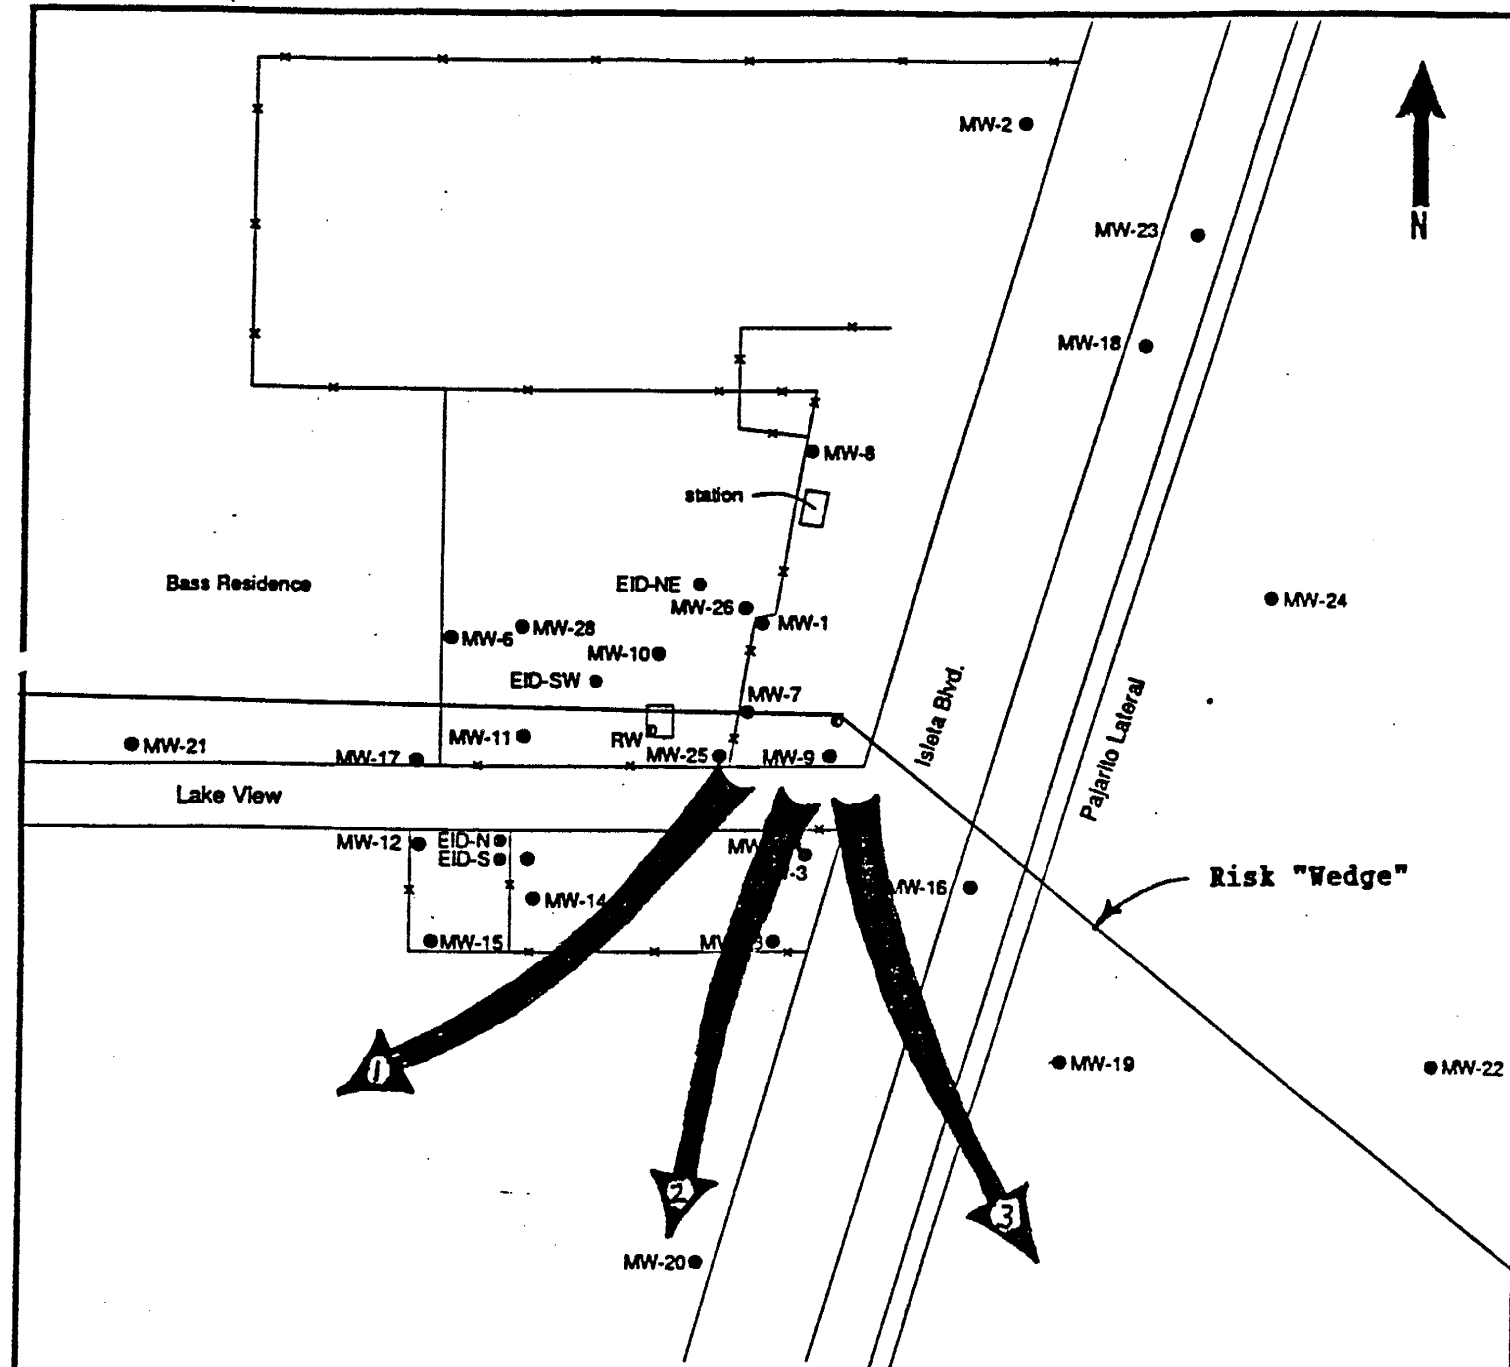
As noted earlier, the horizontal direction of ground water flow is difficult to define precisely (Figure 24). Based on the flow direction data available and shapes of the benzene plumes shown in Figures 13-18, a risk "wedge" encompassing the possible flow directions was drawn with its apex at the recovery well used for the now-dismantled pump and treat remediation system (Figure 24). The selection of the recovery well as the apex of the risk wedge was somewhat a matter of convenience, although the benzene plume maps (Figures 13-18) consistently showed the recovery well at or near the center of the of the 10,000 ppb benzene contour. The

GENERAL FLOW DIRECTIONS & RISK "WEDGE"
Bass Site
Billings & Associates, Inc. October, 1990

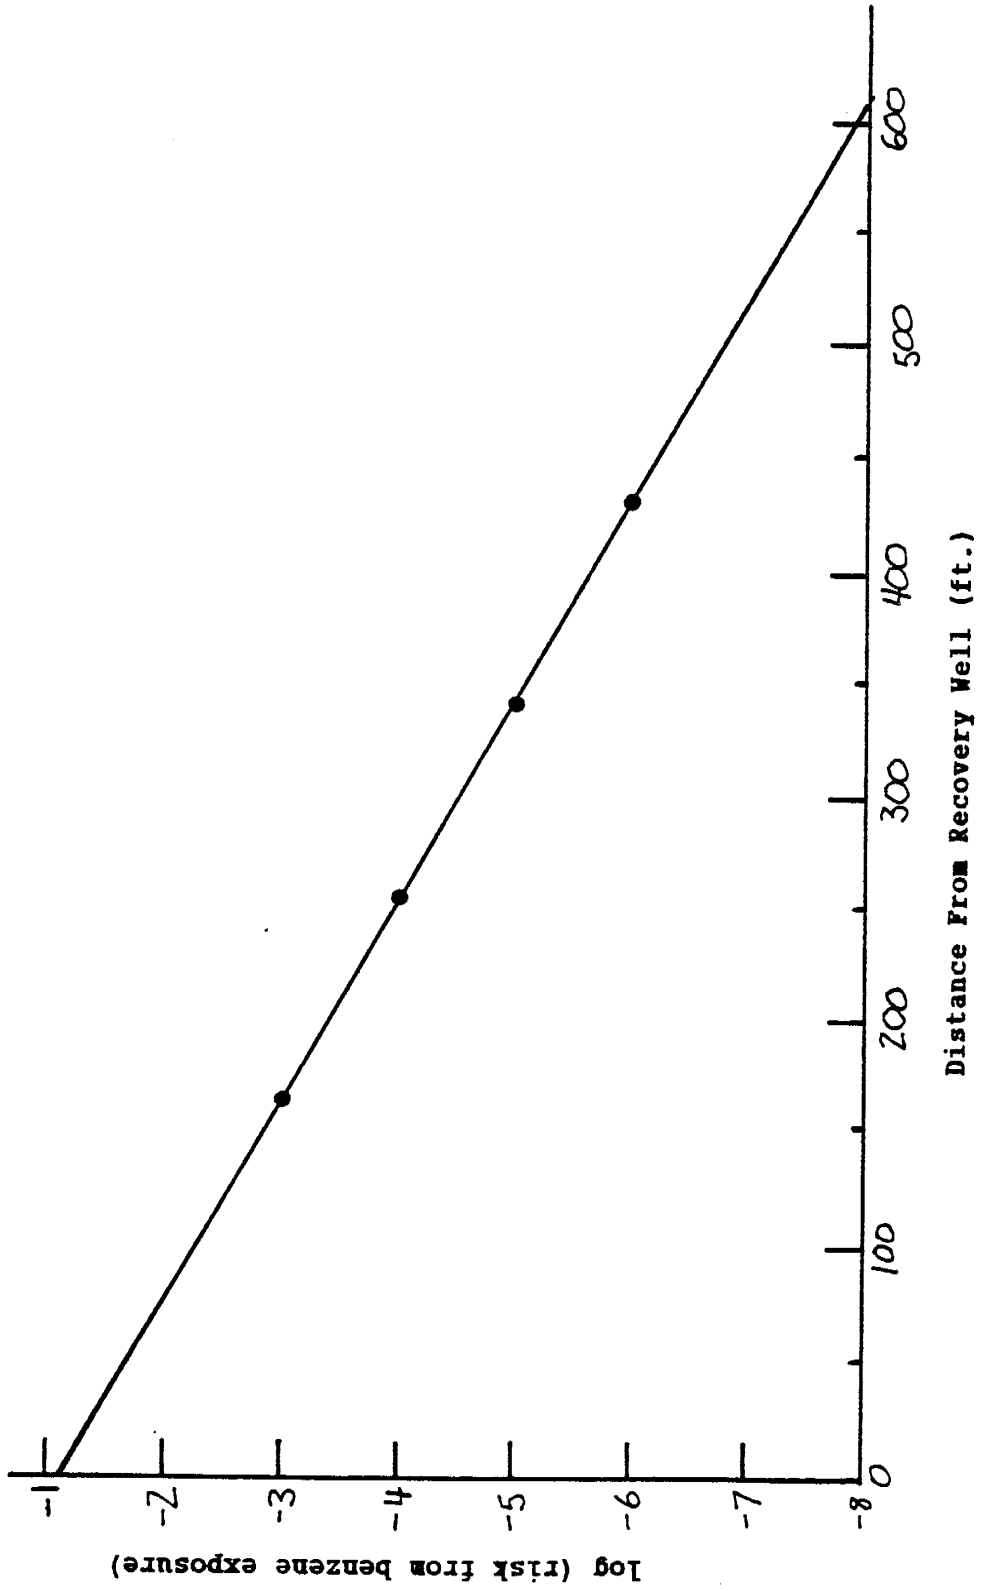
Figure 27. Plot of risk inside the risk wedge from benzene ingestion vs. distance from the recovery well.
