Accident Investigation Report

Underground Salt Haul Truck Fire at the Waste Isolation Pilot Plant February 5, 2014

March 2014

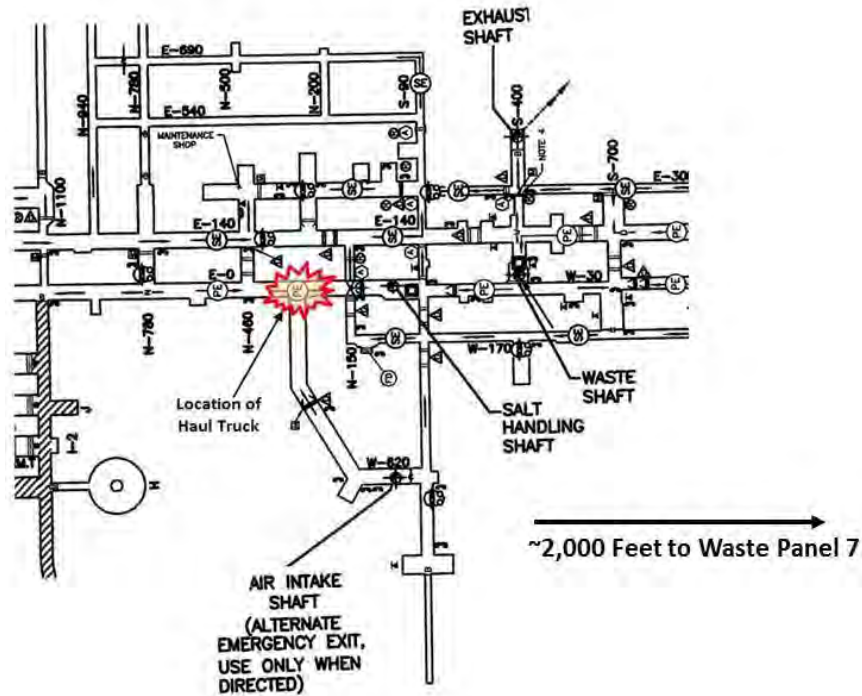
Figure 3: Location of the Haul Truck during the Fire

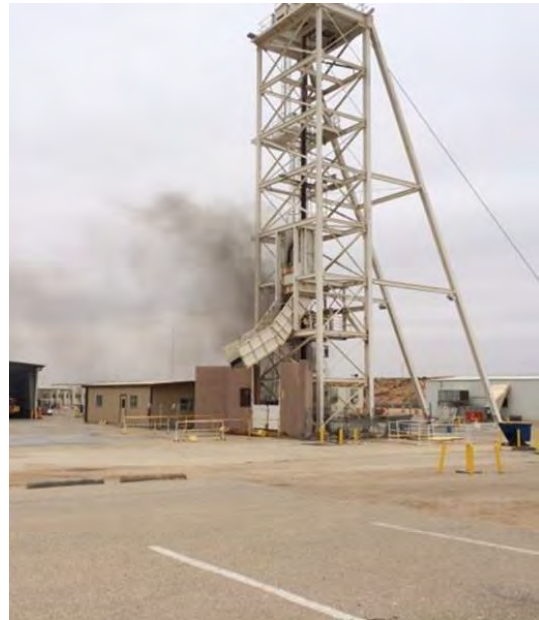
Figure 10: Smoke Visible Exiting through the Salt Shaft

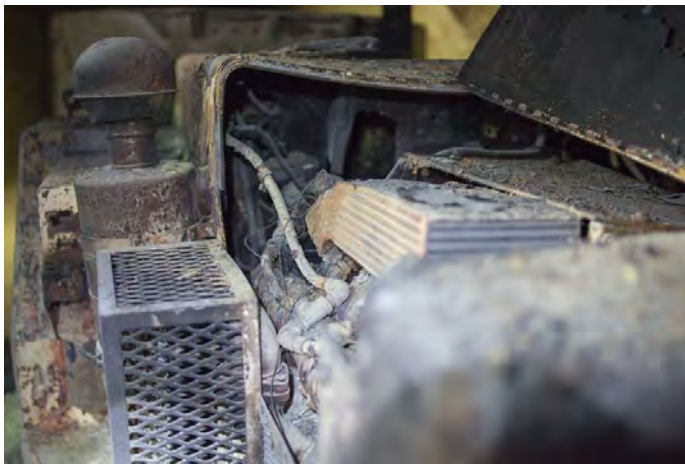
Figure 19: Engine Cooling Coils

The Board observed accumulated grime in the engine compartment of other salt haul vehicles that would have been sufficient to create a sustained fire that would result in additional fluid leaks. The normal hauler ventilation flow pulls air through the front grill and directs it across the cooling coils above the engine block (see Figure 19). This flow exits at the back of the engine compartment and would push the fire towards the transmission (see Figure 18, illustration (c)). In the actual fire, this condition occurred within about 5 to 10 minutes of initial ignition (assumed start time is

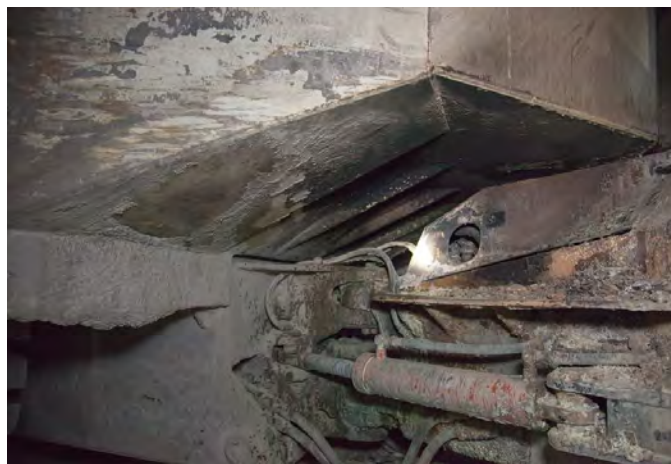
Figure 20: Transmission Fluid Stick Access

1043) and was recognized by the truck Operator at 1048. The Operator shut down the engine, exited the hauler on the left side, and moved to the right side. The Operator then discharged his hand-held fire extinguisher through the transmission access hole, which is forward of the pivot pin (see Figure 20) and under the haul truck. Because the fire was enclosed, using a handheld fire extinguisher was ineffective. The delay between initial ignition and activation of the engine compartment fire suppression system resulted in development of multiple leaks.

When the Operator had discharged the hand-held fire extinguisher, he returned to the left side of the haul truck to initiate release of the on-board fire suppression system. The effectiveness of suppression system is uncertain. At activation, the fire could have been too severe to control, or if initially controlled, a hot surface within the engine compartment might

have reignited the fire. When the engine was shut down, the cooling fan stopped. Because of the haul truck orientation, mine ventilation flow was opposed to the cooling system airflow. This prevented further propagation towards the rear of the haul truck and prevented ignition of the rear tires. The change in engine compartment airflow direction also created a V-shaped discoloration on the haul truck grill. This discoloration was created by the most intense flaming. Sooty deposits occurred on either side of this V where the flames were less intense.
