Accident Investigation Report

Phase 2 Radiological Release Event at the Waste Isolation Pilot Plant, February 14, 2014

April 2015

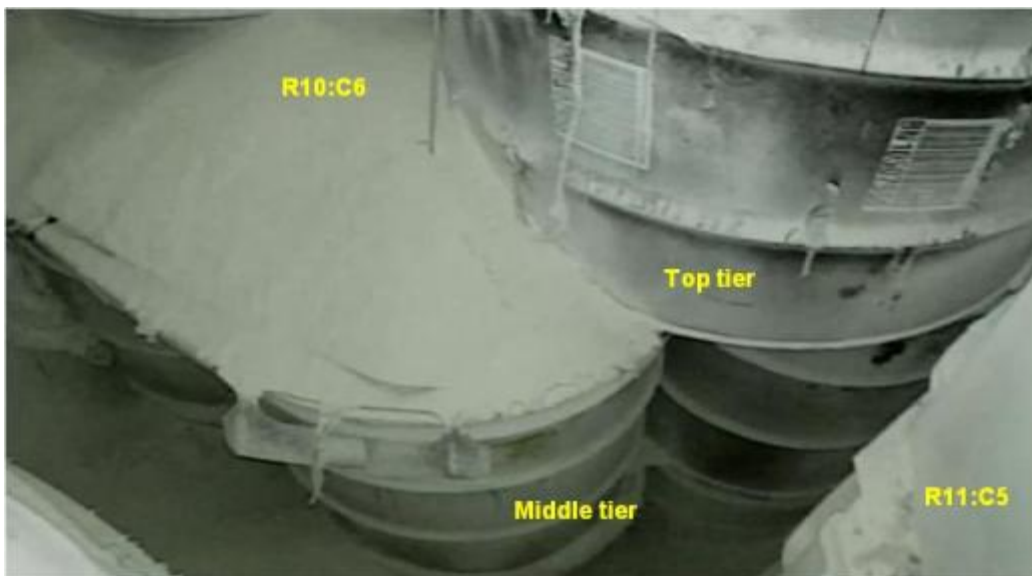
The MgO super sacks in Row 10 were damaged, with most of the fabric melted or gone (Figure 6-21, Figure 6-22, Figure 6-24, Figure 6-25, and Figure 6-26). The residual MgO formed conical piles consistent with the outline of the waste containers on the top tier at each stack. At R10:C6 the 100GD assembly slip sheet, the middle tier reinforcement plate and slip sheet, were partially damaged and conformed to the outline of the drums (Figure 6-27). Many locations had

Figure 6-27: R10:C6

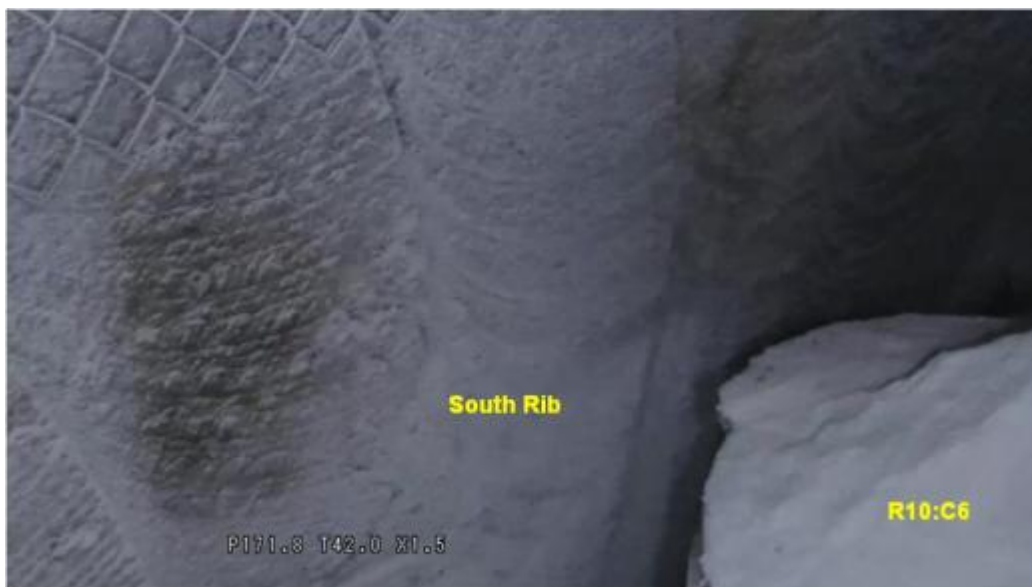
evidences of black discolorations on the sides of the waste drums. There was also evidence of flame impingement on the south rib (Figure 6-28).

Figure 6-28: Flame Impingement Evidence on South Rib near Row 10

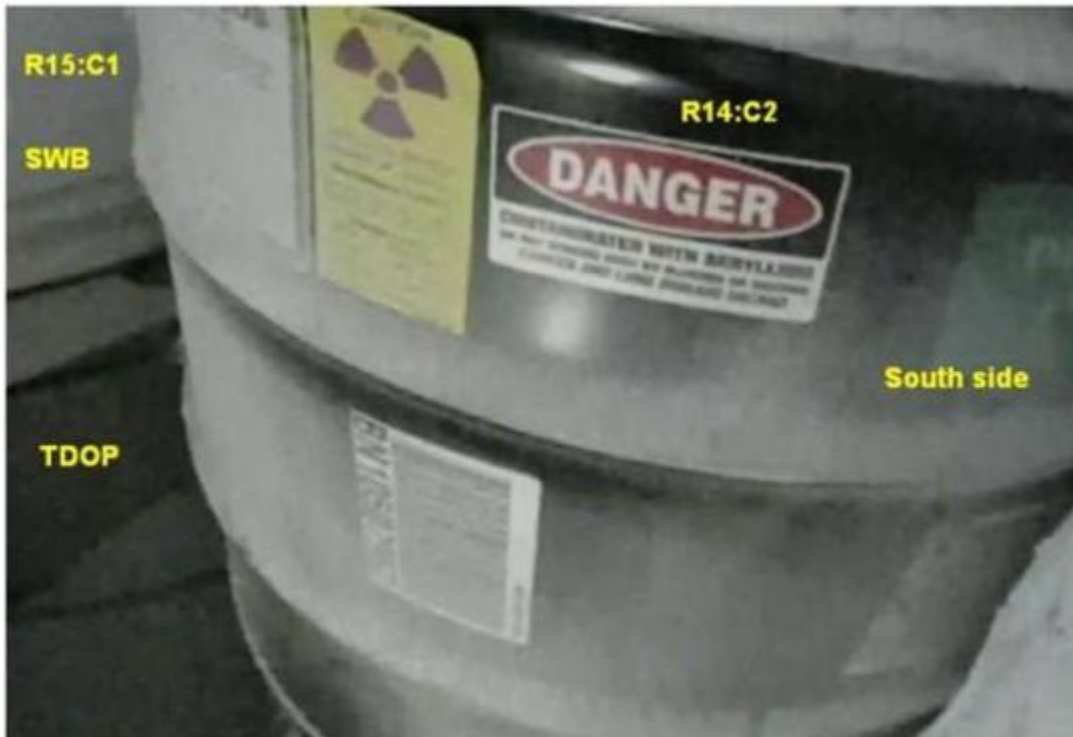
The exposed plastics (fiberboard and polyethylene slip sheets, reinforcement plates, stretch wrap, cardboard stiffeners and polypropylene super sack fabric) in stack R14:C2 were severely damaged. The polyethylene plastic burned and melted to the outline of the waste drums (Figure 6-29 and Figure 6-30). The MgO formed three conical piles on the three top-tier drums (Figure 6-31). The 100GDs were originally a glossy black, but were covered with a coating of fine white powder (Figure 6-32).

Figure 6-32: R14:C2 (south)

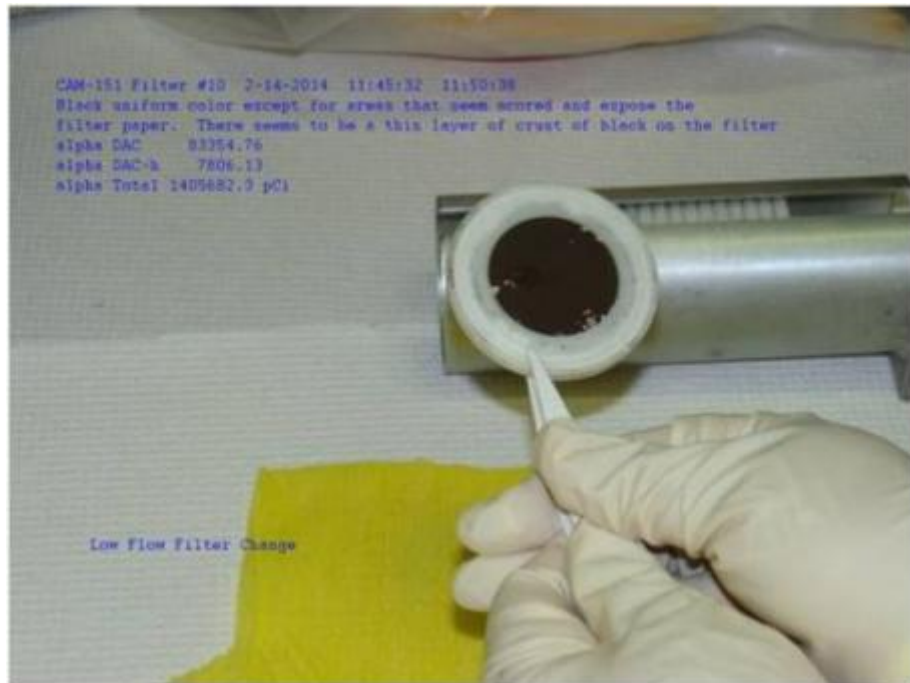
Following the event, the CAM (Figure 6-47) filter housing was disassembled at SRNL. Each filter was assigned a specific number based on the order in which the filters were removed from the CAM cartridge, visually examined, and recorded. Each CAM filter was then screened by gamma pulse height analysis. The first six CAM filters were white and had low levels of activity; three of these are from routine monitoring before the event took place. The following 10 sample filters had various shades of black and brown, and had high levels of activity. Table 6-5 summarizes sampling start and stop time for each CAM filter and the DAC-hr value as recorded by the CAM, as well as total gamma emitting activity as measured by gamma pulse height analysis. CAM 151 filter papers are numbered and described in the order in which the filter paper was removed from the cartridge. The CAM 151 cartridge is loaded with filter papers with the earliest filters first. This means that the first filter used by the cartridge is the last filter paper to be removed. The CAM cache records indicate filter labeling as December 27, 2013 - 6 Filter 01 (Figure 6-48) through December 27, 2013 - 6 Filter 13 (Figure 6-49) during the period starting from February 12, 2014, 0304:43 through February 15, 2014, 0005:34 when the CAM shut down after the radiological event.

Figure 6-49: CAM 151 Filter #10
