SOME ASPECTS OF THE ROCK BURSTS
IN THE KIRKLAND LAKE GOLD MINES AT
KIRKLAND LAKE ONTARIO CANADA

A THESIS
SUBMITTED
TO
THE BOARD OF TRUSTEES PRESIDENT
AND FACULTY
OF
THE NEW MEXICO SCHOOL OF MINES
IN PARTIAL FULFILMENT OF THE REQUIREMENTS
FOR
THE PROFESSIONAL DEGREE OF
GEOLOGICAL ENGINEER

BY *Walter Riddell*
Walter Riddell
Kirkland Lake, Ontario
April 15, 1936.

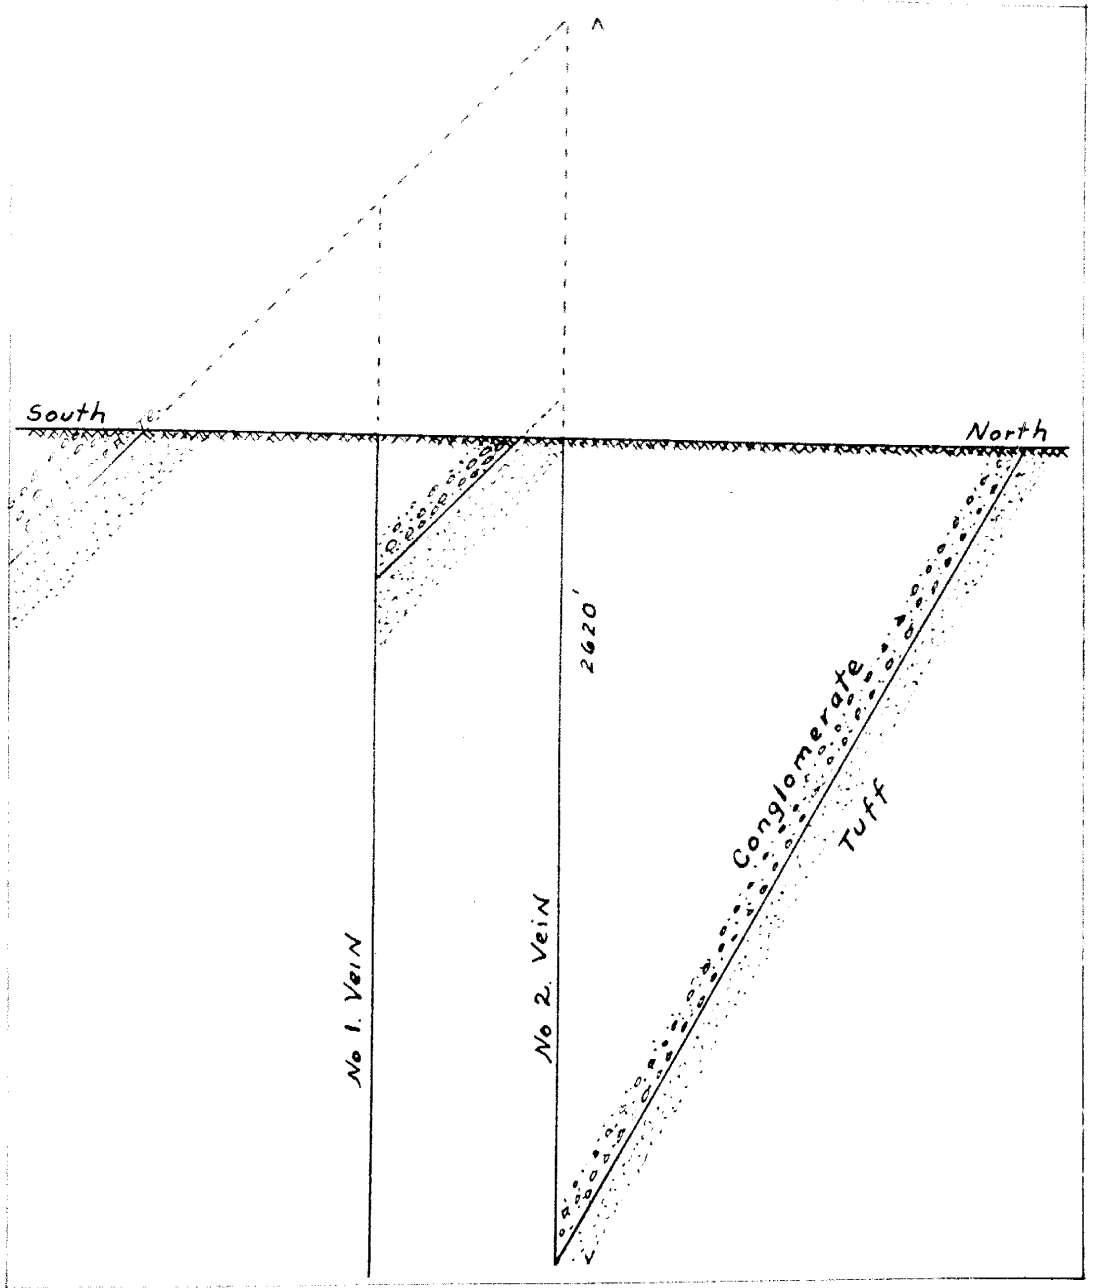
Geological section 250 feet west of No. I shaft at right angles to the veins
 showing probable vertical components of the north and south faults, based
 on the locations of conglomerate and tuff, as found on surface and underground
 Scale 400 feet to the inch.

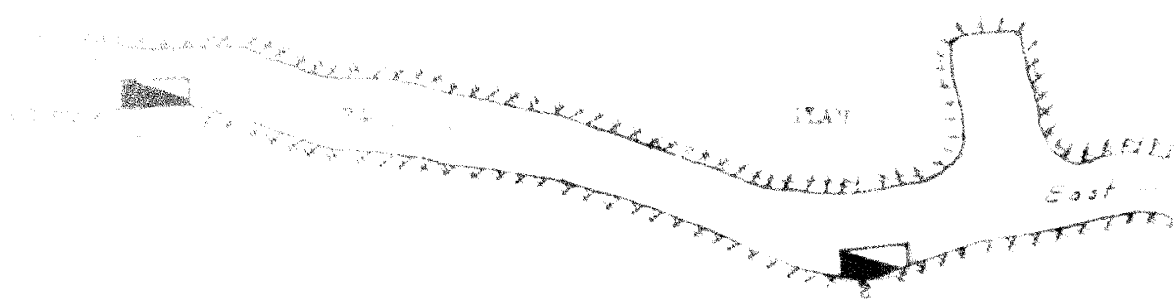
2401 W. Drift

The stope walls were shattered at 2--3 raise and at a point 20 feet east of 2--3 raise the square sets were down. The damage extends over beyond No. 2 raise. Figure shows the narrow condition of stope on page 74. Photograph on page 75 shows the fractured condition of the foot-wall. The area marked in red is the rock burst zone.

Shows shattered condition of the foot-wall after the
stope had been cleared of loose rock from the walls.
Photograph taken in the narrow section of drift just
east of No. 2 raise.

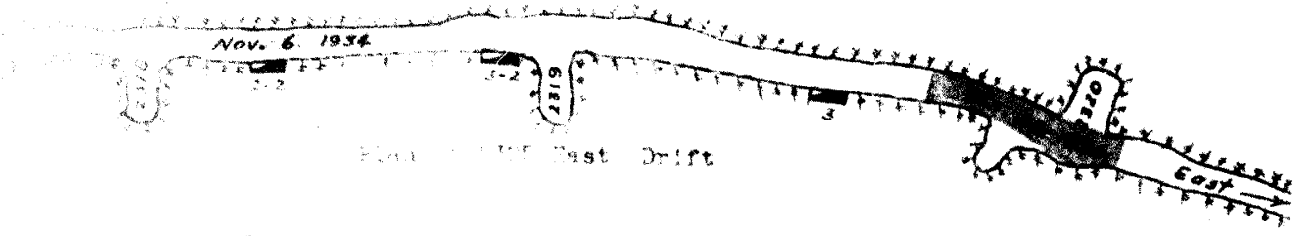
Rockburst Nov. 6 1934
2325 East Drift Sec. 3

On November 6th 1934 at 2.30 A.M. a small rock burst occurred which was followed immediately by a heavy one. See figure page 40. The miners had just blasted 3 breasts in the 2401 E. stope section 2. The vibration from these rounds was strong enough to bring on the burst.

The locus of the rock burst appears to have been in the floor pillar at a point 20 feet to the east of 2--2 raise from the 2401 E. stope. Here the track is heaved about 4 feet bringing loose rock from the floor pillar into the drift. The drift at this point is nearly closed from broken timber and loose rock from the walls and floor of the drift.

In the 2301 E. drift sections 2 and 5 the damaged area begins 20 feet west of No. 2 raise from the 2401 E. stope and extends to the east for a distance of 180 feet. For the first 70 feet of this distance to the 2318 cross-cut the drift has about 2 feet of loose rock thrown from the walls on to the track. In this area there are ten caps broken. Then from the 2318 cross-cut to the 2--2 raise the track has been heaved and thrown out of place. Then from ten feet east of 2--2 raise to 20 feet west of 3--2 raise a distance of 40 feet, the drift is nearly closed with loose rock from the floor

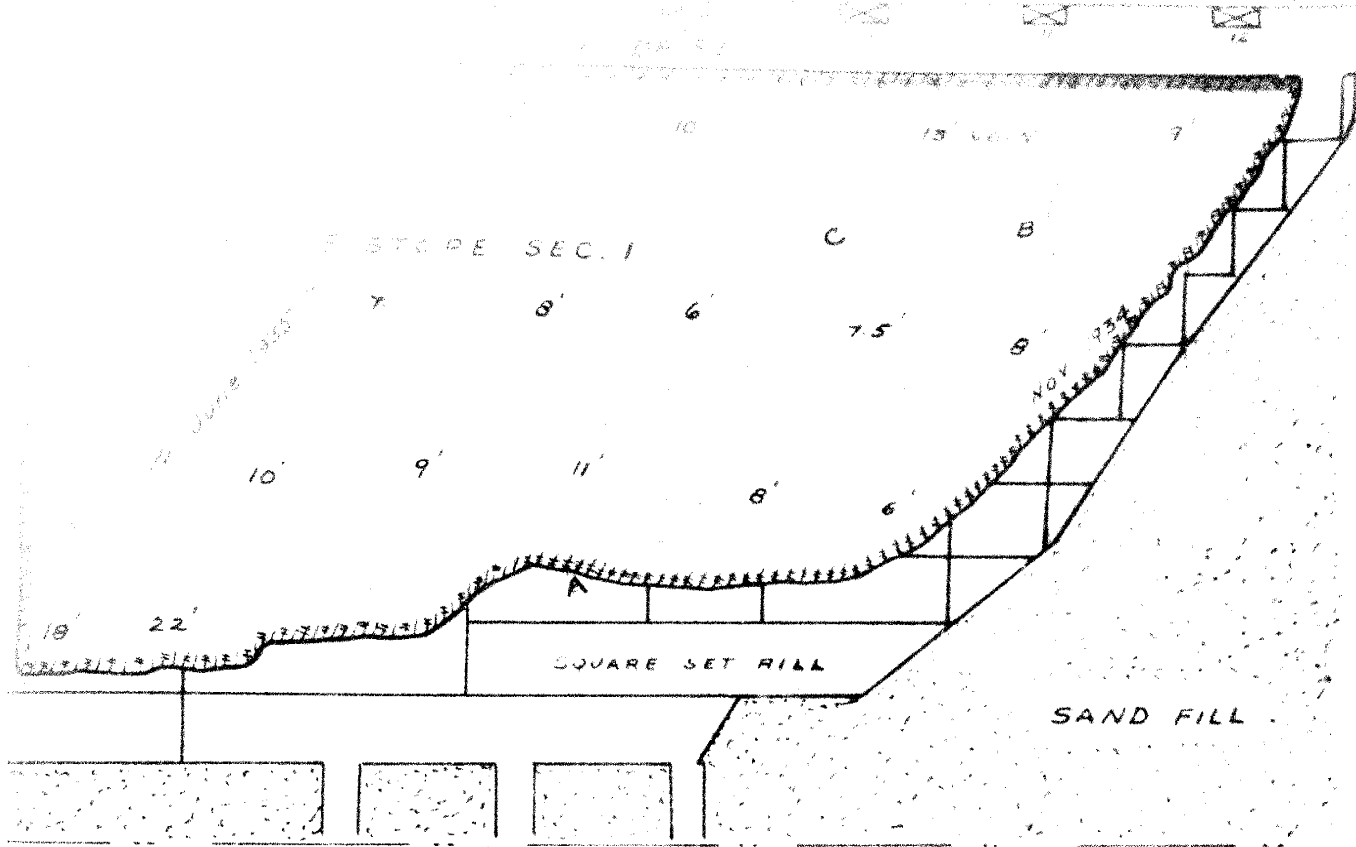
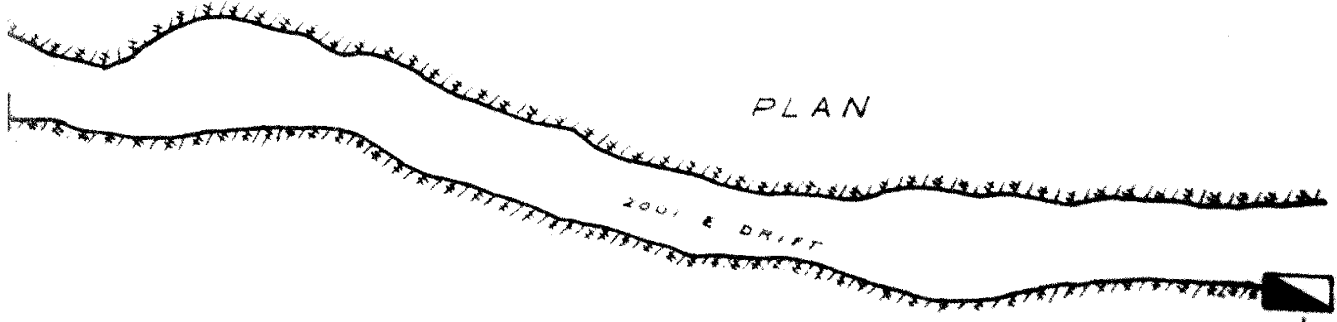
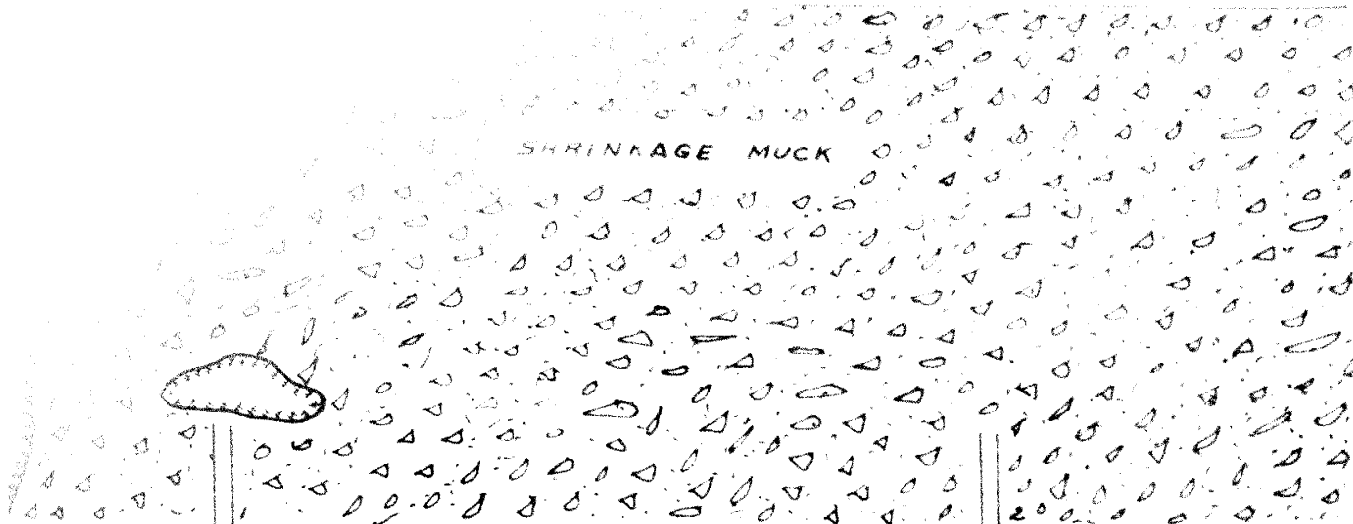
PLAN

For a period of 8 months a close check was kept on the pressure movements of a remnant in 2301 E. slope section 1. Figure 1 page 47 shows this remnant on a scale of 1" = 20'; while figure 2 page 48 is on a smaller scale and shows the area surrounding the remnant.

When the first cut on the rill was brought up to a point B about 20 feet from the 2001 east drift the track started to heave at an alarming rate along the distance marked in red on the figure page 47. See photographs also on page 49. It was thought that a rock burst was imminent. The same indications of pressure occurred when the second cut reached a point C on the figure marked in yellow. It was decided to avoid flat backs on the rill as far as possible. The remnant was made more into the shape of an isosceles triangle with a steep rill making an angle of approximately 55 degrees with the drift. Since this procedure has been adopted it is believed that the remnant will be removed without a

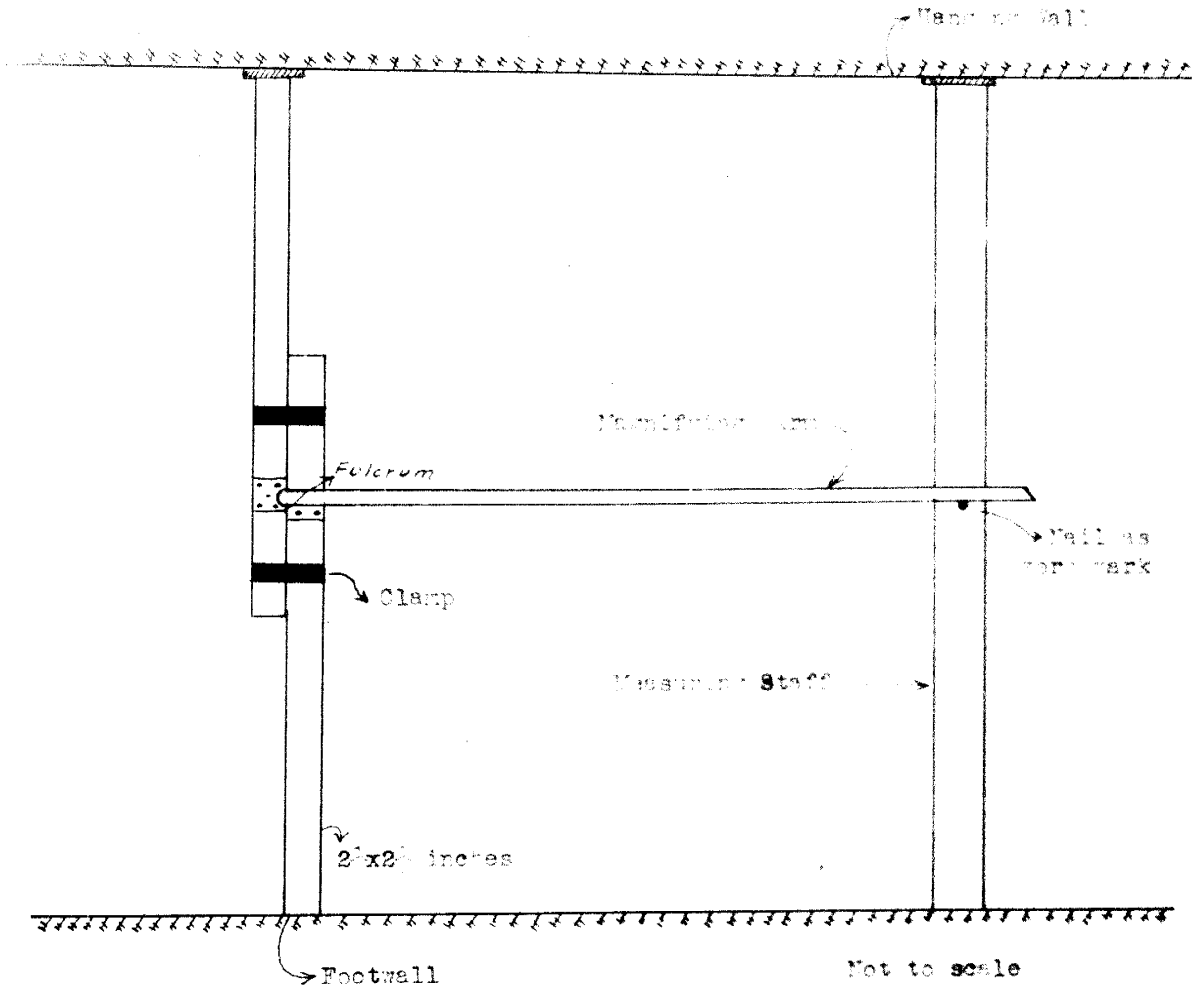
W. D. SAC- Meter

Sag meters consisting of an upright beam and pointer arranged so as to measure the increased pressure were once under consideration. These sag meters are used in the South African Mines; but as conditions in the Lake Shore Mines are different from those in the African Mines it was decided that these sag meters would not be practical. In the mines of South Africa the veins are flat and narrow; while in the Lake Shore Mine the veins are wide and almost vertical. There was also the psychological effect on the miners to be considered. A sketch on page 56 shows one of these sag meters.
