1990 Site Investigation
and
Benzene Hazard Assessment
at the
Bass Site in Albuquerque, New Mexico

Robert R. Alexander

*Submitted in Partial Fulfillment of the Requirements for
the Degree of Master of Science in Geology*

New Mexico Institute of Mining and Technology

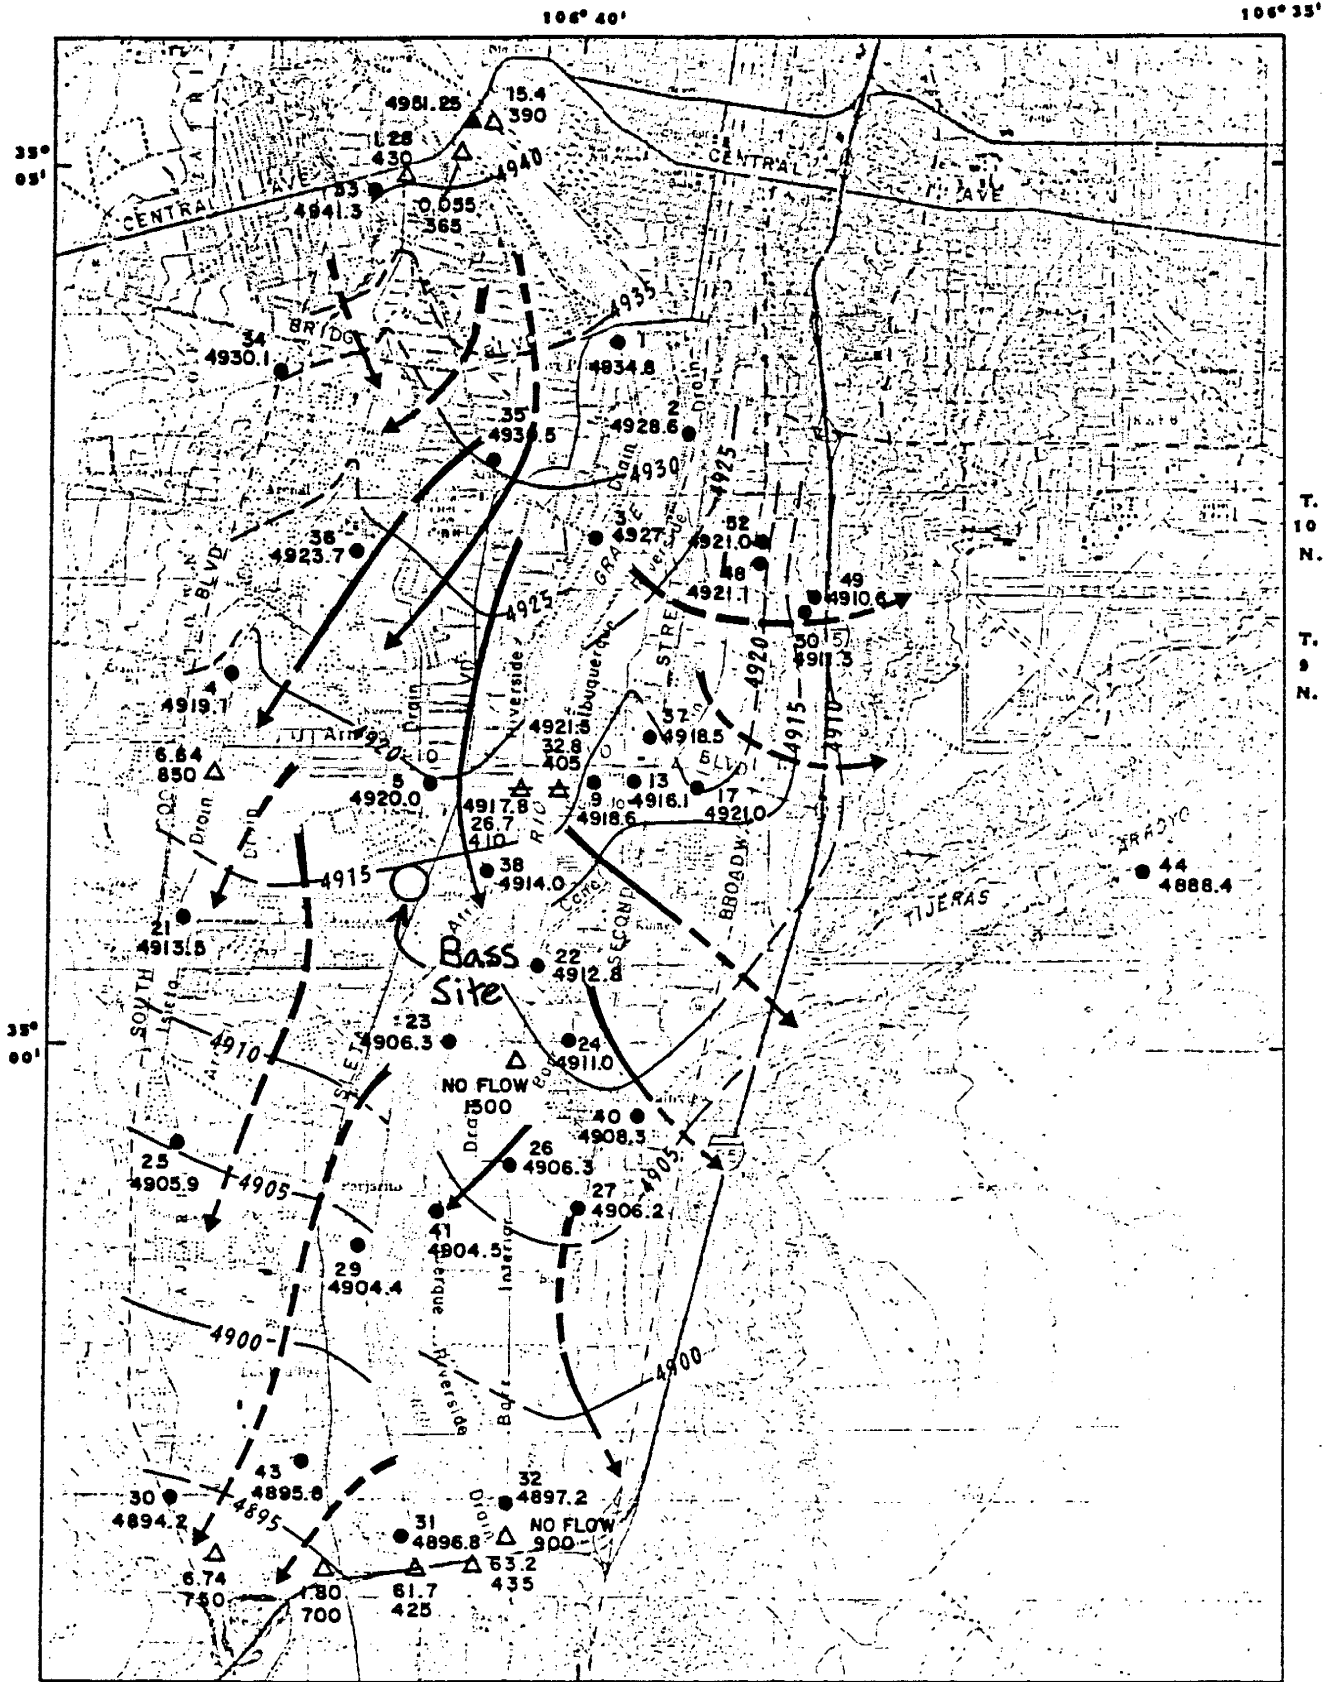
With exception of items #4, #6, and #8, the conclusions reached in Jercinovic's (1984) study appear to be still valid. In regard to item #4, homes on Isleta Blvd. were being hooked up to the City of Albuquerque's water supply starting in August, 1990. It is not known at this time whether this service will be available to homes on Lakeview Rd. With respect to item #6, there was no evidence found during the 1990 field study that sources other than the Bass facility contributed to the contamination at the Bass Site. Finally, there is evidence that suggests that the ground water may flow in directions other than those cited in #8. Studies by Kues (1986) and Peter (1987) indicate that the ground water may also flow to the south or southeast, perhaps as a result of seasonal pumping or inflow from the other drains referred to in #7 (see Figures 4 and 5).

Figure 4. Water levels for wells completed below 4,800 feet above sea level (from Kues, 1986).

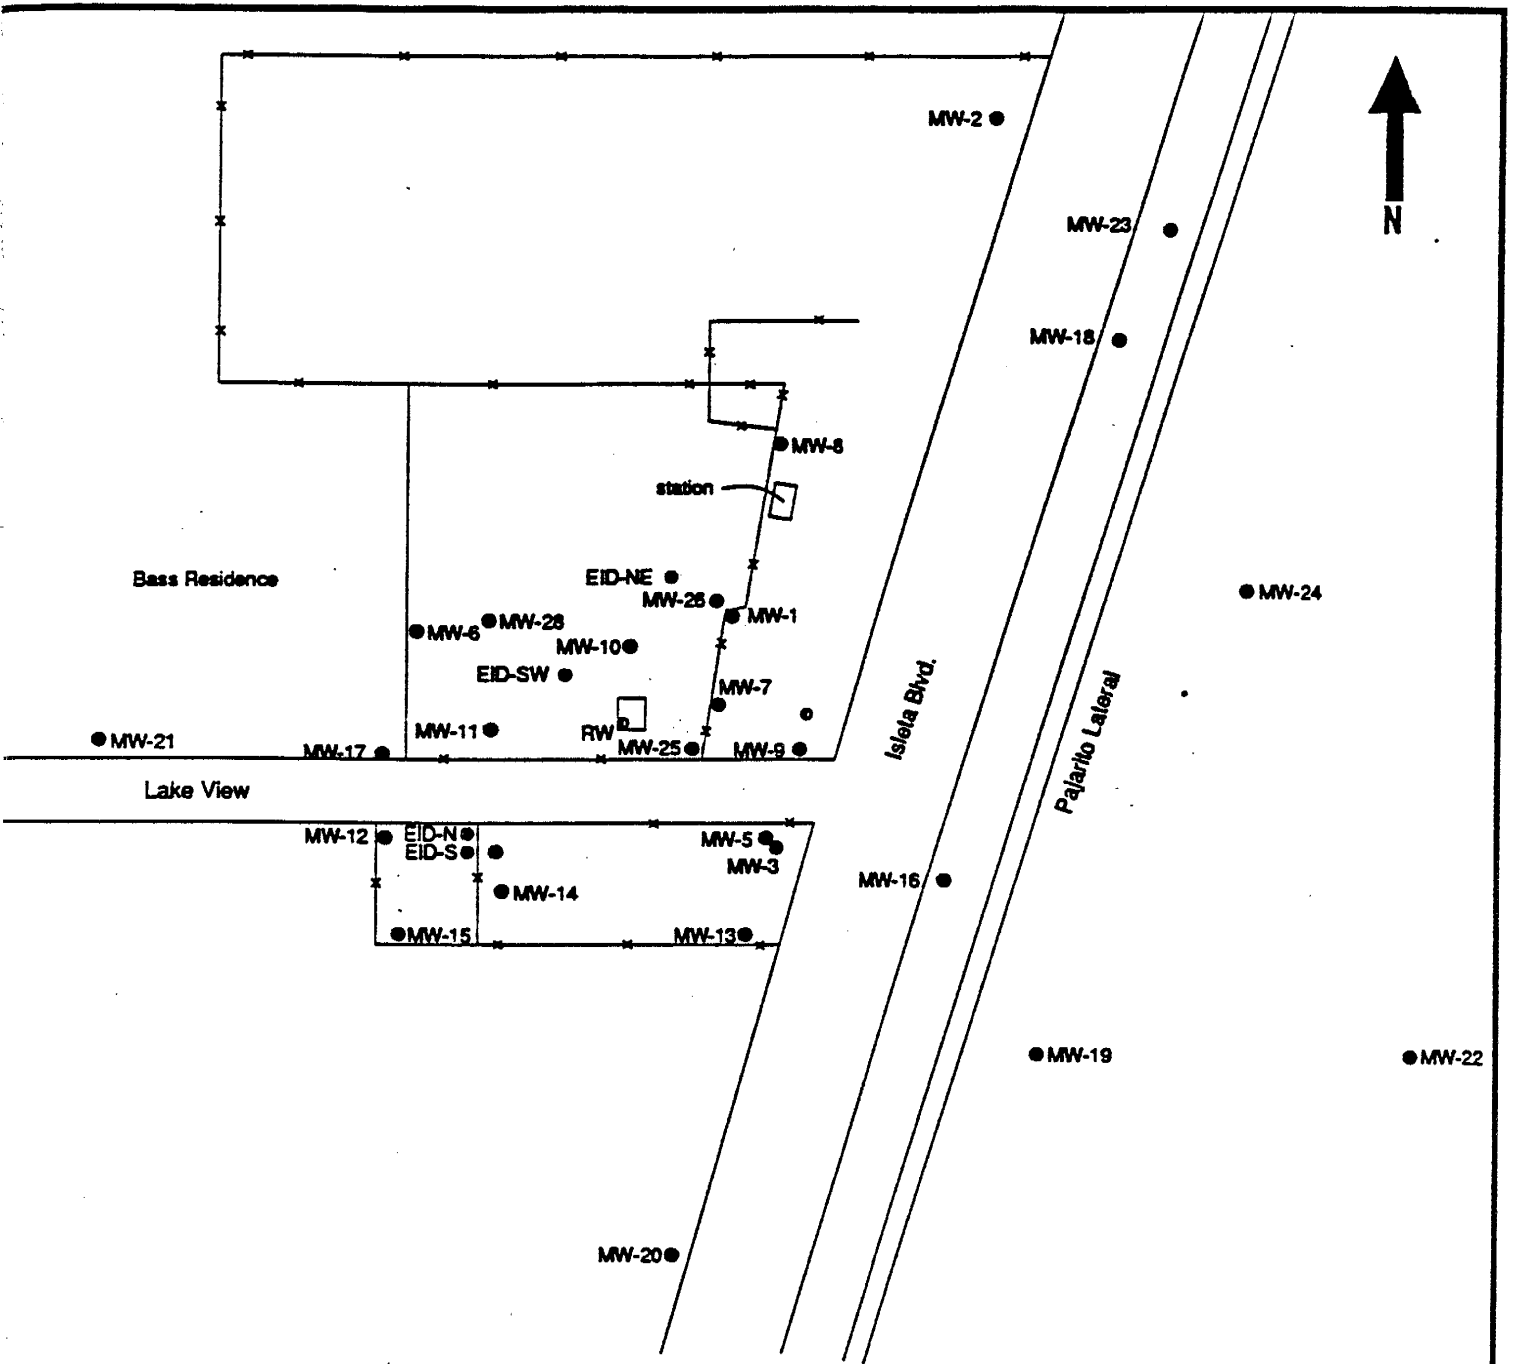
Figure 11

The final action in the 1990 site investigation was the collection of ground water samples at the various monitoring wells around the site. Some 30 monitoring wells had been previously installed in and around the Bass Site by the NMHED and Contractor DEC (Figure 11). Unfortunately, some of the wells have been rendered unusable by acts of vandalism or by degradation of their annular spaces. Others simply could not be located due to dense vegetation.

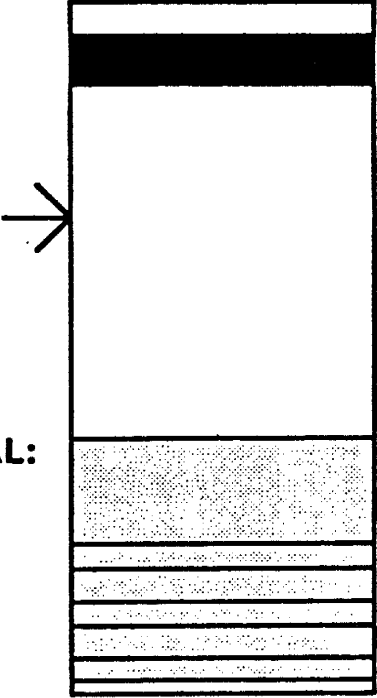
The remaining monitoring wells were sampled in August, 1990. Most of the wells are approximately 15 feet deep and screened above and below the water table from 5 to 15 feet. All are finished above grade with 2" stainless or galvanized steel casings (Figure 12). The well construction details are available in the BAI Update Report (April, 1990).

Figure 12. Typical finishing detail for Bass Site monitoring wells.

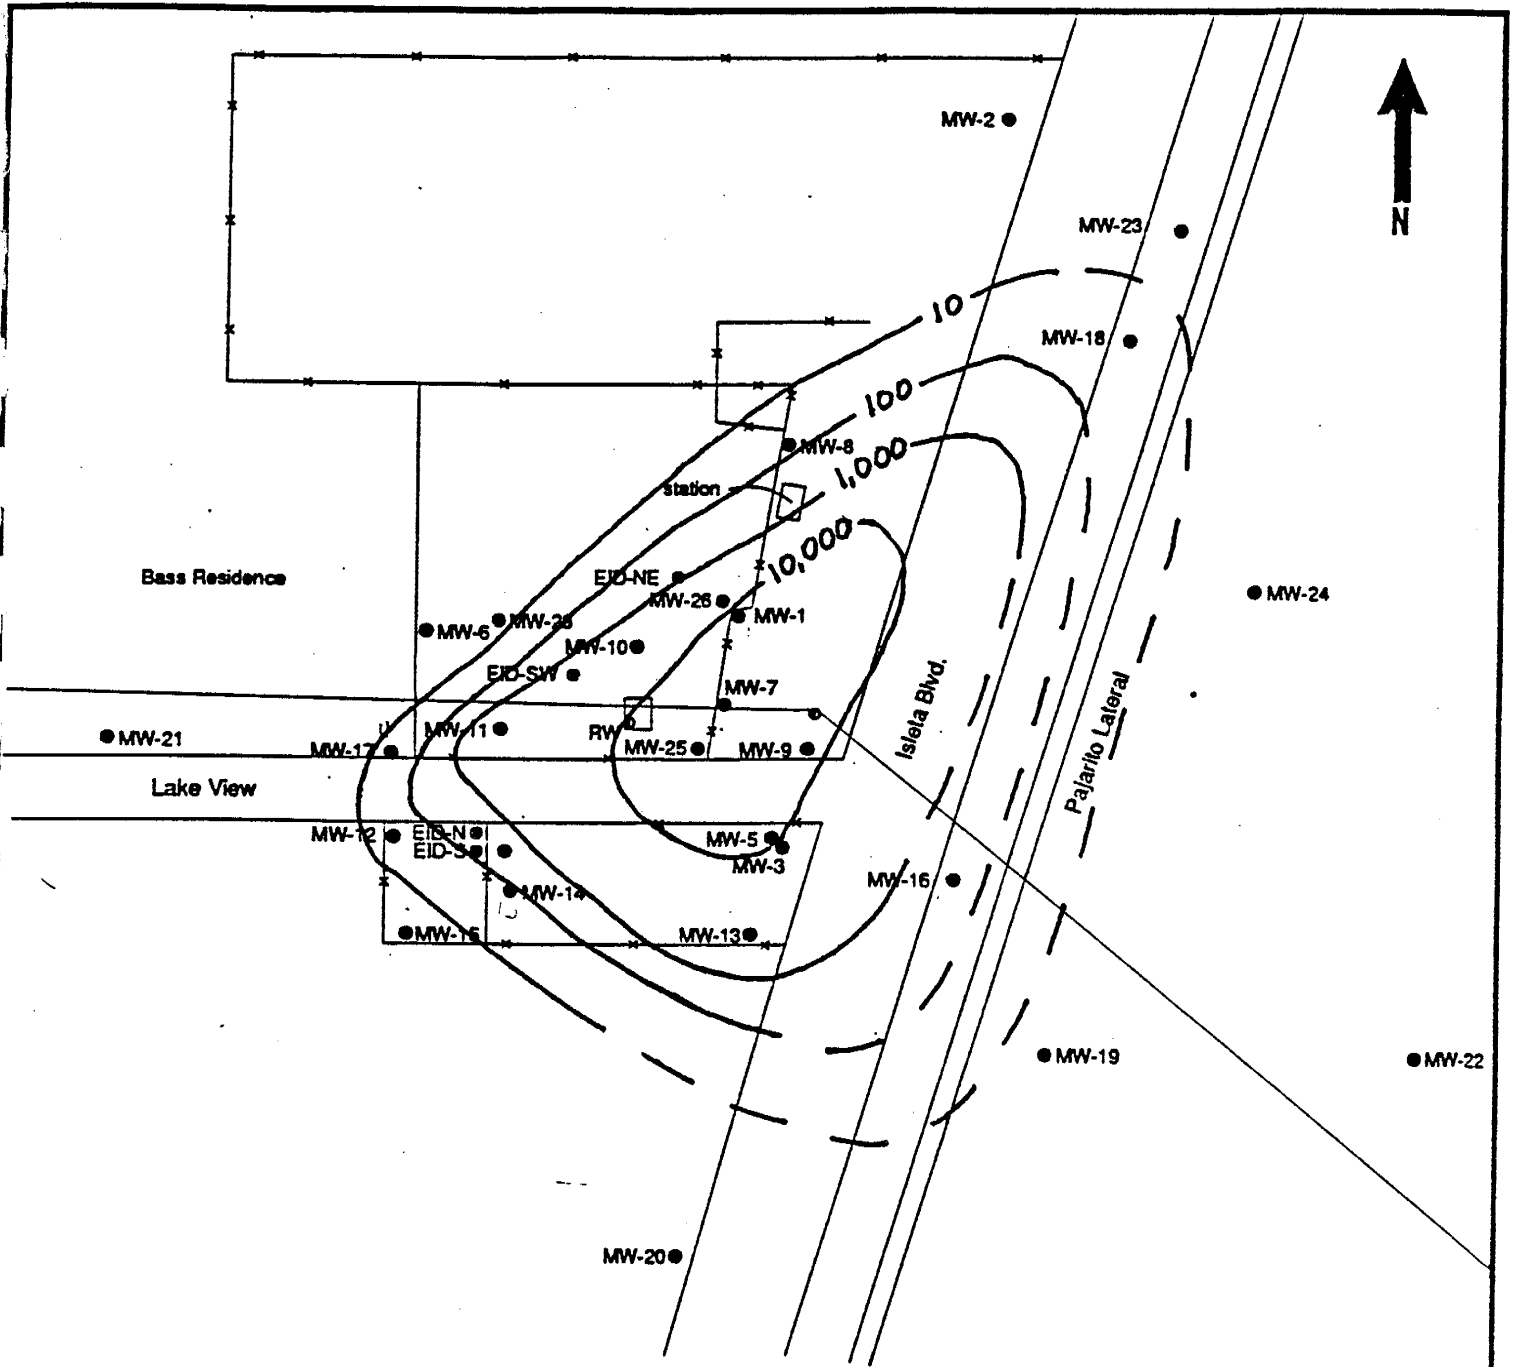
Figure 17

Benzene Concentration July 1989
Bass Site
Billings & Associates, Inc. April, 1990

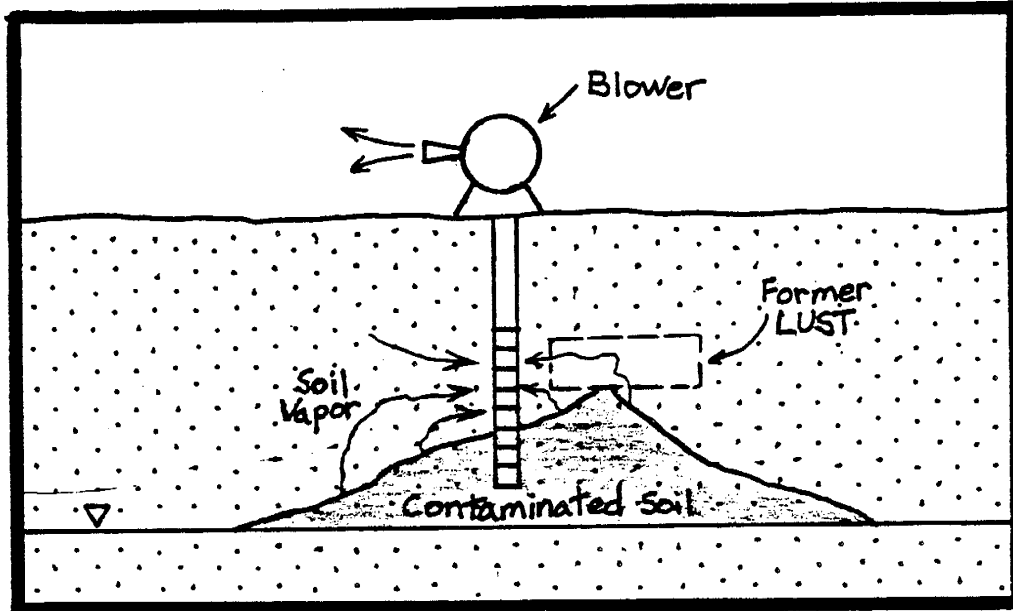
Figure 19. Possible configuration utilizing a single soil venting well (adapted from Hinchee and Miller, 1990).

A relatively new technology, in-situ venting or aeration, was considered to be a much better alternative for the Bass Site. This technique, discussed by Hinchee and Miller (1990), involves actively extracting air out of or injecting air into the vadose zone to encourage microbial activity and/or volatilization through a well drilled near the center of the petroleum contamination. Typically, an extraction well or wells accompany an injection well so that an air flow pattern through the vadose zone is established. Sketches of both systems are presented in Figures 19 and 20. Reports indicating the successful employment of these methods are becoming common in the literature (e.g.

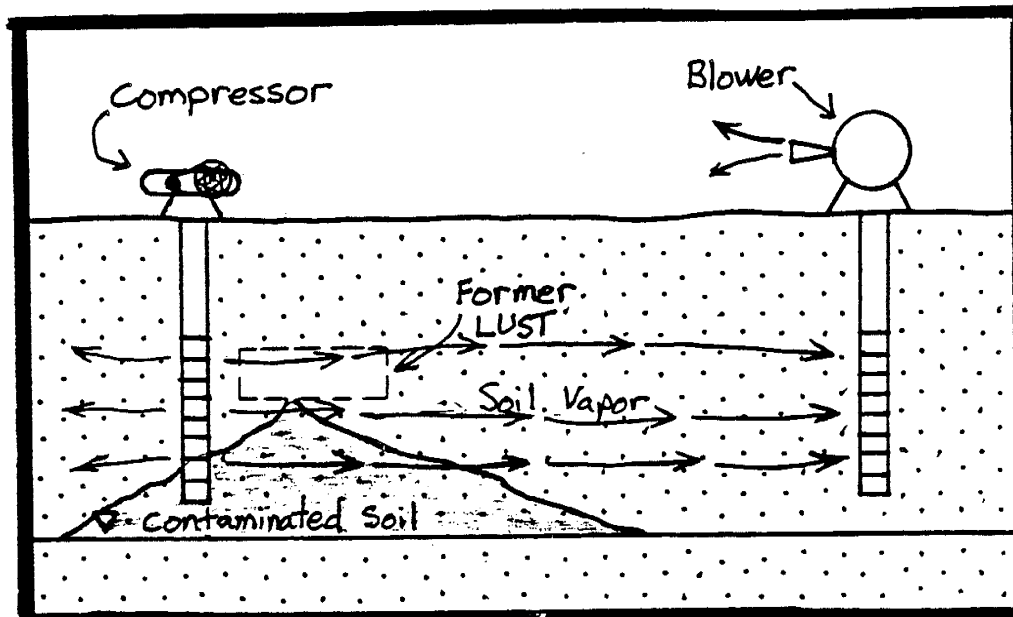
Figure 20. Possible configuration utilizing air injection and soil venting (adapted from Hinchee and Miller, 1990).

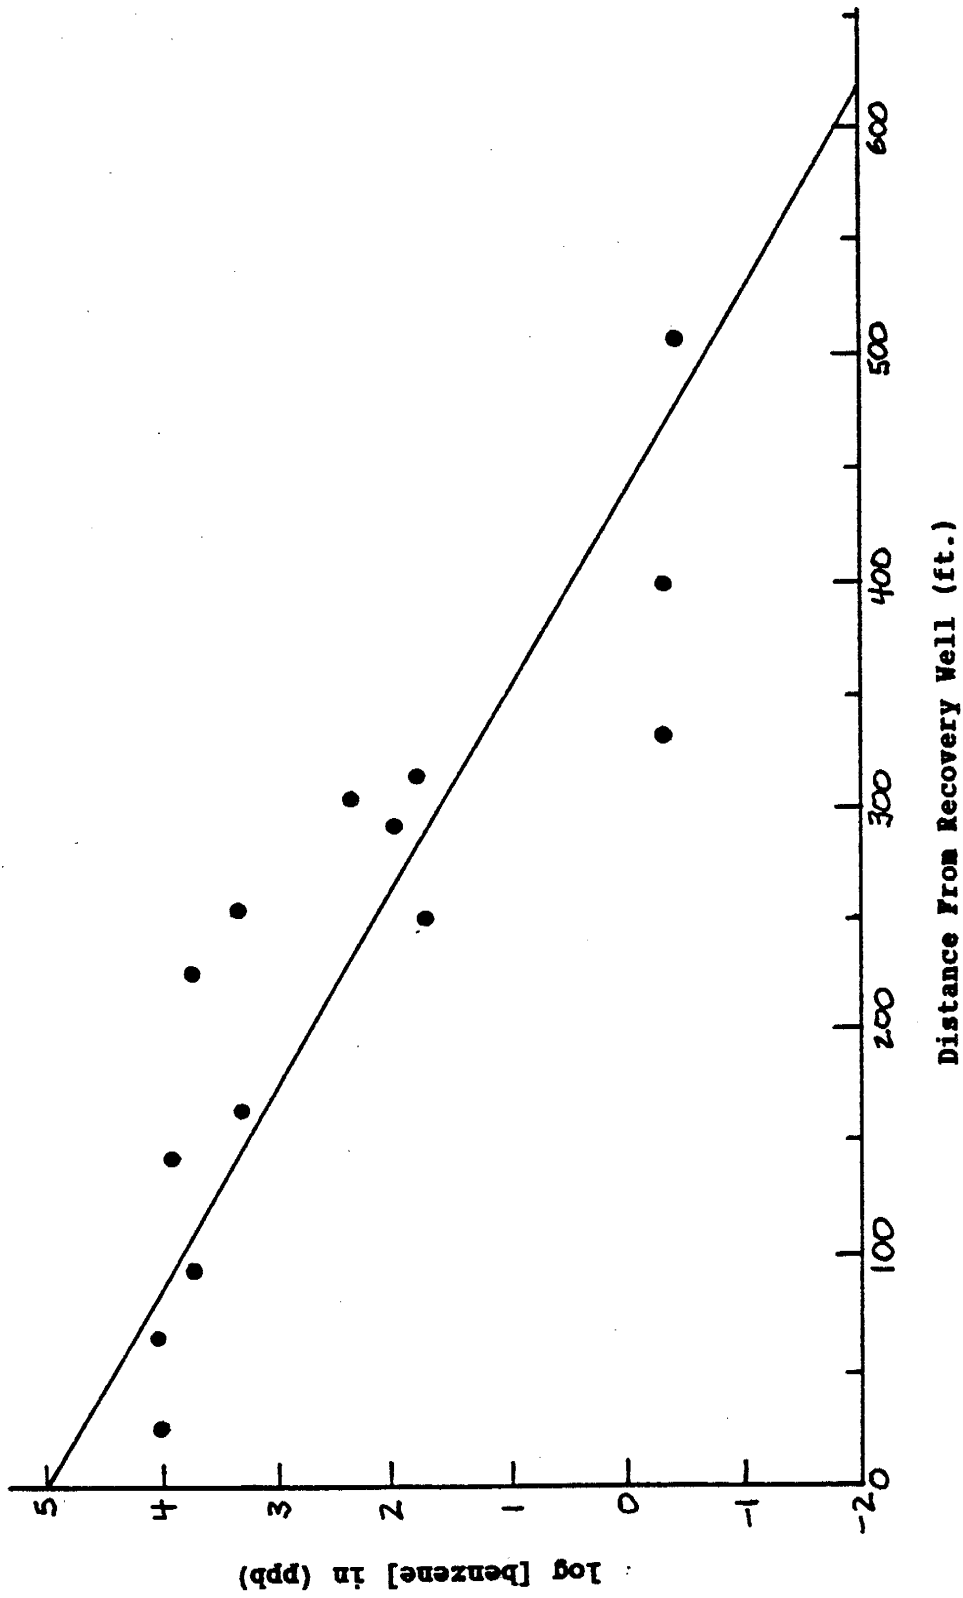
Figure 25. "Best fit" of benzene data vs. monitoring well distance from the recovery well.

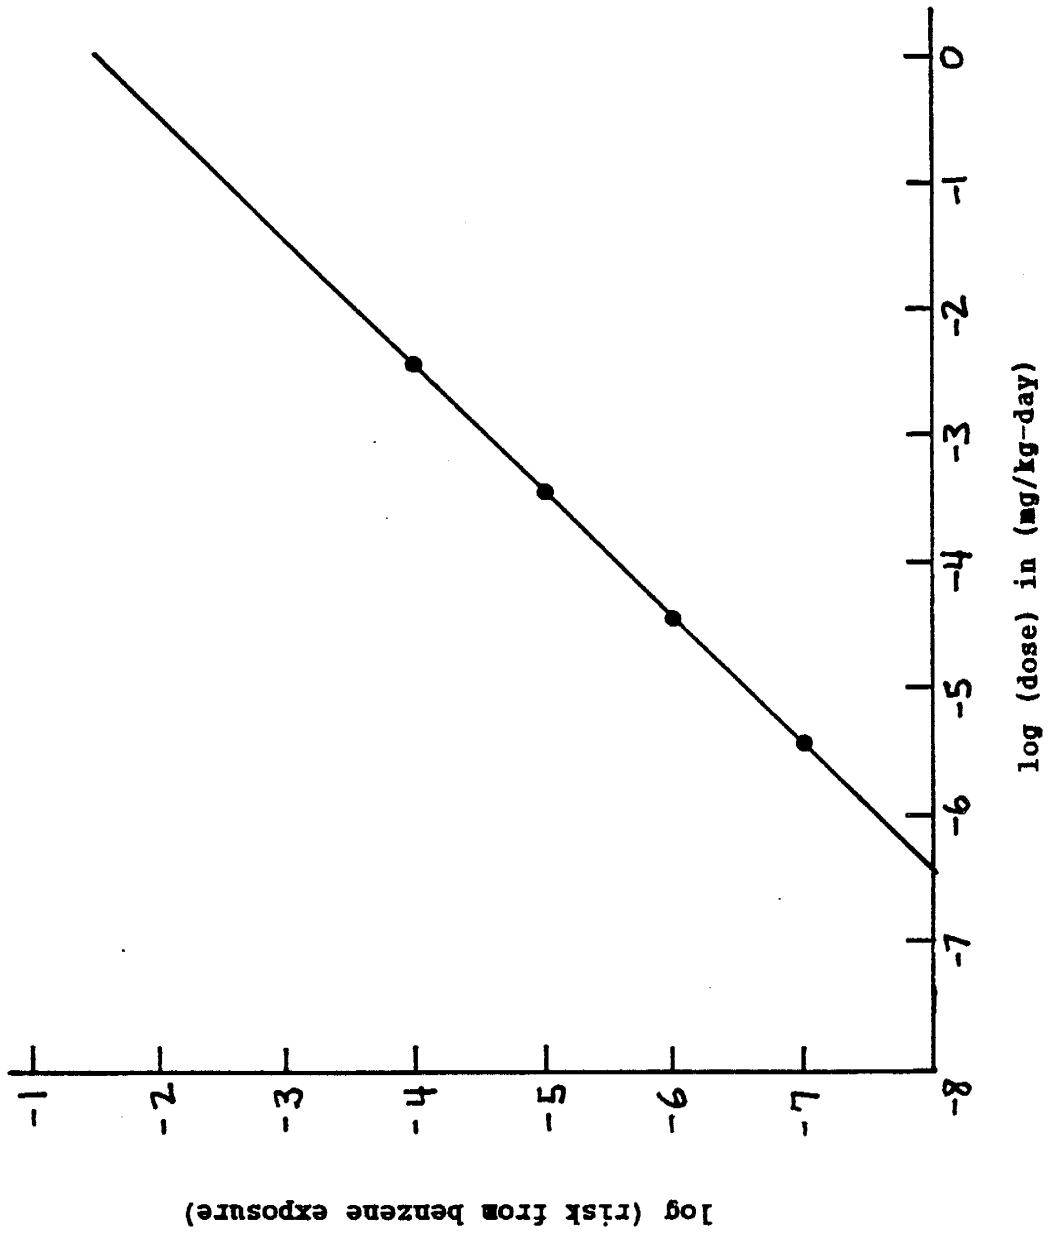
From data presented in the ATSDR (1989) profile, a dose vs. cancer risk plot for the ingestion of benzene was prepared (Figure 26). From Figure 26, the cancer risk can be defined by:

Figure 26. Plot of risk from benzene ingestion vs. dose (prepared using data from ATSDR, 1989).
