**GEOLOGY AND HYDROGEOLOGY OF THE COSTILLA DAM LANDSLIDE,
TAOS COUNTY, NEW MEXICO**

**Submitted in Partial Fulfillment
of the Requirements for the**

Master of Science in Hydrology

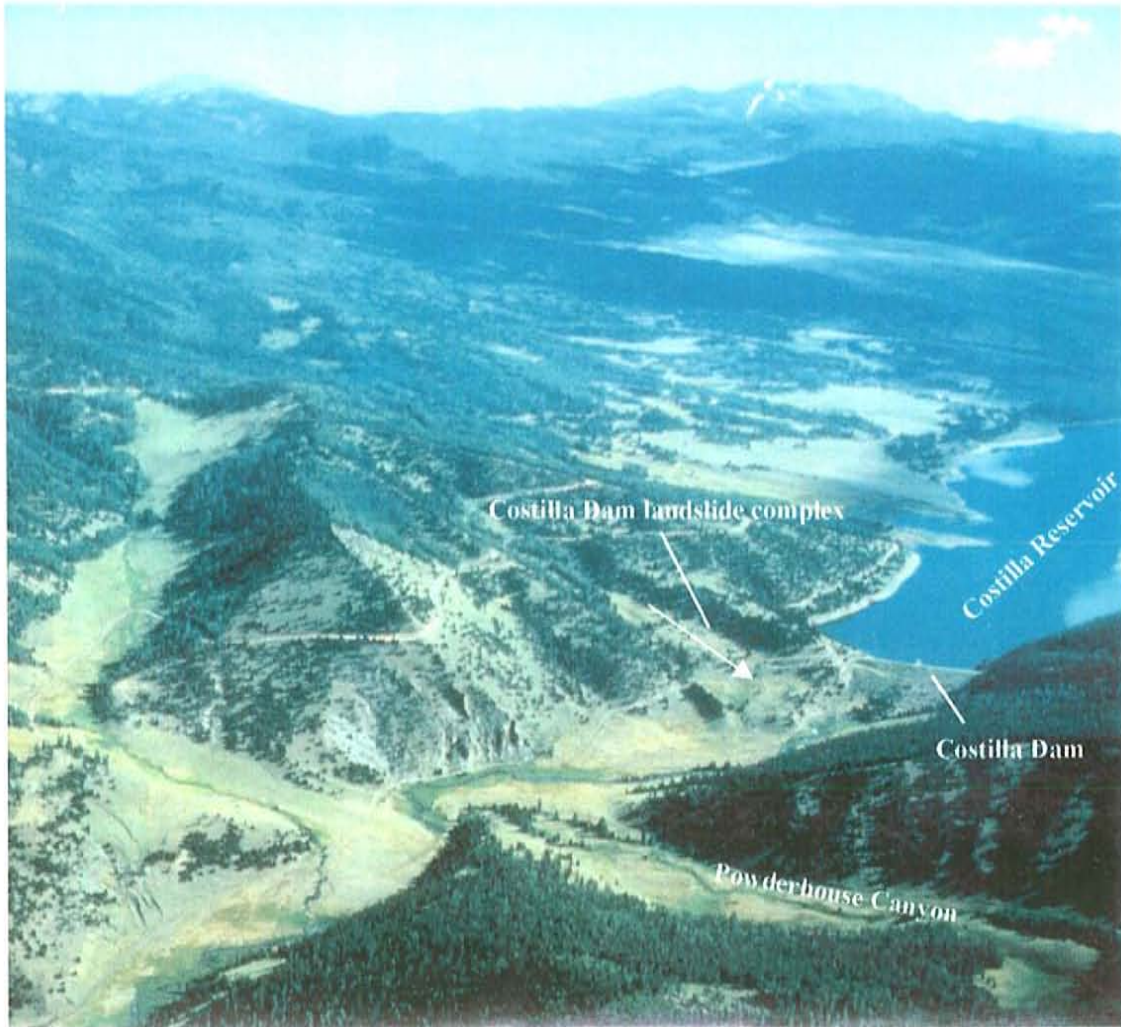
Figure 2

Oblique aerial photo. This photo, taken by the United States Bureau of Reclamation prior to 1989, shows the Costilla Dam landslide complex protruding into the valley, forming the right abutment of Costilla Dam. The photo is taken roughly facing north.

Costilla Dam and the Costilla Dam landslide are located in north central New Mexico approximately 13 km (8 mi.) south of the Colorado-New Mexico border. They are located in the Costilla Valley upstream from the towns of Costilla and Amalia, New Mexico (Figure 1). The Costilla Dam landslide complex forms the right (northern) abutment of Costilla Dam (Figure 2).

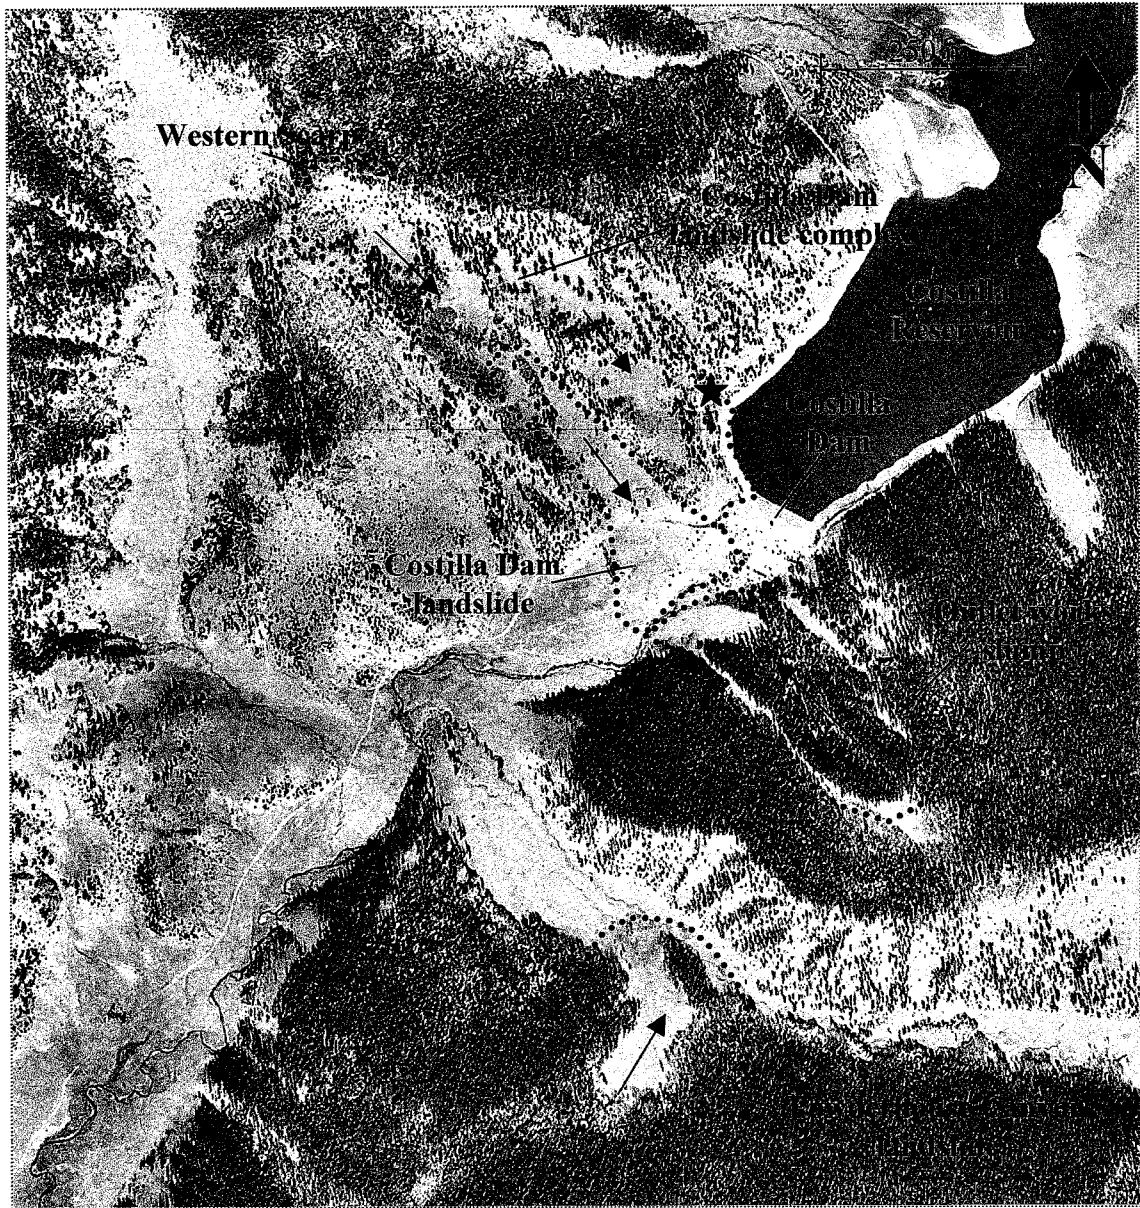
Figure 4

Aerial Photo. This photo was taken in 1962. The Costilla Dam landslide complex has two head scarps, with the eastern scarp being partial. The location of the Costilla Dam landslide activated in 1988 or 1989 is also depicted. Other landslides seen in this photo are the outlet works slump and Powderhouse Canyon landslide. Star indicates the location of the photos taken in figures 12, 16, and 22.

Construction began near the end of the 1988 field season. Specific construction activities directly caused the reactivation of a portion of the Costilla Dam landslide complex. The reactivated portion of the complex will be referred to as the Costilla Dam landslide (Figure 4). A timeline of the events surrounding the reactivation of the Costilla Dam landslide follows. Figure 5 is a topographic map that shows the location of important features identified in the timeline below.

Two old arcuate head scarps of the landslide complex are evident at the crest of the hillside, in aerial photos. The western scarp is a full arc while the eastern scarp is partial (Figure 4). This cross cutting relationship suggests that the eastern landslide moved first and its head scarp was subsequently truncated by activation of the western landslide. The toe of the landslide complex has been obscured by Costilla Creek through erosion and fluvial reworking. However, during movement of the Costilla Dam landslide, a pressure ridge developed near the opposite side of the valley bottom (Figure 18). The location of the landslide toe suggested correctly that the landslide was deep-seated. The northeastern (left) lateral margin of the complex was identified through both topography and geologic mapping. The topography of the valley changes abruptly where the landslide protrudes onto the otherwise broad valley floor (Figure 9 and 4). Also, a small gully has formed at this location (Figure 22). In road cuts on the lower road, the gully separates an unstratified landslide deposit (Figure 16) from a well-stratified basin-fill deposit (Figure 12).

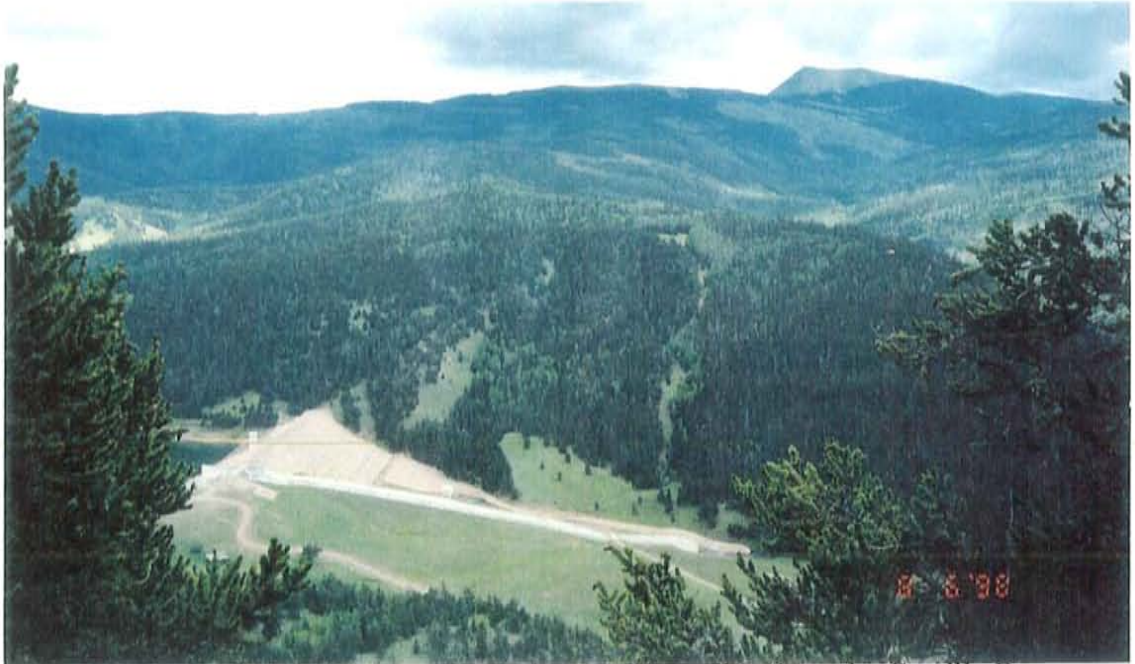
Figure 13 Outlet works slump located across the valley from the Costilla Dam Landslide. The landslide is outlined downstream from the dam by grass vegetation in the midst of the pine forest. Costilla Dam can be seen in this picture. The new spillway lies on top of the toe of the reactivated Costilla Dam landslide and stabilization berm.

Landslide deposits in this area possess most if not all of the above characteristics (Figures 13 through 15). Withholding the recent reactivation of the Costilla Dam landslide, other landslides in the study area do not reflect evidence of recent movement,

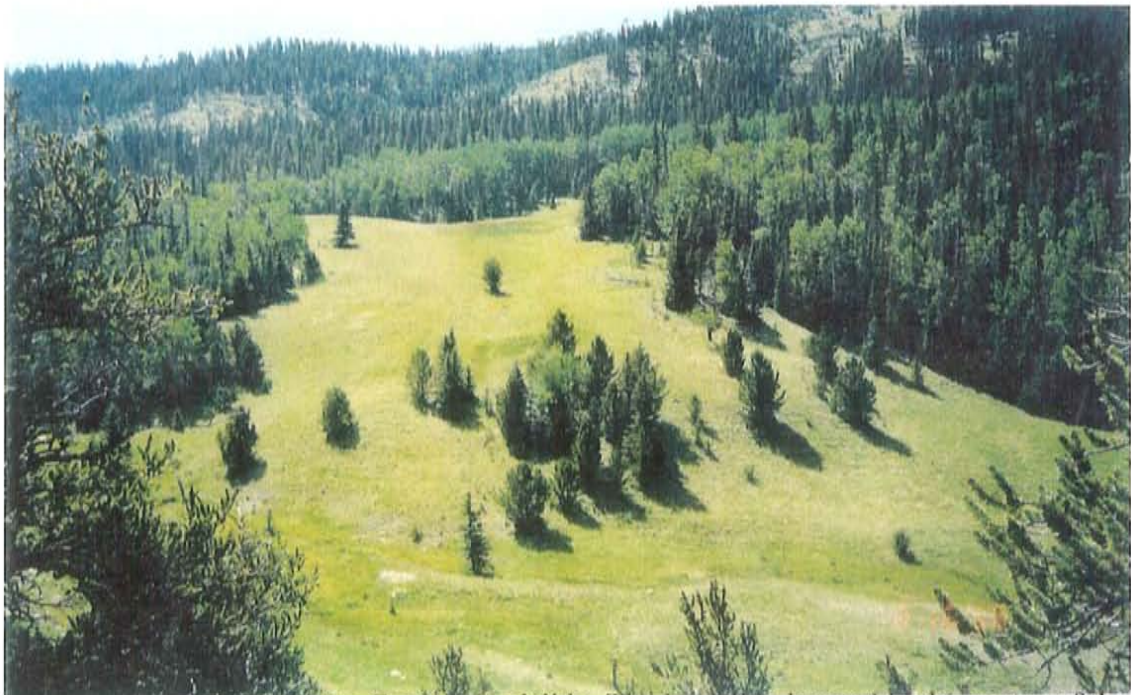
Figure 14 Powderhouse Canyon landslide. The landslide located in the center of the picture can be identified by the hummocky surface, blunt nose, protrusion into the valley, and the dominance of grass on the surface of the landslide. For location of the landslide see figure 4.

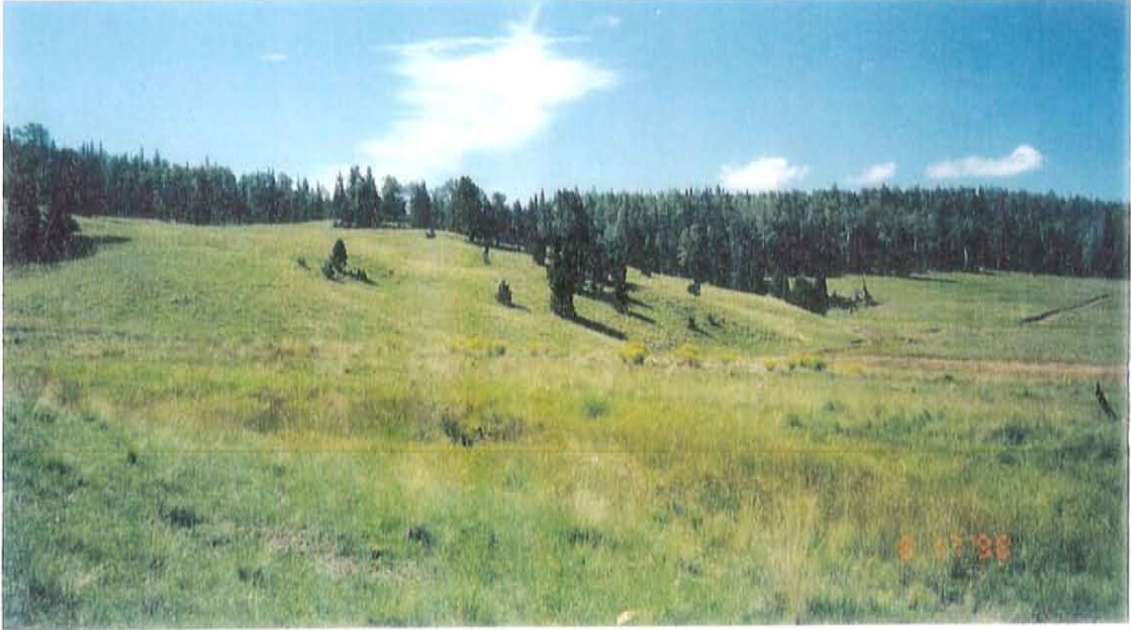
Figure 15 Landslide east of Costilla Reservoir. The landslide located in the left-center of the picture can be identified by the hummocky surface, blunt nose, protrusion into the valley, and the dominance of grass on the surface of the landslide. For location of this landslide see figure 9.

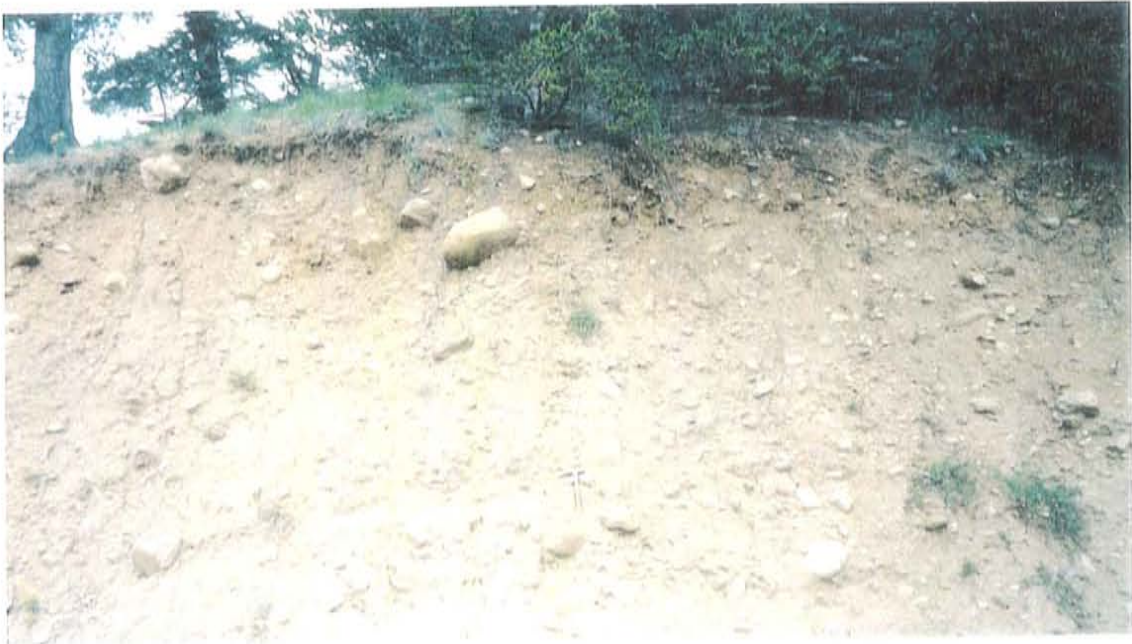
Figure 16 Outcrop of Costilla Dam landslide complex deposit. This landslide deposit is unstratified, poorly sorted, and contains material derived from the parent sedimentary facies of the Santa Fe Group. Outcrop located just upstream of the dam. Rock hammer for scale. For location of photo see figure 4.

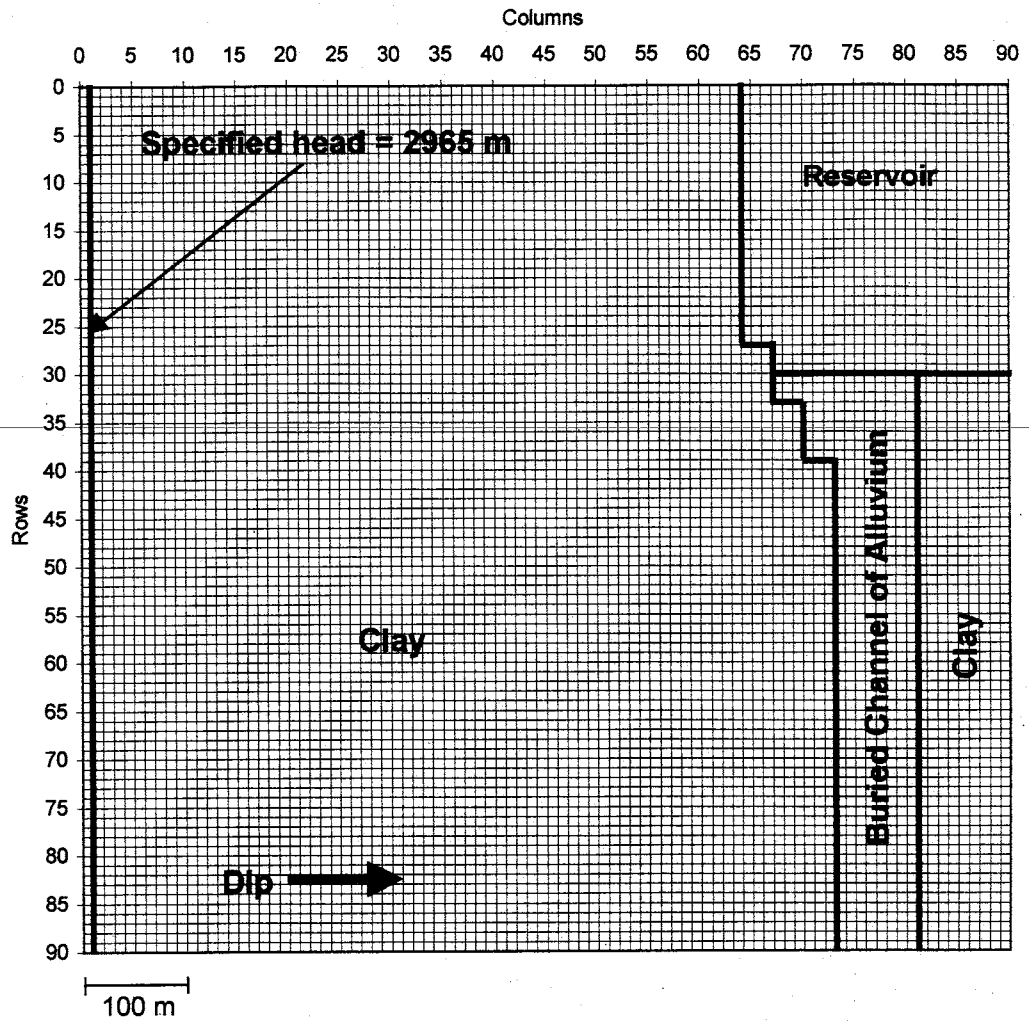
Figure 38

Layer 2 model setup. Layer 2 is a confined model layer that is 5 meters thick. Hydrologic properties of variable cells are either for clay or if within the buried channel, alluvium (Table 2). This layer represents the slide plane beneath the landslide. Cells in column 1 are specified at 2965 meters. The reservoir cells are specified, but are not always constant depending on the simulation.

The conceptual geology of the site is represented by a three-layer model. Layer 1 consists of landslide deposits (upper piezometers), layer 2 consists of clay and the buried alluvium channel, and layer 3 is basin-fill deposits (lower piezometers). Each layer of the model dips 10° into the valley. This dip was determined from the average dip of the landslide slide plane, down the axis of the landslide (Figure 17). Ten degrees is not the same as the dip of the geologic units in the area ($\sim 15^\circ$), but this was chosen to align the dip of the model layers perpendicular to the axis of the valley. Figures 37 - 39 show each individual model layer with areas of interest noted. The hydrologic properties of each material are listed in Table 2. Layer 1 is unconfined with the free surface being limited to this layer, while layers 2 and 3 are confined. "Actual" and "model" values are described in Appendix X and relate to transformations to input data necessary when calculating dipping layer simulations. Actual values would normally be the value of

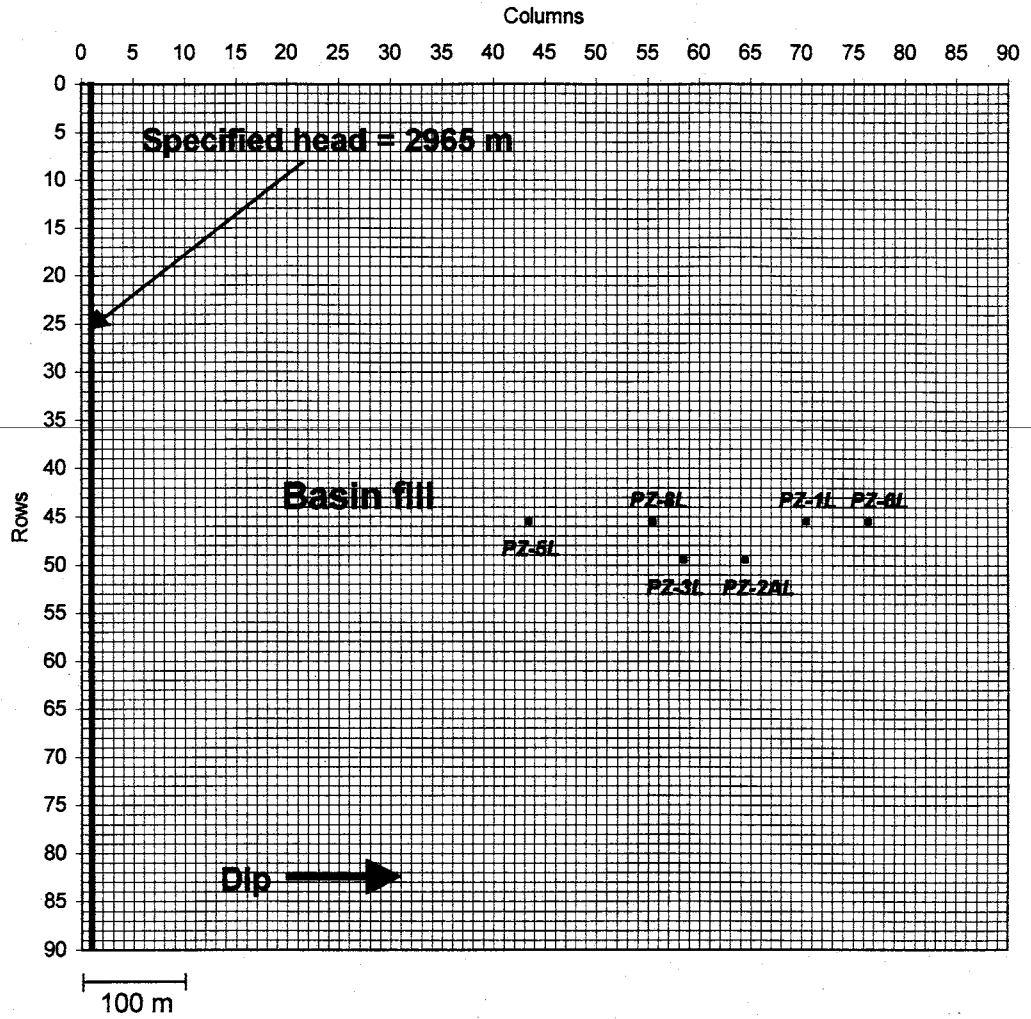
Figure 39

Layer 3 model setup. Layer 3 is a confined model layer that is 30 meters thick. Hydrologic properties of variable cells are all represented by basin-fill deposits (Table 2). Cells in column 1 are specified at 2965 meters. The nodes that were compared to lower piezometer observations are identified.

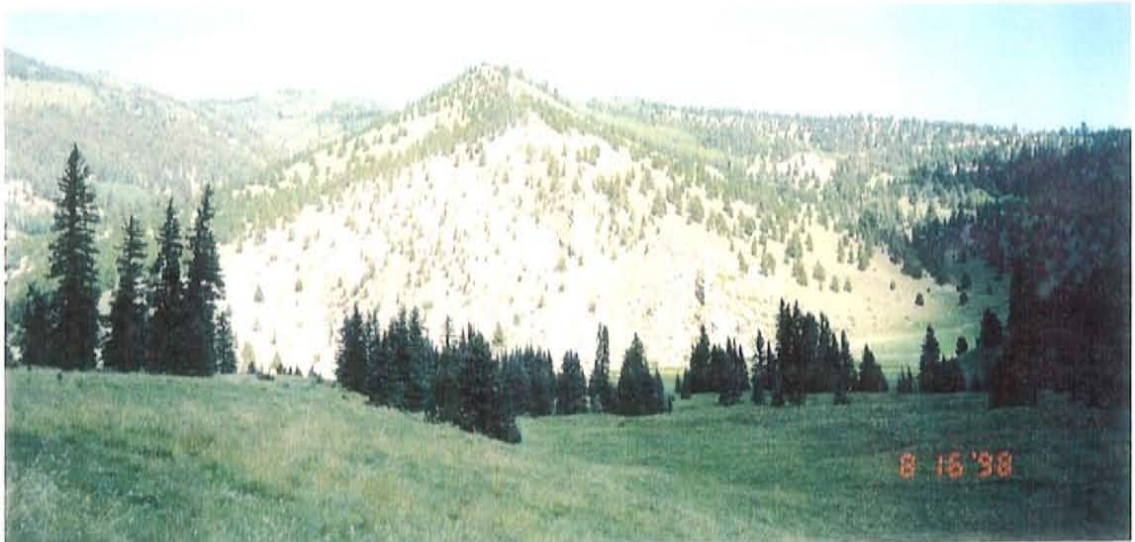
Figure 45 Colluvium/Alluvium unit at the mouth of Powderhouse Canyon. The current colluvium/alluvium unit is located at the bottom of Powderhouse Canyon to the right in the photograph. The abandoned colluvium/alluvium unit is the planar surface that is seen on the far left hand side of the photograph. Vertical difference between these two surfaces is from 3 to 6 meters (10 to 20 feet).

1. The south side at the mouth of Powderhouse Canyon, on the east side of the andesite outcrop (Figure 45).
2. On the north side of the road to the dam, just south of the mouth of Powderhouse Canyon. The larger overall clast size can be observed in the road cut. On the north side of this deposit, the current and abandoned surfaces have the same slope.
3. The mouth of Blind Canyon adjacent to the ash with basal vitrophyre and basalt units (Figure 46).
4. At the mouth of Santistevan Creek upvalley from the dam.

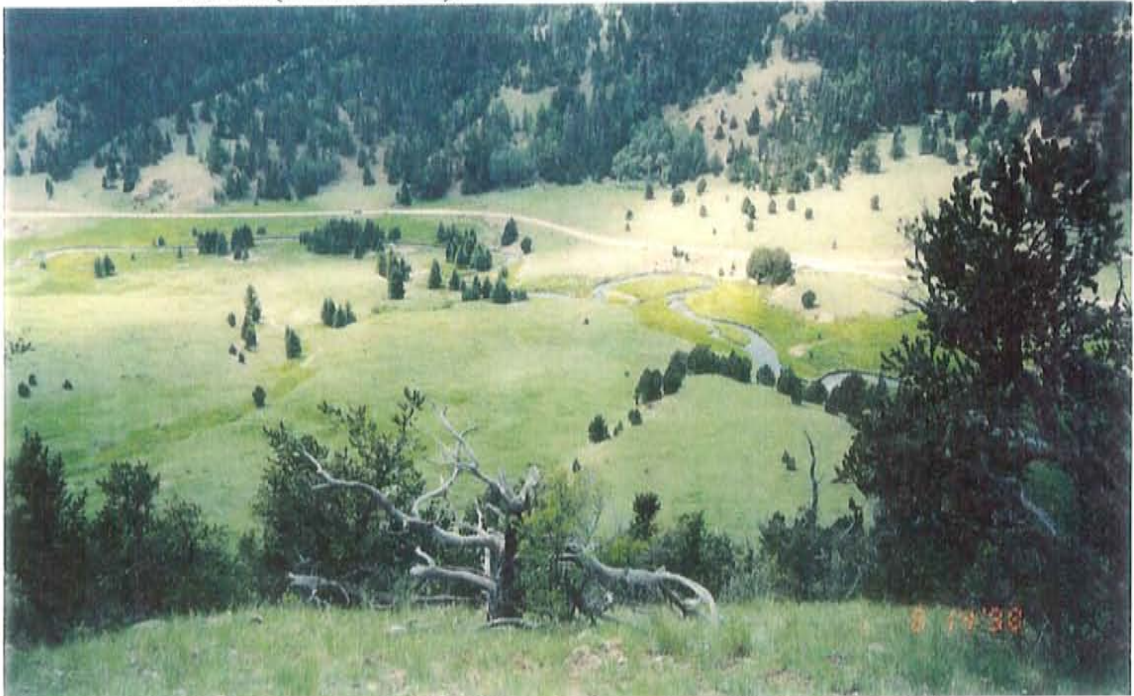
Figure 46 Colluvium/Alluvium unit at the mouth of Blind Canyon. The current colluvium/alluvium unit is seen adjacent to the small tributary stream that flows into Costilla Creek which is the larger stream flowing from right to left. The abandoned colluvium/alluvium deposit is the planar surface that is seen at the base of the hill in the foreground. Trees grow on the steep sides and grass grows on top. The surface is roughly triangular in shape.
